# FINDING the FLAWS in SUPERINSULATION

*The thermal bugs in these 144 superinsulated houses were much the same as in any housing stock. So what have we learned?*

by Gary Nelson

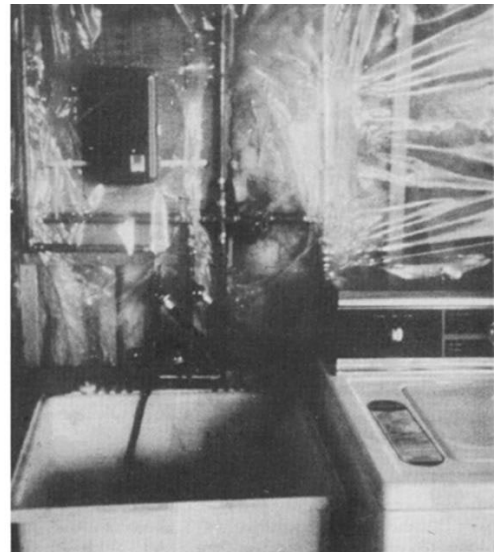
**Figure 7.** A fancy poly job turned to Swiss cheese by a careless plumber. Message: if subs aren't educated and enlisted to help, forget about airtightness.

The program required continuous vapor barriers to reduce moisture problems and infiltration. Although all builders used polyethylene, they paid little attention to making the poly continuous where partitions or floors intersected exterior walls. Vapor barriers were also discontinuous behind bathtubs—creating significant air leaks there. In addition, few builders attempted to seal the poly at plumbing and electrical penetrations. Figure 7 shows a poly vapor barrier that was melted while the plumber soldered the piping for the laundry room. Subcontractors were apparently unaware or didn't care that the poly was supposed to be airtight. A better understanding of the vapor barrier was needed by the subtrades.

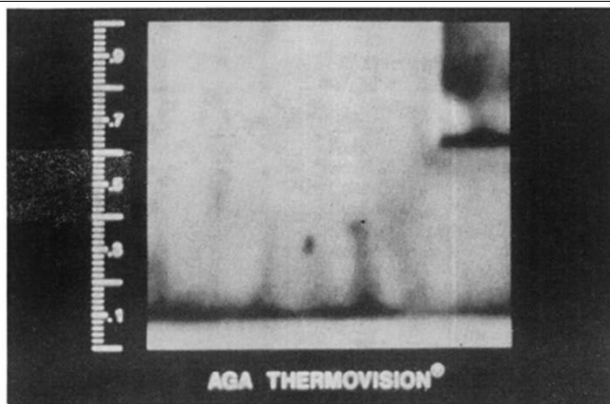
was not performing well. Figure 8 is an infrared photo of a well-insulated wall. Note that the studs appear to be uniform in temperature and width, and are clearly distinguished from the insulated cavities. The cavities appear warmer (lighter) and are also uniform in temperature. Figure 9 is an infrared photo of a wall that's not working as well. Studs are hard to distinguish because large areas of insulated cavity are as cold as the studs. Also the studs appear to get wider and colder at the bottom of the wall. The temperature at the bottom of the wall varies greatly from one cavity to another.

Figure 8 is an infrared photo of a well-insulated wall with warm cavity areas and cooler (darker) stud areas.
