## CASE STUDY:

# FLAT TRUSS FAILURE

BY STEPHEN SMULSKI

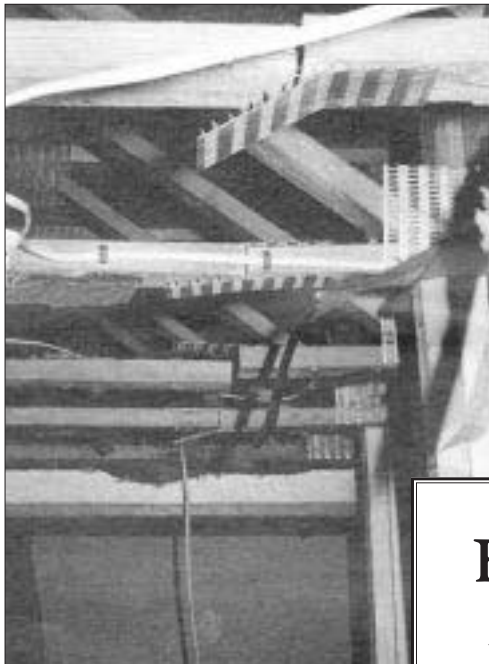
When the insulation was removed, it was discovered that metal connector plates had partially or completely withdrawn from splices in the 4x2 bottom (tension) chords of many trusses ("4x2" is truss terminology for a horizontally-oriented 2x4). Plates were popped at random, with about half of the trusses affected. A few top (compression) chord splice plates were also partially backed out. Web-to-chord panel point connections were essentially unaffected. The trusses were temporarily shored (they were eventually repaired by screwing and gluing southern pine splints over the loosened splices) and an investigation begun.

All observations pointed to the presence of excessive heat and moisture in the closed truss space. Water at 160°F to 180°F circulated through the uninsulated copper pipes of the building's forced hot water heating system that ran through the space. Pipes passed within inches of many of the popped plates, raising the possibility of local overdrying and excessive shrinking. The domestic hot water lines, carrying water at about 110°F, were also uninsulated.

water pipes that ran through the cavity were coated with a heavy green surface patina, and were speckled with drip marks from water vapor that had condensed on their surfaces. The batt insulation located below these pipes was heavily stained and damp in places, as was the truss lumber.

Ungalvanized pipe hangers and fasteners in the space were caked with rust. The surface of the truss lumber had severe raised grain and was dappled with mildew, indicating exposure to at least the threshold 70% surface relative humidity required for its growth. A leaky first-floor shower drain worsened things.

The kraft-faced insulation was a well-intentioned, but misdirected effort to reduce heat loss to the basement. The main problem was that it had been stapled vapor-retarder-out to the bottom chord, effectively closing off the truss space. The insulation acted together with tongue-and-groove plywood subflooring to impede the flow of heat and air into and out of the space. With no easy way to escape, water vapor condensed on the uninsulated cold water supply lines, driving up the relative humidity and wood moisture content during the cooling season. Heat radiating from uninsulated domestic and forced hot water lines drove relative humidity and moisture content down during the heating season.

plate teeth were embedded could easily fluctuate from as low as 6% during the winter to 14% or higher during the summer. Since installed eight years before, the truss plates had endured eight cycles of across-the-grain shrinking and swelling of the wide face of the flat-sawn chords. This cyclic movement caused the chord faces to cup alternately concave and convex with respect to the plane of the plates, ratcheting the 3/8-inch-long teeth out of the lumber.

**EXCESSIVE HEAT  
AND MOISTURE  
CAUSED THE METAL  
PLATES IN THESE  
EIGHT-YEAR-OLD  
FLOOR TRUSSES TO  
LOSE THEIR GRIP**
