Rain Screen Siding R E T R O F I T

by Henri de Marne

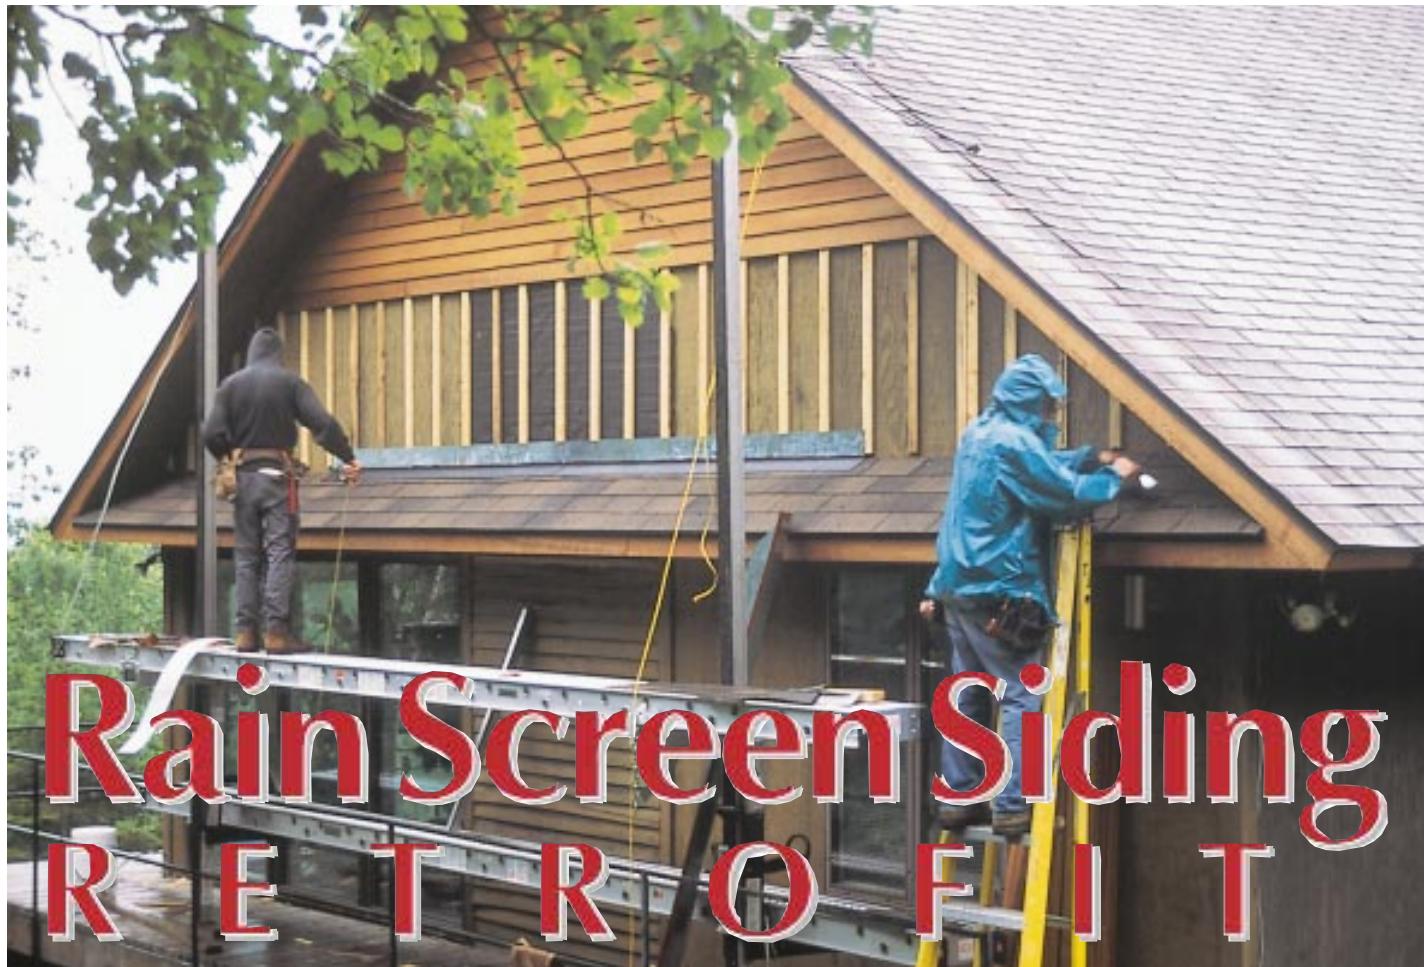
Figure 1. Years of sun and rain on the south-facing gable-end of this 17-year-old house (left) had caused delamination in the rough-textured T1-11 cladding (middle). Clapboards in the central feature strip had also cupped badly, exposing the underlying structure to moisture damage.

bore only the original coat of dark solid stain (see Figure 1). The exposed T1-11 siding had also begun to delaminate.
