These oversights, omissions, and bad design details can lead to early failures

TIME BOMBS

by Martin Holladay

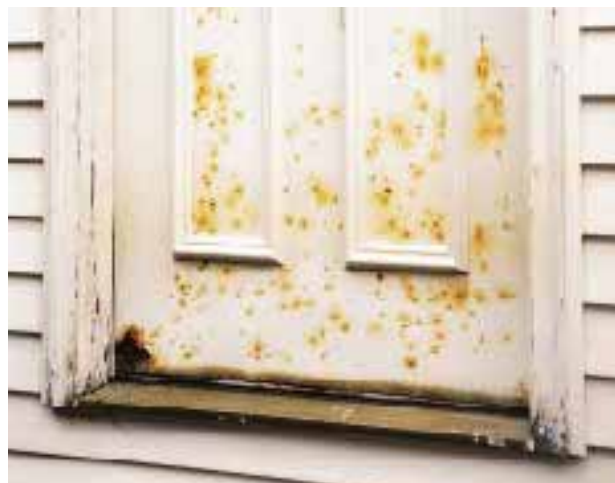
When an exterior door has no roof protection, the lower sections of the jambs and door are vulnerable to rot or rust.

Unroofed exterior doors can begin to deteriorate just five years after installation. They are vulnerable to direct wetting as well as splashback. Usually, the first signs of deterioration are jamb rot and rust spots near the bottom of the door.

Steel door proponents sometimes say that “unlike wood, steel doesn't rot.” Steel doors can rust right through, however, and it happens particularly quickly when the builder fails to paint them. The factory-installed primer on a steel door is not intended to be a finish coat of paint.

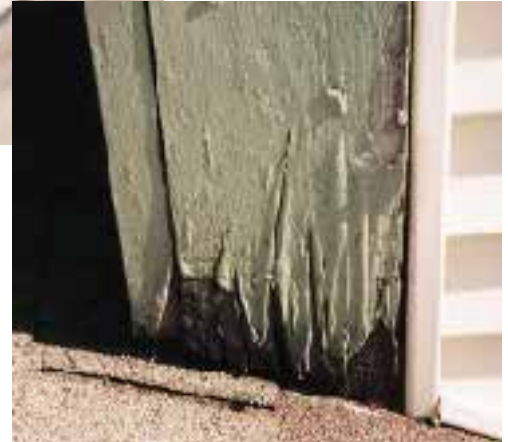
When an exterior wall with wood siding rises above a roof — for example, where a two-story house extends above the roof of an attached one-story garage — the siding and corner trim nearest the roofing can rot quickly. Rain bounces off the roofing onto the adjacent wall. Snow may sit on the roof for months at a stretch.

Instead of butting wood siding and trim up to the roofing, it should be held back to prevent the wood from wicking up water, and to allow for drying.

Ideally, step flashing should be at least 12 inches wide, with 8 inches on the vertical side of the crease, and 4 inches on the roof slope side. That way, the siding and corner trim can lap the flashing by 4 inches, and still leave a gap of 4 inches between the siding and the roofing.

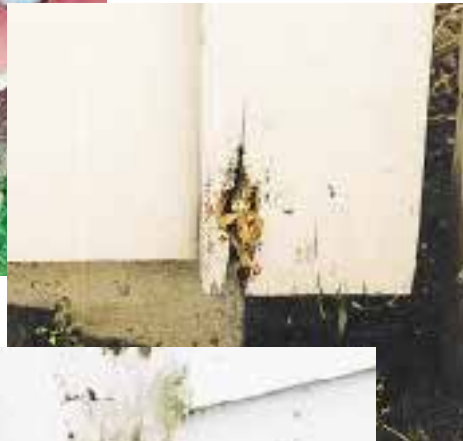
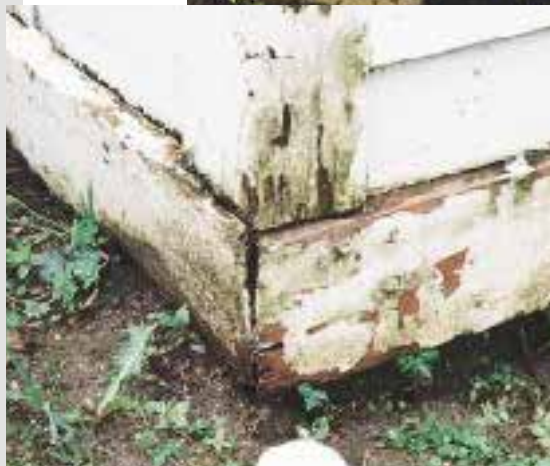
If the grade is too high, the water table and corner trim are kept constantly wet from splashback and damp grass.

Some design and workmanship problems are easier to fix than others. One of the most frustrating errors to encounter, years after construction, is a high grade. Ideally, the final grade should be at least 8 inches lower than the lowest wooden components of a building —usually, the water table or lowest course of siding. Unfortunately, far too often a builder establishes the final grade within an inch or two of the lowest course of siding.

By the time the wooden components nearest grade are beginning to rot — due to splashback or damp vegetation — landscape plantings are usually well established, and concrete walkways may have been poured. At this point, lowering the grade is very expensive. Worse yet, the builder didn't save any money by doing it wrong in the first place. Usually, establishing a lower grade at the time the foundation is back-filled won't cost the builder an extra penny; in fact, if it saves bringing in some fill, it might even be cheaper.

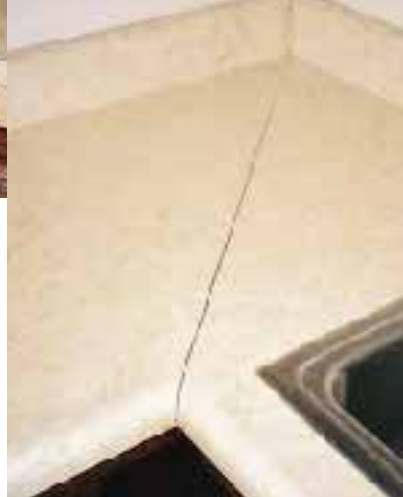
Over time, water will enter a mitered joint on a laminate countertop, causing the particle-board substrate to swell.

In theory, mitered joints in post-formed laminate countertops can work — if they are kept dry. (As we all know, kitchen countertops never get wet.) If these miter joints do get wet, the particleboard substrate begins to swell. If you prefer to use post-formed laminate for kitchen countertops, at least plan the kitchen to keep the miter joint as far from the sink as possible. If the sink is within 4 feet of the miter joint, you had better hope the homeowners don't use their sink very much.

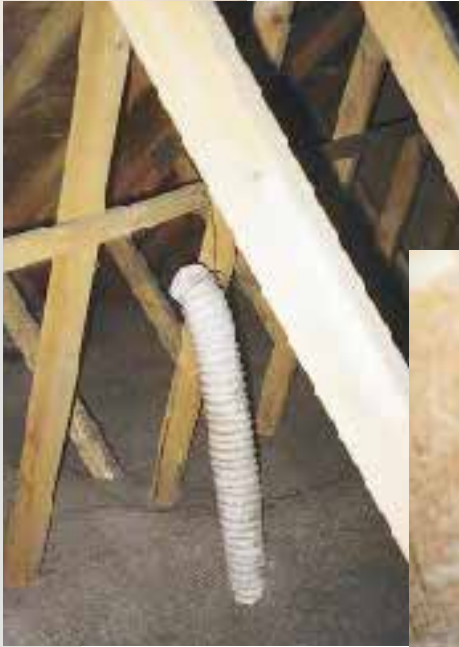
Whenever a bath exhaust duct terminates in the attic, the warm, humid exhaust air can cause mildew and ice dams.

What's wrong with blowing the bath exhaust (or the range hood, or the dryer vent) into the attic? After all, the attic has soffit and ridge vents, so it shouldn't be a problem, right? Actually, there are two problems with this idea: warm temperatures and high humidity. The warm interior air from the exhaust duct raises the temperature of the roof sheathing, melting the snow and leading to ice dams.

And since the interior air (especially bathroom air) is very humid, that moisture will want to condense on the cold surfaces in the attic.

In houses with a bath exhaust fan vented to the attic, the underside of the roof sheathing is often black with mildew. The soffit and ridge vents do not provide enough ventilation to handle the added warmth and moisture from an exhaust duct.

The bath exhaust fan should always be ducted to the exterior, never terminated in the attic. To be charitable, this is one of those items that is not so much a deliberate error as a forgotten detail. "Sure, I was going to get back up in the attic, as soon as the siding was done, to take care of that bath exhaust duct ..."
