Rainproofing Stucco Trim

Nailing trim through stucco without proper flashing is a recipe for disaster

by David Dobson

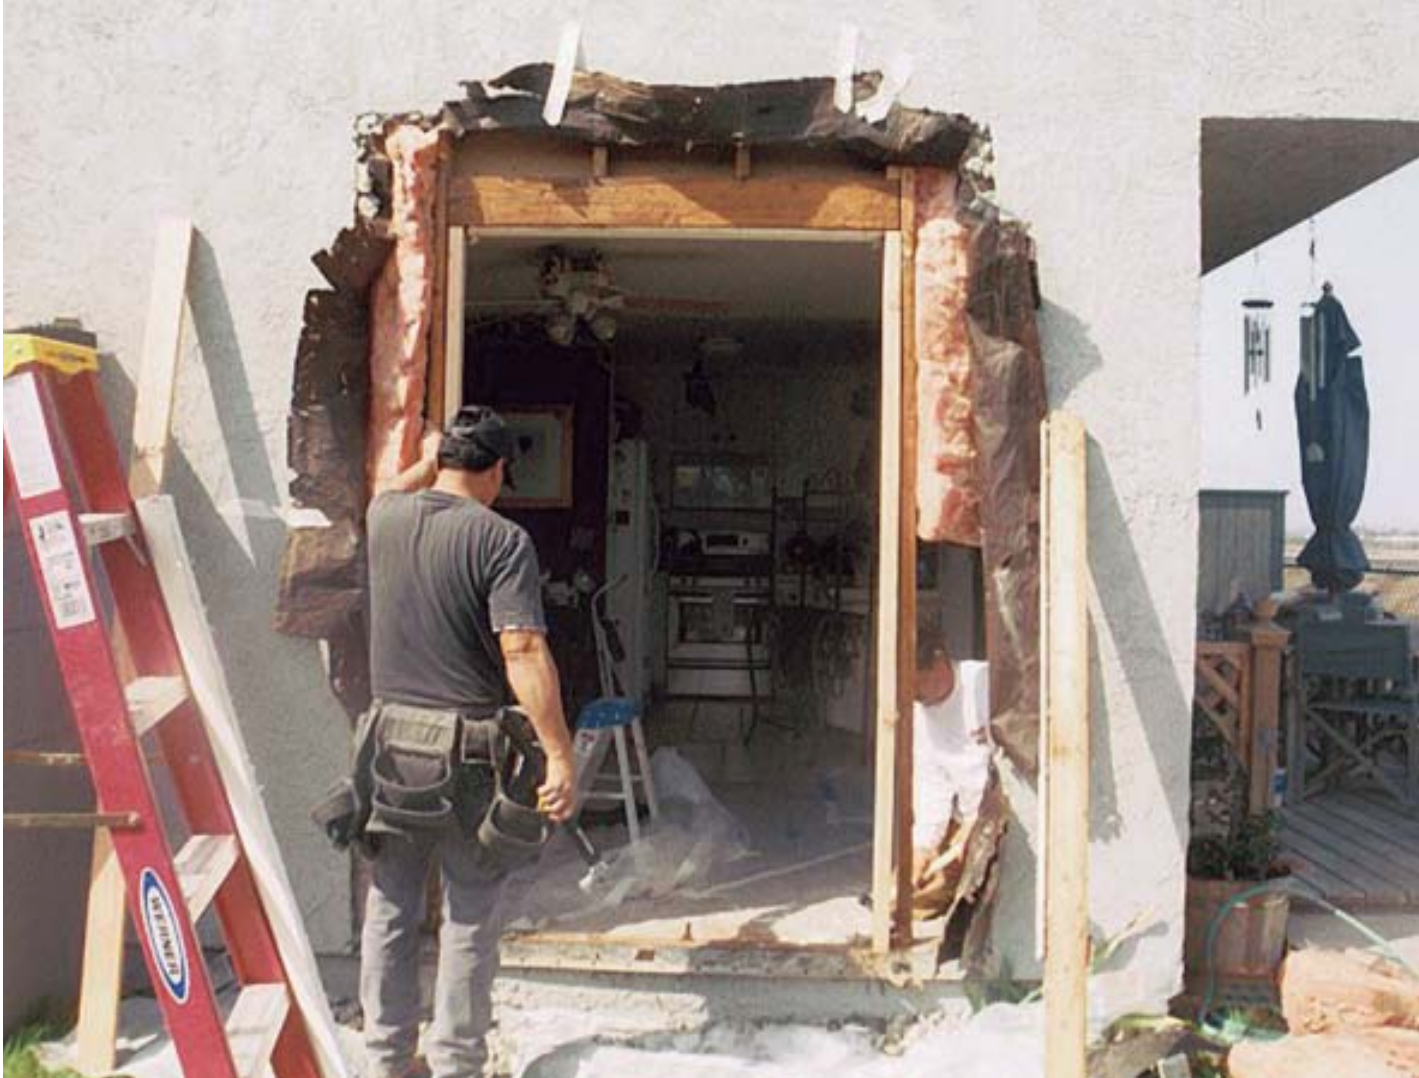
Every time it rained, water would soak the carpet under the windows of an acquaintance's Southern California condominium. Built about 20 years ago, this former apartment complex had a standard three-coat stucco and lath finish applied over building paper stapled directly to framing; 2x6 rough-sawn wood trim

was nailed through the stucco around the windows and horizontally around the entire building. Because the window, trim, and surrounding stucco appeared to be undamaged on the exterior, I suspected that water was probably following the trim's nails right through the stucco and into the walls (see Figure 1, next page).
