# A Cost-Effective Energy Retrofit

With careful air-sealing and the right insulation details, a leaky older home becomes a tight and thrifty one

by Terry Nordbye

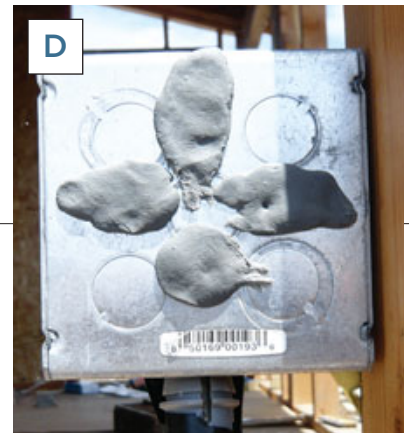
After sealing every crack and penetration we could find, we sheathed the exterior walls and crawlspace ceiling with OSB, having already removed the original fiberglass batts from the framing cavities to make room for the dense-pack cellulose that would be blown in later. To further cut back on air leaks, we installed the wall sheathing over freshly applied beads of canned one-component spray foam, which expanded to fill the gaps between sheets (Figure 4, next page). There was no edge-blocking in the crawlspace ceiling, so we sealed the joints not backed by framing members with paper drywall

tape embedded in a coating of DP 1010 duct mastic (800/641-0808, designpoly.com). The gap at the perimeter of the ceiling was too large for mastic, so we sealed it with more spray foam.
