Rebuilding on the Gulf Coast

A combination of engineered lumber, steel, and structural insulated panels provides protection against the next hurricane

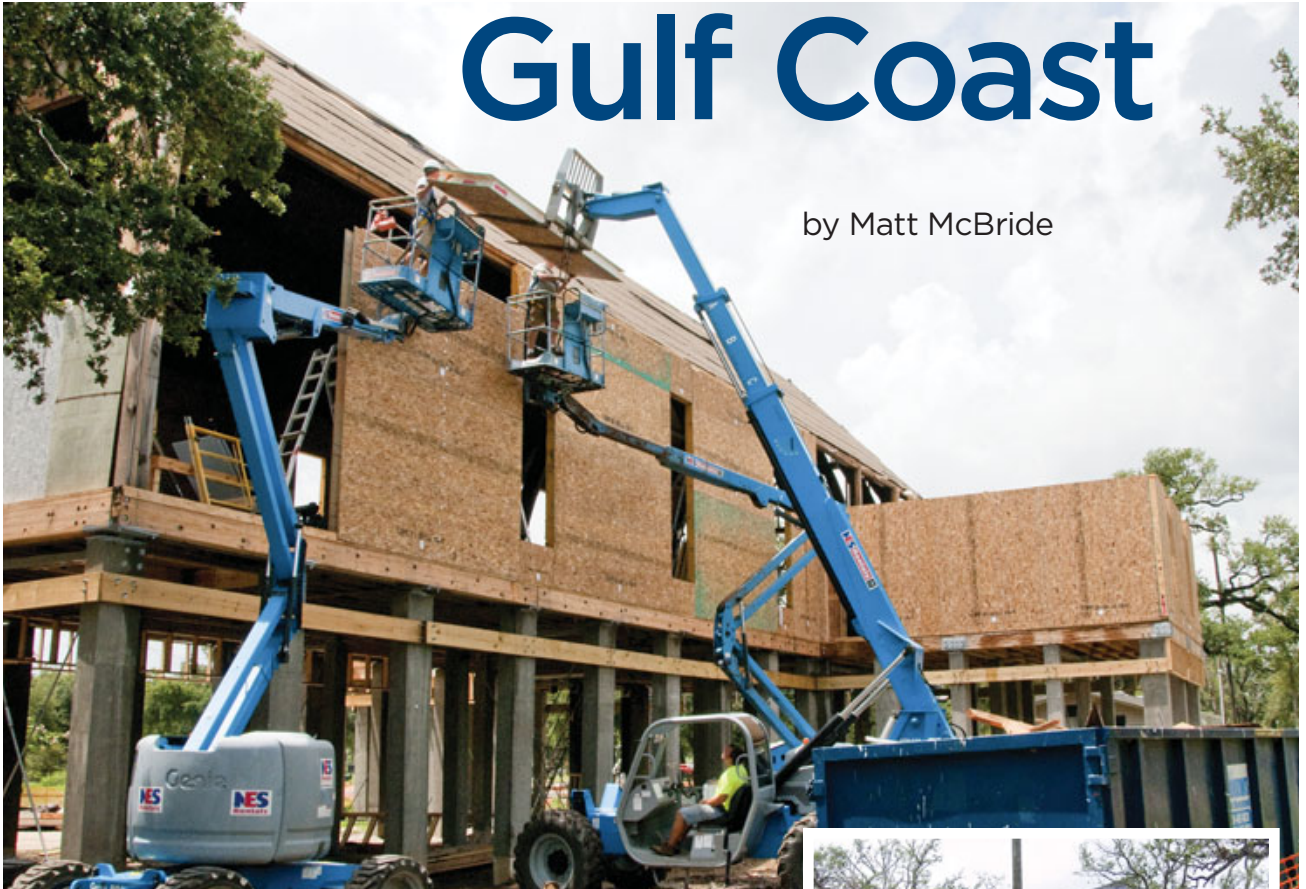
Trinity Episcopal Church used to sit on short concrete piers, about 4 feet above grade and 14 feet above sea level in Pass Christian, Miss. But when Hurricane Katrina devastated the Gulf Coast in August 2005, the 26-foot-deep storm surge left Trinity under more than 12 feet of water — enough to wash away the walls and another two buildings on church grounds, and enough to destroy the middle school across the street. Somehow, the building's floor system, laminated arch framework,

and roof survived virtually intact.
