# In the Path of the Storm

A firsthand look at the damage inflicted on new wood-frame homes by the April 2011 tornados in North Carolina and Alabama

by Bryan Reading, P.E.

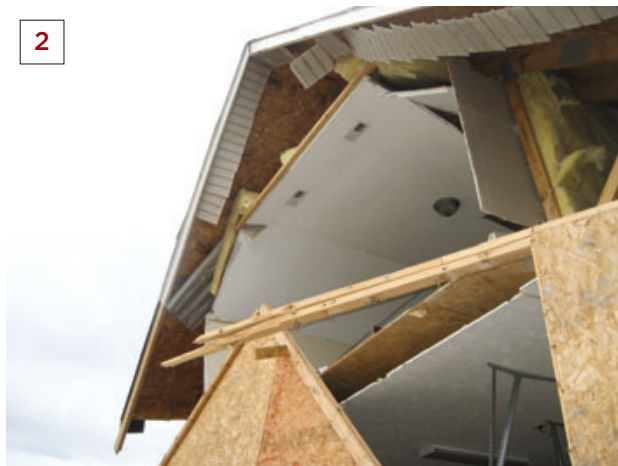
Damage to this home (1) most likely started with the failure of the garage doors. Subsequent pressurization of the garage blew out the sidewall and pushed out the back wall. A close look showed inadequate nailing of the drywall ceiling and the bonus-room floor sheathing (2) to the bottom chord of the gable-end truss, seen here from behind (3). The gable triangle was intact, with the OSB sheathing still in place — it's the connections that failed.

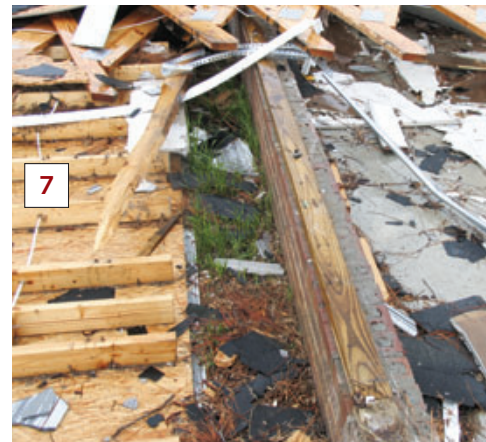
Another home in the same subdivision fared much worse (6); most likely the garage walls were blown out due to pressurization through the large garage-door opening, seen in the foreground. A closer look at the left-hand garage wall (7) shows that the OSB sheathing was poorly attached to the bottom plate with 8-penny nails 16 inches on-center. Foundation anchor bolts with round washers were spaced 48 inches on-center along the sill plate. The home's roof trusses had been attached with toenails (8).

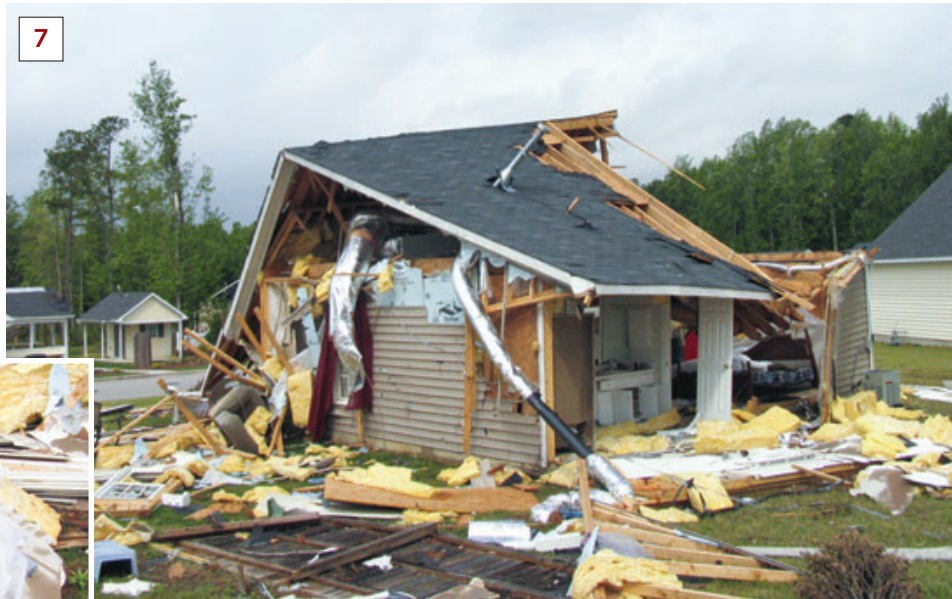
building envelope. The back corner is still supported by the OSB corner bracing panel (7). A braced corner in front was pulled off when its connection to the bottom plate failed (8). On the opposite side of the house, the foam sheathing at the gable truss is almost completely stripped from the framing (9). Below, the foam-sheathed portion of the wall was lost, though the OSB corner bracing is still in place.

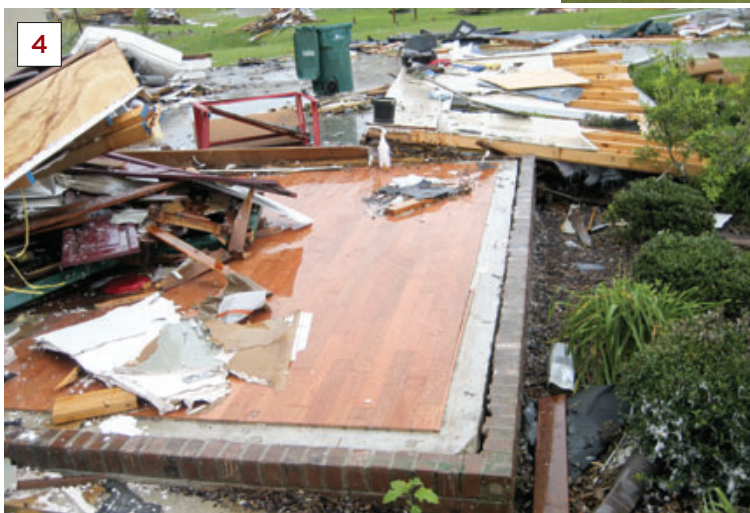
A nearby home lost all its exterior walls (3); its sill plates had been fastened with spiral shank nails 24 to 48 inches on-center (4, 5).

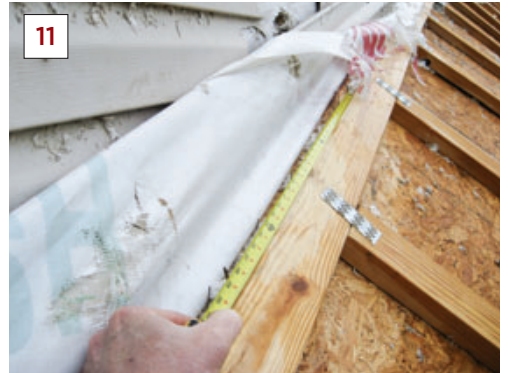
home (10). The bottom chord of the gable truss had been attached to the plate below with 16-penny toenails more than 2 feet on-center (11); the roof sheathing was secured with nails every 48 inches and staples every 12 inches between the nails (12).
