Troubleshooting Brick Veneer

Missing through-wall flashing and clogged cavities spell disaster

by Harrison McCampbell

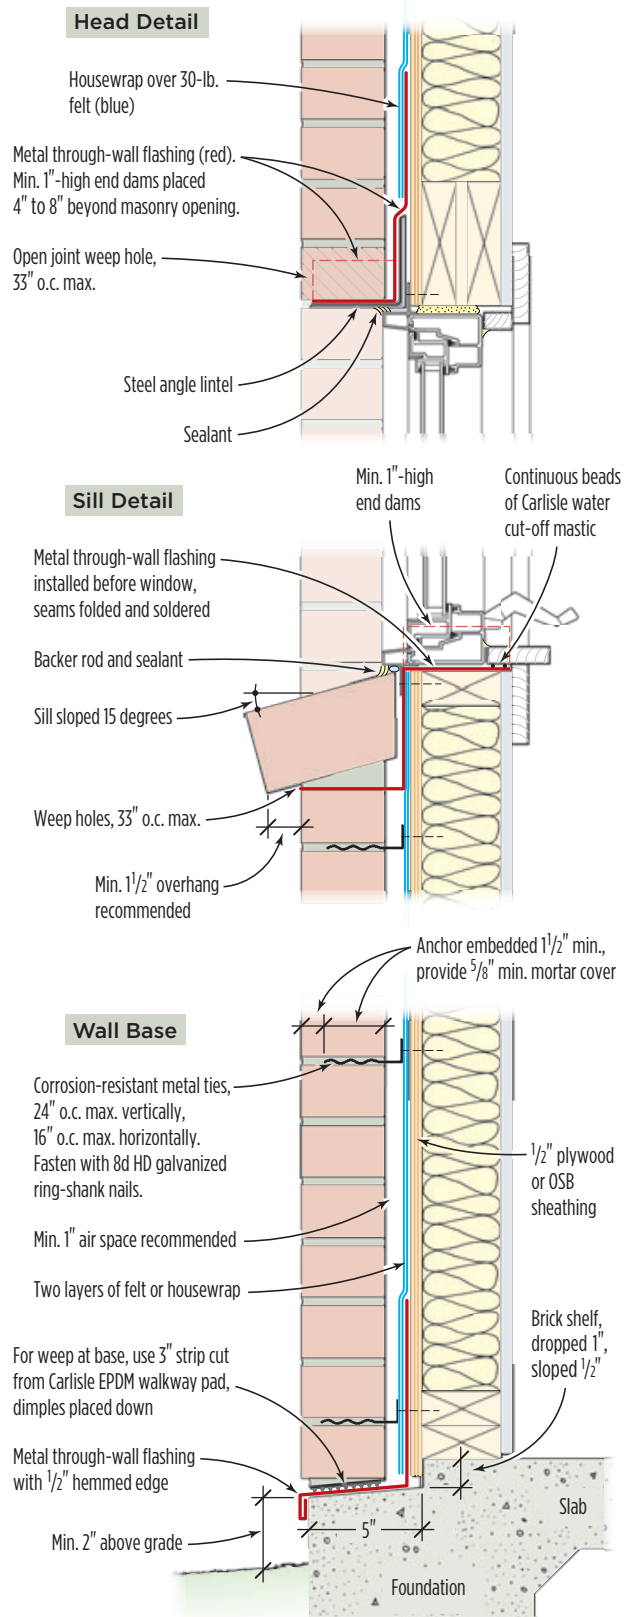
Through-Wall Flashing Details

Above grade. Too often, the bottom courses of brick are simply buried in the soil. There should be a through-wall flashing under the last course of brick above grade; this course must also be below the bottom of the first-floor framing. Flashing at this location serves two purposes: It prevents ground moisture from wicking up into the wall, and it catches any water coming from the cavity above and sends it outside.
