A Historic Building Gets an Energy Upgrade

Satisfying the commissions while bringing an 1840s building up to 21st-century energy-efficiency standards presented a challenge

by Andrew Borgese

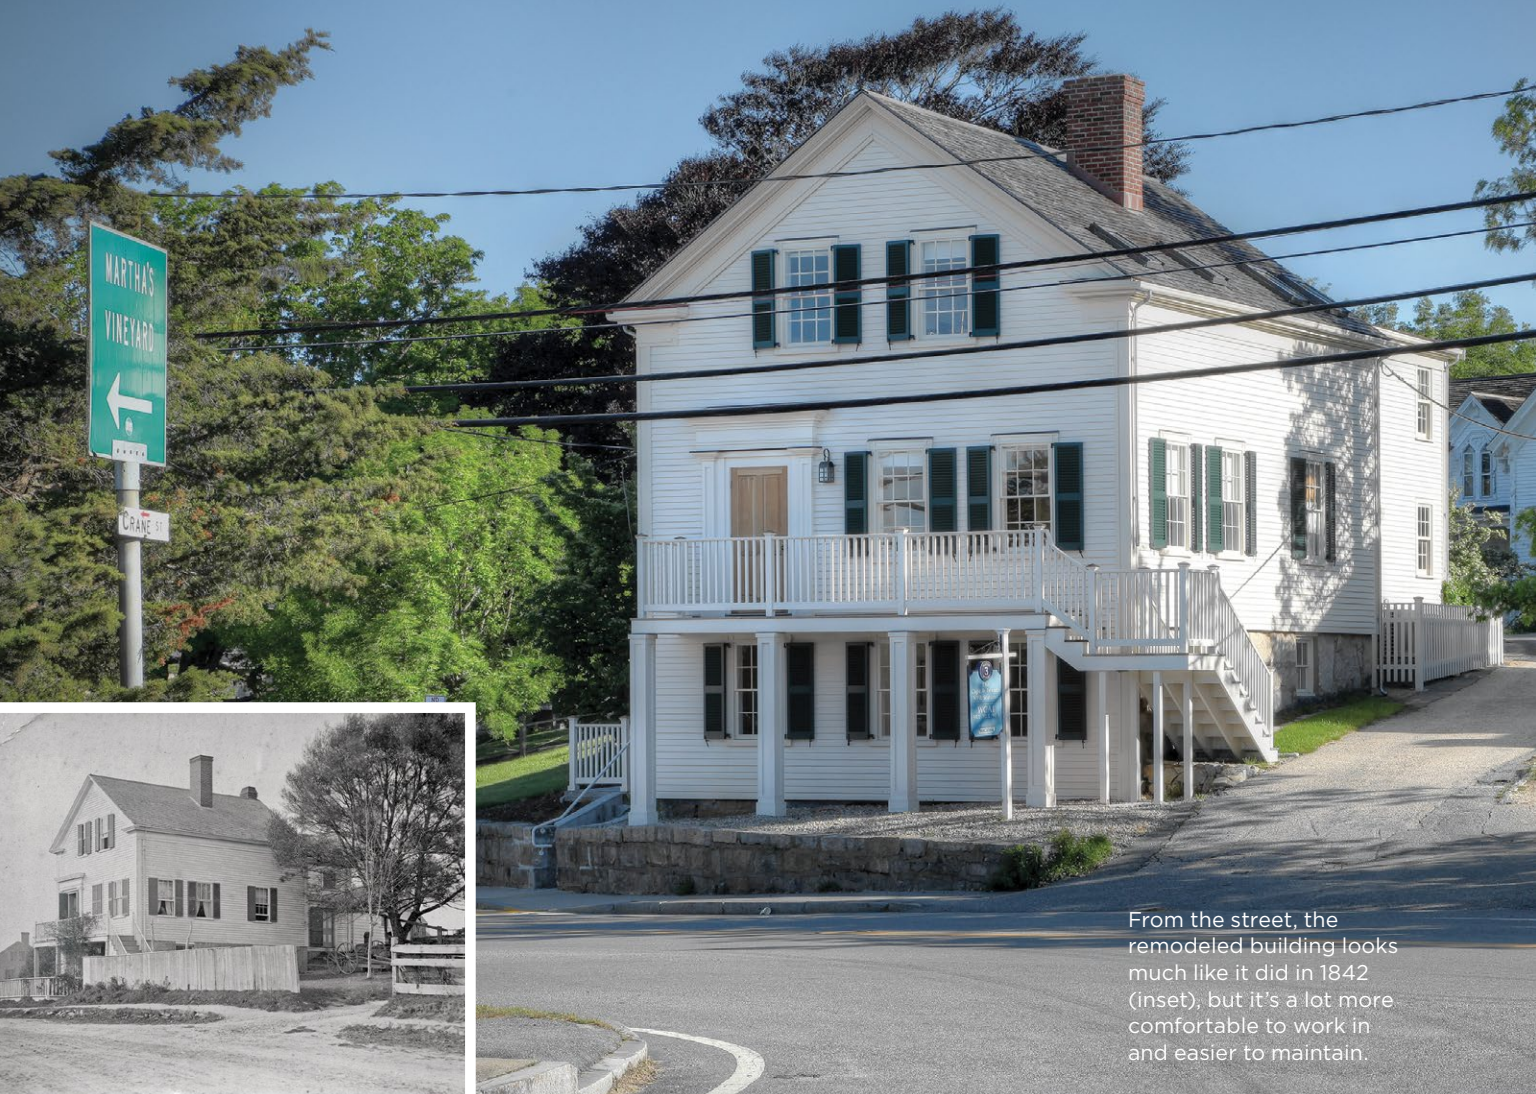
From the street, the remodeled building looks much like it did in 1842 (inset), but it's a lot more comfortable to work in and easier to maintain.
