# Restoring a Round Porch

**Rot-resistant materials and better details extend the life of this unique coastal porch**

by Ben Kelley

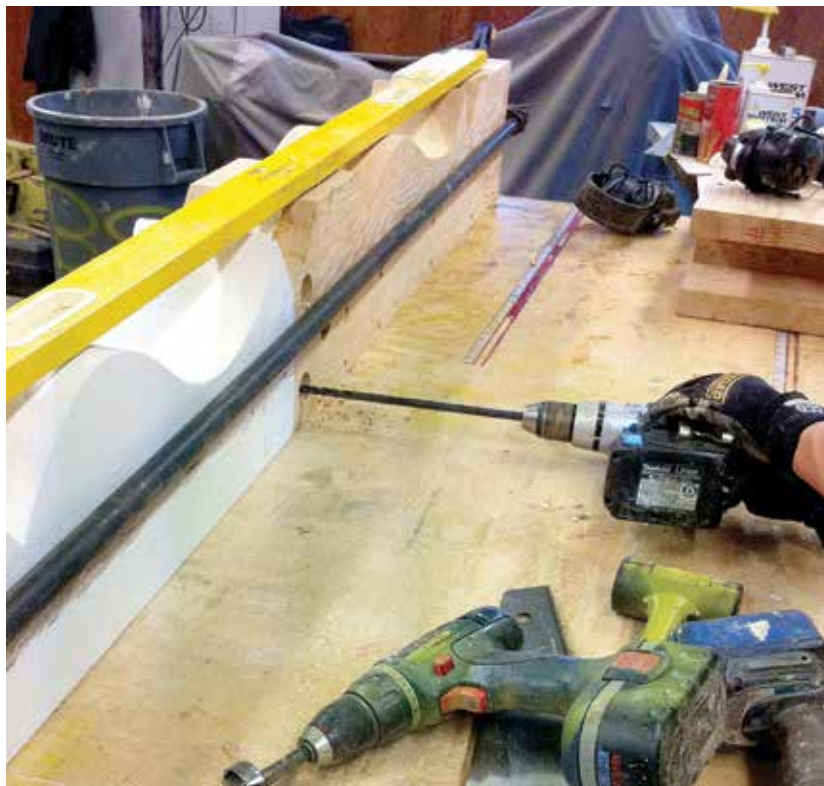
galvanized carriage bolts, which we drove through predrilled holes (**Figure 2**). We also countersunk these holes, and later filled them with wood plugs. Some of the old 6-inch-by-9 1/2-inch columns were warped, so we trued and cleaned them up with our 16-inch beam saw. We patched blemishes and minor areas of rot with epoxy thickened with epoxy filler, then smoothed the cut edges with a belt sander. To clean up the scroll work, we used a drill-mounted paddle-style sanding wheel and a Fein detail sander. Then we primed the columns and brought them back to the site.

**Figure 2.** The new and old column sections were joined together with galvanized through-bolts and epoxy (left). Once the columns were reassembled, a worker straightened them with a large-capacity beam saw (right).
