Major Surgery for a Failing Fat Wall

Modern materials and proper details restored the double stud wall to a high-performance system

BY JIM BRADLEY

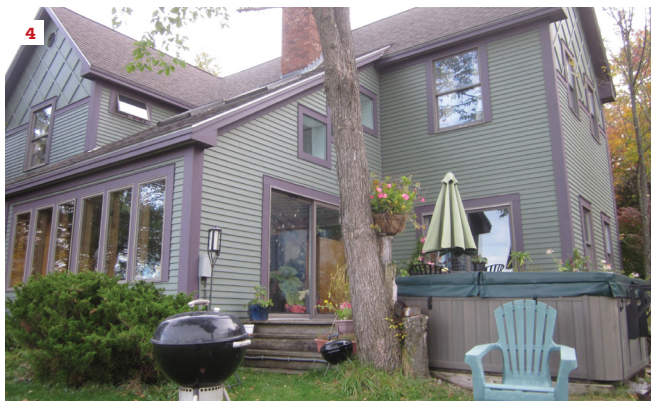
Built in 1983, the house had typical styling and materials from that era (4). Stripping off the siding revealed the usual OSB sheathing and housewrap, both in a deteriorated condition (5). Ants had tunneled into the foam insulation around the home's foundation (6), pursued by hungry woodpeckers. With the siding removed, the author found that he could flake away the moisture-damaged OSB sheathing with his fingers (7).

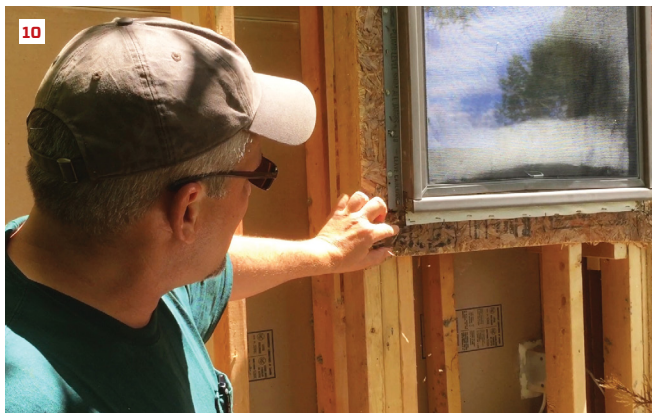
The author's crew stripped the compromised OSB sheathing off the stud wall (8), and vacuumed the damp, settled cellulose out from the double stud cavity (9). The team attempted to preserve the existing windows in place, but the failure of the OSB meant that the windows would have to come out in order to repair the sheathing (10). The wall's condition was worst at its base (11), where it rested on the ant-infested perimeter insulation and floor framing.

sound, but the floor framing was not; we discovered that we would need to remove and replace portions of the first-floor band joist where the wood was rotted and infested with ants.

After opening up the walls, we vacuumed out the moisture-damaged and settled cellulose insulation, along with its load of animal droppings, urine, hair, insects, and mildew. That contaminated material and its load of allergens got pumped into disposal bags inside the dumpster.
