BY DAN WATSON

Replacing Rotted Beams on a Seaside Condo

Cripple-Wall Failure

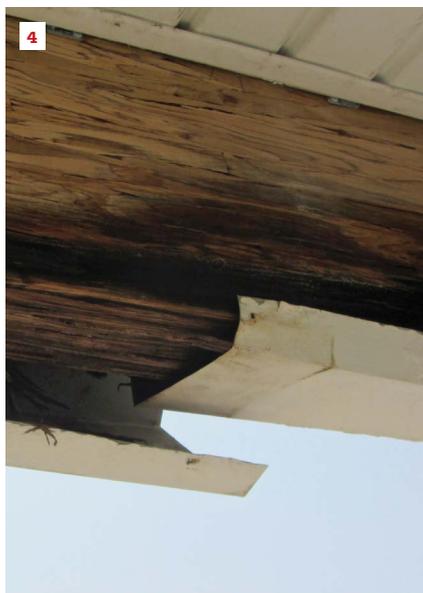
The problem was originally discovered by one of the condo-unit owners, who saw water pouring out of the aluminum capping that covered a beam above his second-floor balcony (1). We were contacted to investigate the leak and discovered mold and rot in the beam under the capping (2). The balcony on which we were standing was supported by a similar beam, in the first-floor ceiling of the carport. We also removed the cladding from this beam, and discovered similar conditions (3).

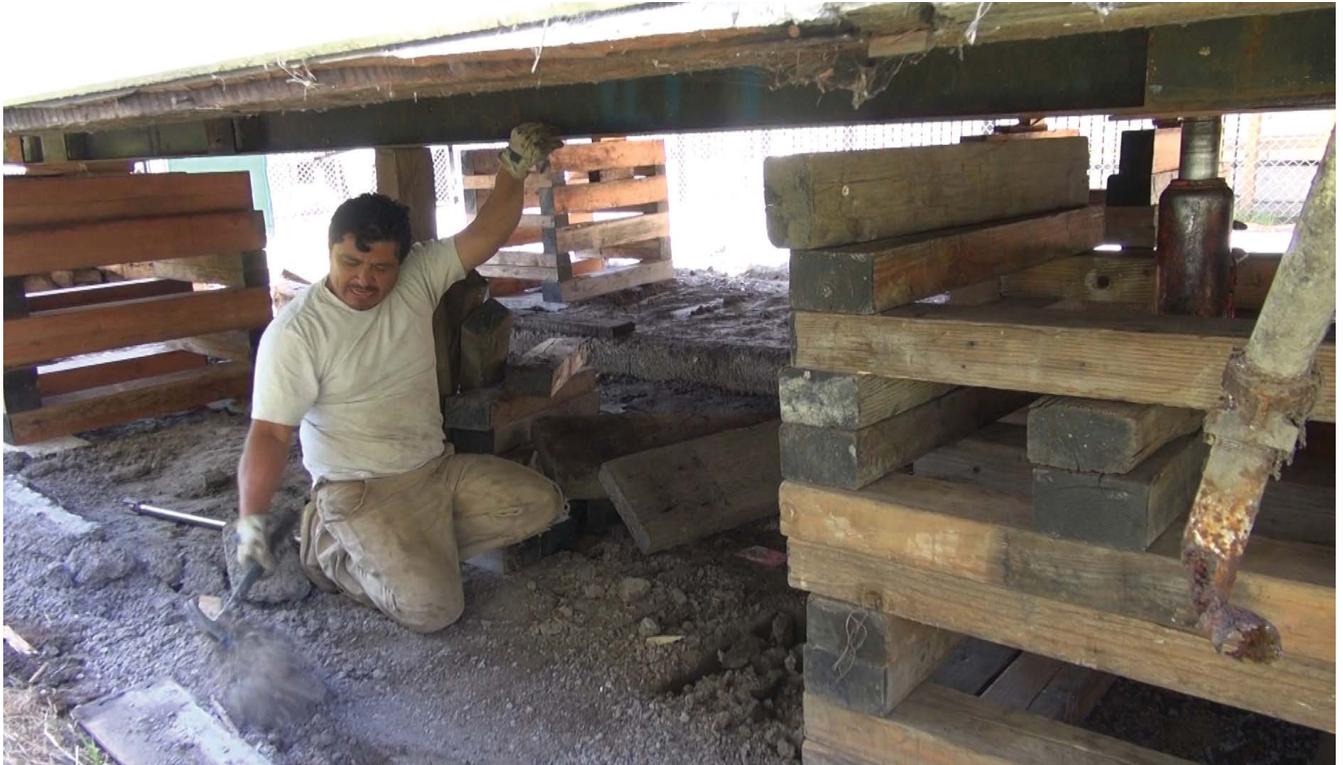
But it doesn’t take an earthquake for some cripple walls to fail. Recently, Joy has been called to lift two houses for which cripple walls had collapsed, seemingly without provocation. In one case, in Oakland, the house was vacant after the owners had passed away; while the family was deciding how to handle the building, it simply toppled off its cripple wall in the middle of the night.

“Right now it seems like we’re having an epidemic of hundred-year-old buildings falling down,” Joy told *JLC* in an email. “This is due to flawed underfloor framing. The buildings typically have redwood V-rustic siding on the lower 3 feet. They don’t have plywood sheathing. The V-rustic siding below the floor line doesn’t have much shear capacity to begin with, and the redwood rusts the nails. So when the nails rust, the houses have a tendency to lean over and slowly fall down.”

Once he has one side of the building levered up off the ground, said Joy, “we start the process on the other side: rock the building up, and put in another steel beam. Now that we have two steel beams underneath the building, we hook up to the unified jacking machine and raise it straight up, and then roll it back over the foundation on rollers.”
