BY KYLE DIAMOND

## Premature Trim Failure

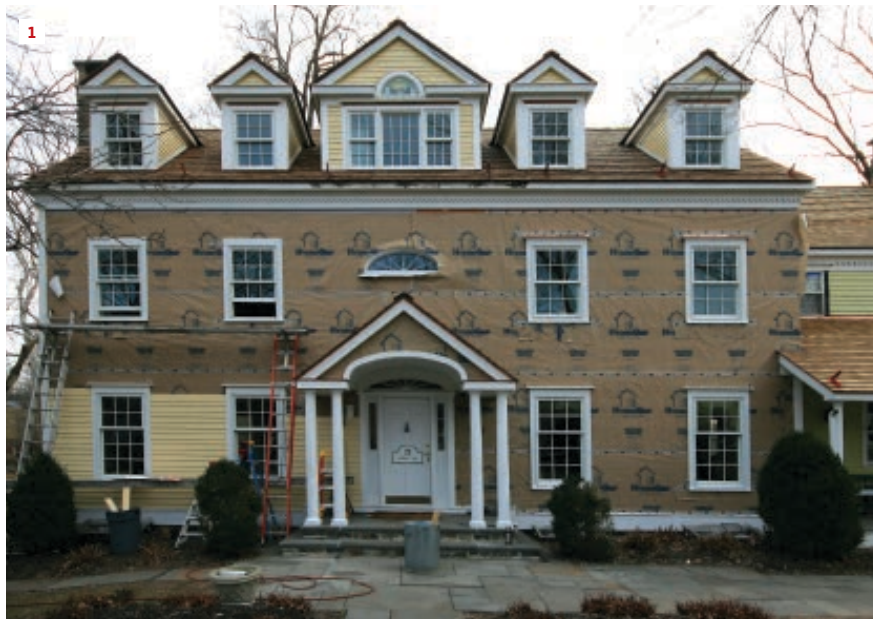
**Last year my company**, New Dimension Construction, began restoring the exterior envelope of a neo-colonial home, in Millbrook, N.Y. The scope of work included tearing off an existing wood-shingle roof, replacing windows, and upgrading the siding and trim with more-durable materials **(1)**. The house was only 28 years old, but poor trim detailing had caused the exterior cladding and windows to prematurely fail on many parts of the home. For this story, I'm going to focus on a few of the trouble spots I encountered on this project—and continue to encounter on similar projects built around the same time period.
