## Rebuilding a Wind-Damaged Deck

BY ROB CORBO

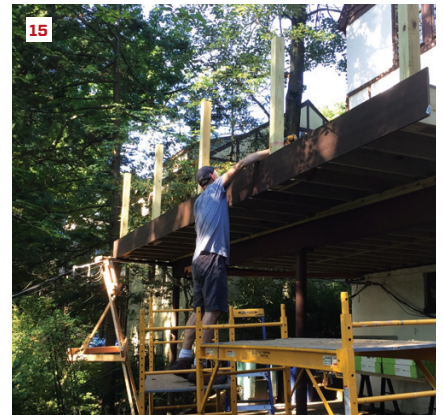
The new ledger was lag-bolted to the house framing (10), while the old girder was primed, painted, and capped with a flashing membrane and a treated 2x6 plate (11). A string line established a reference elevation for the out-of-level girder, and notches (12) or shims (13) were used as needed to bring the joists flush with the string (14). Here, the deck is almost completed (15).
