Repairing a Bungalow Balcony A beam replacement project with a Storybook ending

BY GERRET WIKOFF

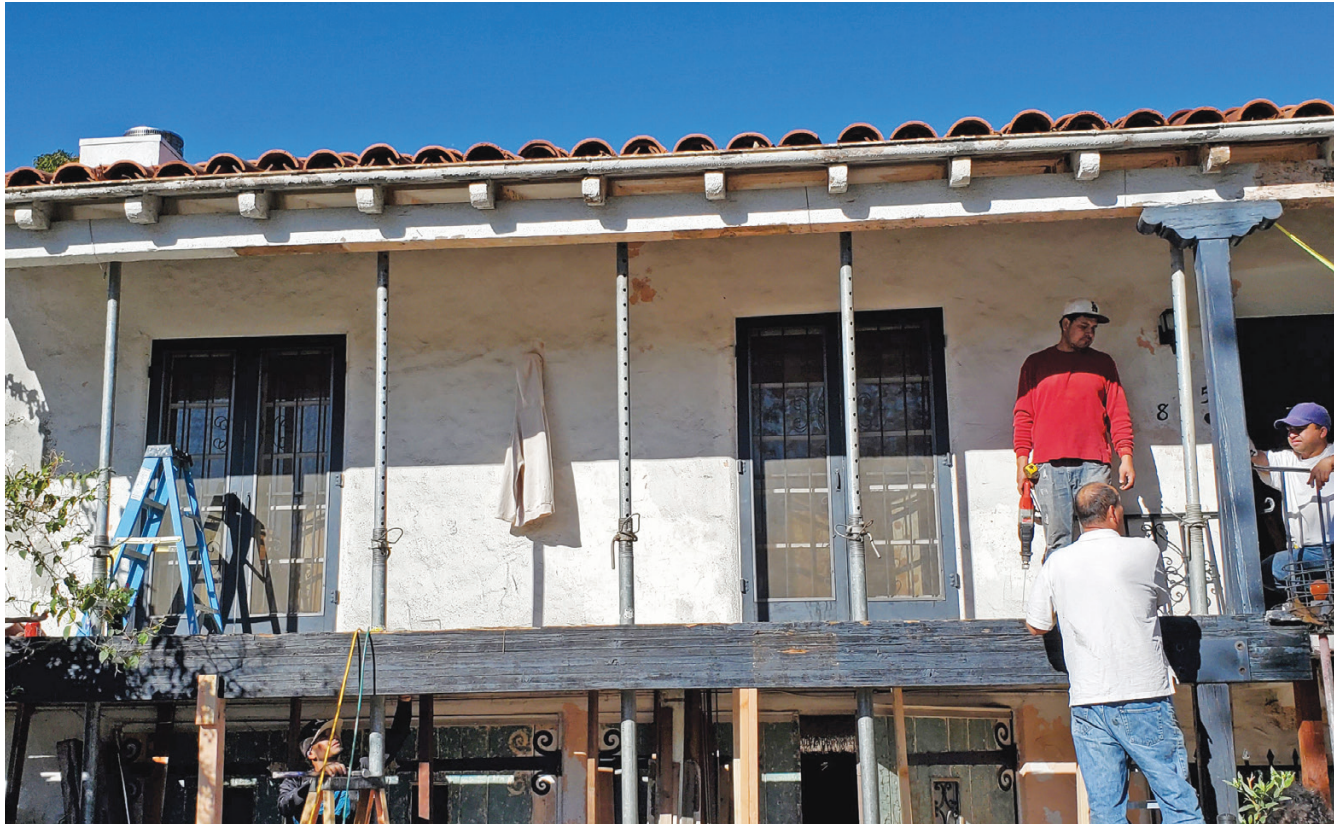
The wood-framed entry stairs were clad with stone veneer, which was popping off, and they connected the home's flagstone driveway to a raised first-floor entry, also clad with stone veneer. The first seven steps of the 14-step staircase were winder treads, while the remainder formed a straight run up to the entry. Adjacent to the entry, a 24-foot-long porch-style balcony ran the length of the bungalow's front façade above a garage.

Along with the failing stone veneer, the entry staircase's underlying wood framing had rotted, primarily at the stair-to-balcony

connection. More alarming, I noticed the adjacent balcony's floor beam was failing and that both the balcony and the roof above were sagging more than 2 inches. The homeowners mentioned that the bungalow's 54-inch-deep balcony originally had been supported by cantilevered 6x6 beams, and that it had been rebuilt in the 1970s by a previous owner. To prop up the balcony's cantilevered 6x6 beams and the roof above, a 6x12 glulam beam supported by two 6x6 posts on pier footings had been installed.

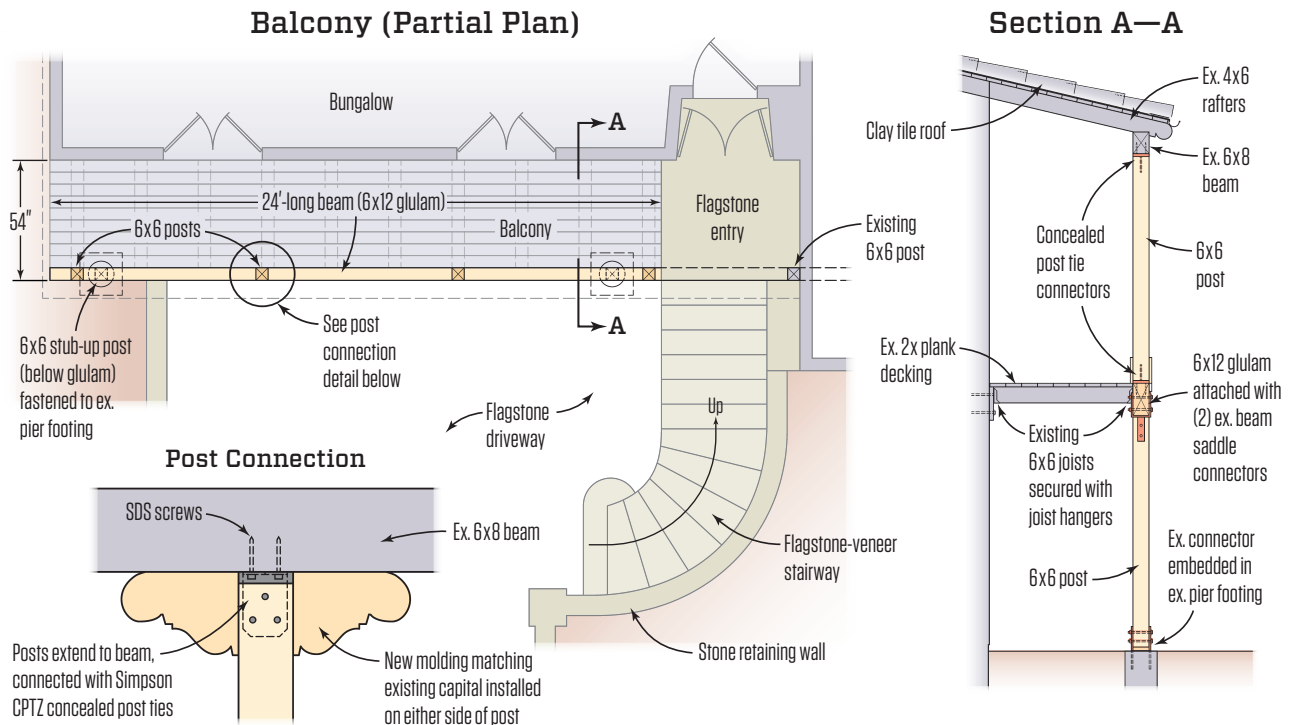
Before we could safely remove and replace the rotted beam, we needed to support the balcony and its heavy clay tile roof. We started by building a temporary 2x4 wall to support the balcony’s existing 6x6 joists, which were 30 inches on-center and supported the balcony’s 2-by plank decking (see illustration, opposite page). Next, we removed the

existing 6x6 hangers connecting the joists to the glulam and began to jack the balcony and roof back to level, unbolting the two post saddles at each end of the glulam and using a 30-ton jack to raise the balcony and roof up 2-plus inches (3). We installed temporary posts, then removed two of the outer decking planks to make room for shoring and moved on to supporting the roof.
