BY JIM BRADLEY AND CHRIS WEST

A Troubled Tiny House

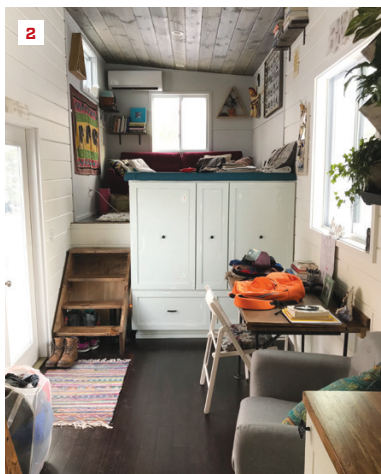
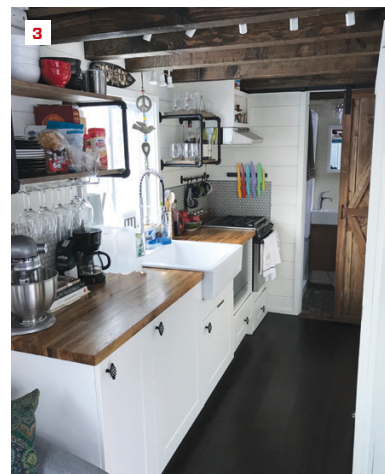
The cozy structure (1) was part of an HGTV program presenting an idyllic look at the tiny house movement—reality proved otherwise for the first-time homeowners. Here are two inside views: looking toward a raised dining room in the front of the home (2), and in the kitchen looking toward the bathroom beyond (3). Sleep quarters were in a loft above the kitchen.
