Rebuilding a Box Bay Window

BY EMANUEL SILVA

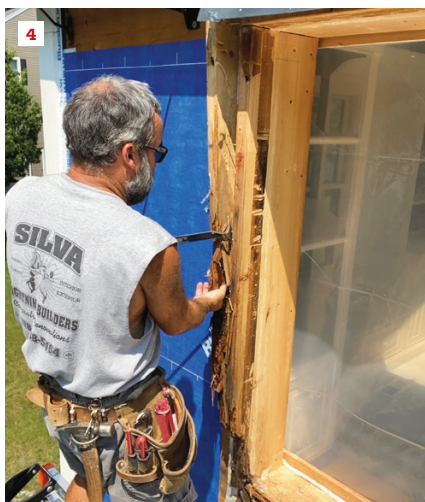
The box-bay framing had a number of problems, such as a lack of sheathing, inadequate flashing, and no structural support for the 2x12 subsill other than the 2x6 wall that it was resting on. But the main problem was that water from the roof flowed down the fascia and behind the exterior head casing used to trim the windows. From there, it worked its way down the 2x4 jack studs separating the windows and collected on the 2x12 subsill. As a result, the subsill was rotted and split, and the bottoms of the 2x4 studs were rotted. At both sides of the opening, the 2x12 trimmers had virtually disintegrated, so once I removed the trim, nothing was holding the windows in place.

The extent of the rot damage to the framing was clearly visible once the windows were removed (3). The author stripped the siding and window trim from the wall (4), then re-framed the box bay with new 2x12s (5). After reinforcing the subsill with a layer of 3/4-inch CDX plywood, he framed the individual window openings with double 2x4 jack studs (6) and used cripple studs to fill in the gap between the flat 2x12 “header” and the soffit (7). The author then completely covered the opening with sheathing to make it weathertight while he waited for the new windows to arrive (8).
