## A Twin-Turret Roof Restoration

BY DARIN KUNS

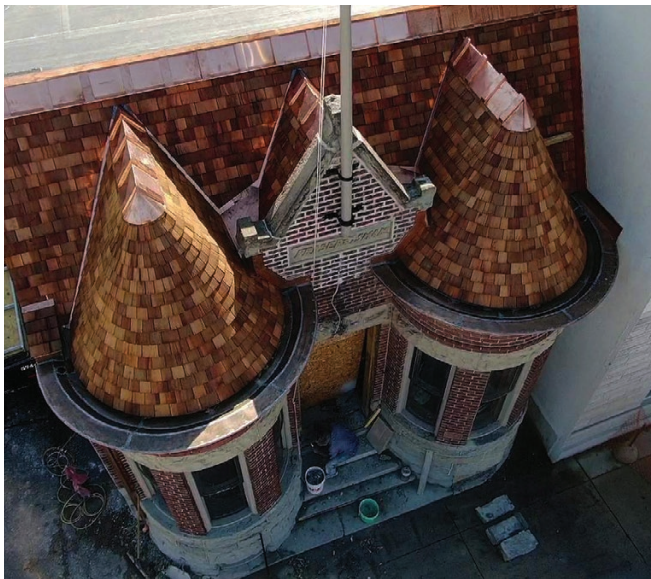
**Existing conditions.** Elastomeric paint had been smeared over the shingles, valleys, gutters, and ridge caps in a poor attempt to increase the life of roof (1). A view between the central gable and one turret shows the cricket, which drained out a small hole beneath the central gable's limestone cap (2). A brick ledge at the intersection of the roof plane and the adjacent building had been a difficult place to flash well and, where it died into the gutter at the base of one turret, it created a trap for leaves and other debris that impeded drainage (3).

After fixing all the rotted areas, we flashed everything in with ice-barrier membrane, running it up high to tie in shingle-style with membrane running down the valleys at the turret intersections. We then wrapped the area in a self-adhering underlayment. Installing the ice membrane and underlayment was a painstaking exercise in advanced origami, with overlapping courses woven across the front of the turrets.

**Copper work.** The first line of defense over the underlying protective layers was thousands of dollars' worth of copper flashing. We had to get approval from Indiana Landmarks to use copper because the original flashings were lead or terne metal. All the new copper work, including the turret valleys, downspouts, circular gutters, and ribbed ridge capping, was fabricated off site. The main work for our crew was templating all the sections with 1/2-inch plywood. Once fabricated, the sections were soldered on site. The crickets behind the central gable were lined with copper that was soldered to the valleys and two extended spouts, creating a watertight assembly that could drain well. Beneath the spouts, we completed the copper work with step flashings and counterflashing that tied in with the wide copper gutters encircling the turrets.
