Peeling Back the Layers of a Kitchen Remodel An old house presents a host of framing and water-control challenges

BY MIKE WHALEN

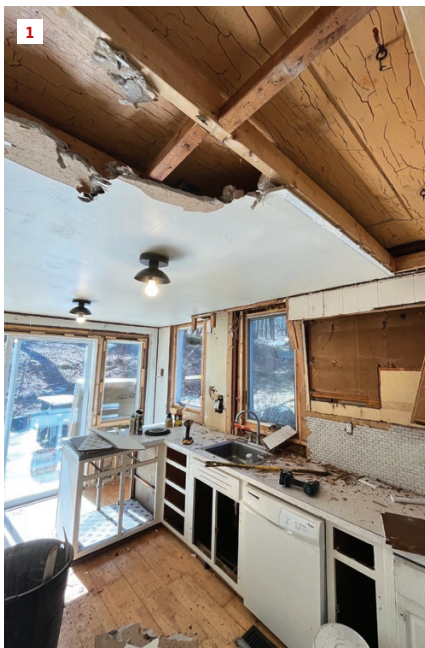
A view of the existing kitchen interior at the beginning of the demolition phase (1). Over the years, this room had numerous floor coverings, including vinyl, slate, an old linoleum tile, and the original plank subfloor (2). The discovery of the old tile prompted a test for asbestos, which proved positive, requiring a pause in the renovation to remediate the asbestos (3). At the end of demolition, the old porch framing had been removed, and only the original framing of the main floor remained (4).

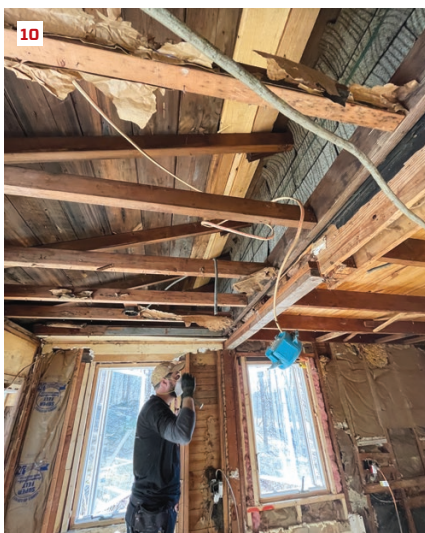
The owner wanted to raise the roof where the old porch roof had been to create a partially cathedralized area (10). There was little existing support at this intersection, requiring a new LVL beam tied into the second-story wall section (11) to support the upper floor and the roof loads (12). This beam landed on top of a new LVL header for new windows (13). Once all the structural work was completed, the exterior walls, roof, and floor were insulated (14).

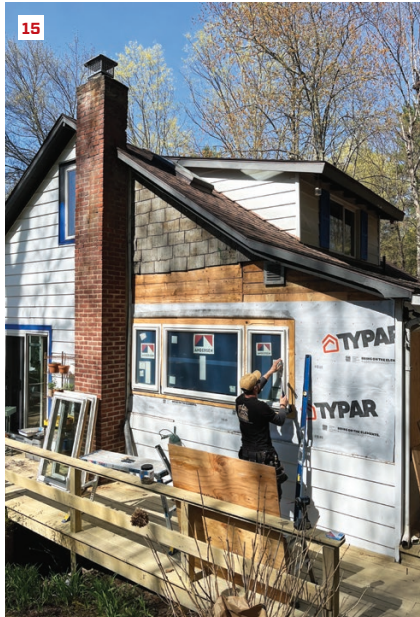
Final steps on the exterior included patching in new aluminum siding to match the existing and trimming out the new windows and door (15). With the house brought back to a "healthy state," the rest of the job proceeded like a normal kitchen remodel, with new drywall (16) and cabinets (17). The cabinets arrived before the owner had made a decision on the finished flooring, so they were installed on plywood strips. Once new countertops and flooring had been chosen, the kitchen neared completion (18). The owner chose to leave the ceiling beneath the upstairs floor exposed, but she had not yet made a lighting selection at the end of the job.
