BRACING WALLS

What Works Best?

Plywood sheathing is tops. But shear panels and let-in bracing do well, too.

by Harris Hyman, P.E.

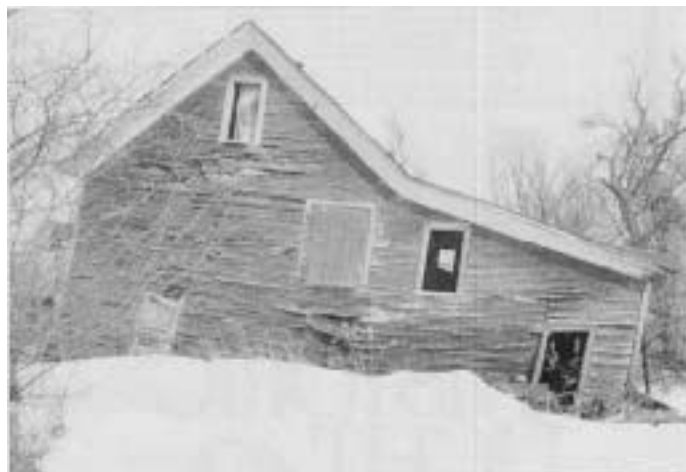
Sketch 1. When a wall racks, what was square becomes a parallelogram.

square shear off into parallelograms (Sketch 1).

So what happened? Simple—the building moved. The upper northeast corner went a little farther northeast while the sill stayed in place. The whole thing was put together properly, but it sheared and twisted. (Unwind the plumb bob, or measure the wall diagonals, and you'll see.)
