Which Way With the OSB?

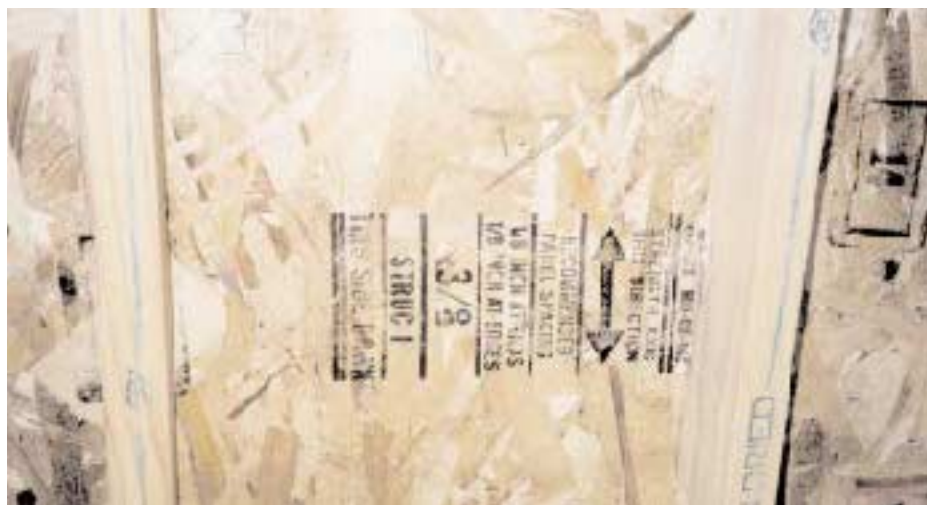
Q. I recently inspected a home that had $\frac{3}{8}$ -inch OSB corner bracing. The surface stamp indicated that the strength axis of the panel ran in the long direction (see photo, below). I assume this means the panel should be applied with the long dimension across the studs, yet the builder had installed the long dimension parallel to studs. I called APA to check and was told the stamp only applies for roof sheathing and not to corner bracing. Why is the strength axis important for roof sheathing but not for corner bracing?

If you look carefully at the sheet of OSB in question, you'll see that most of the fibers are oriented parallel with the

length of the sheet, making that the strongest axis in bending.

A. Scott McVicker, a structural engineer in Palo Alto, Calif., responds: There are two properties of OSB panels at play here: its strength in shear and its bending strength. When using OSB for corner bracing, shear strength — the ability of the panel to resist lateral racking movement — is the issue, and the panel's shear strength is not affected by its orientation. But place that same sheet up on the roof across rafters 24 inches on-center and stand in the middle of the span between two rafters: Now the bending strength of the panel is at play. That's what the arrows refer to.
