# Letters

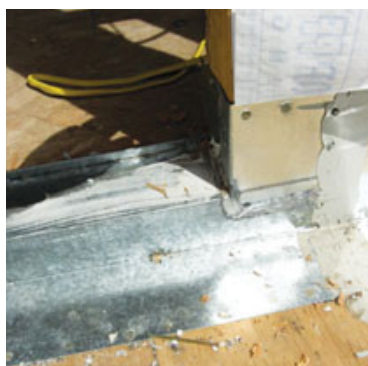
— or if it was, that the door installer damaged the pan’s integrity by crushing its back lip or penetrating it with screws without caulking the penetrations. Sometimes the pan flashing is improperly placed over the building paper — as in the example shown here — rather than the other way around.

As a deck waterproofing contractor and consultant, I often see problem decks that have French doors leading out to them (see “Focus on French Doors,” 8/09). Most of the time the customer’s complaint involves a leak at the door, which usually gets blamed on the deck contractor. We often find that a sheet-metal door pan wasn’t installed
