# Rebuilding an Old Attic Space

Added rafters beefed up an old under-built roof, and a scribed sleeper system leveled the floor

by Will Schwarz

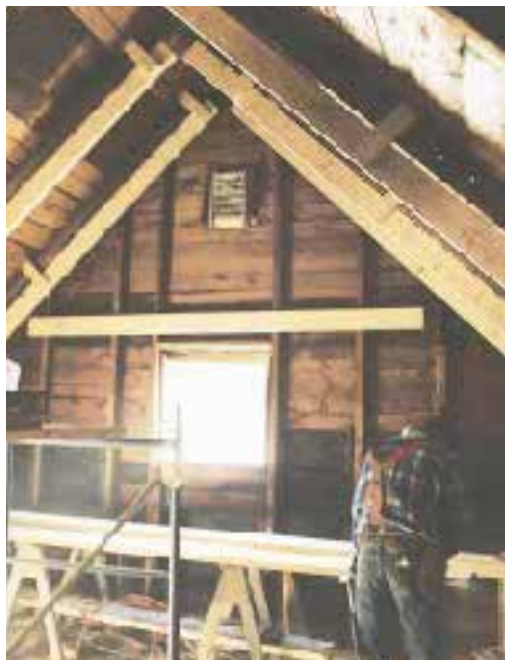
**Figure 1.** New 2x6s sistered onto the undersized existing rafters matched the drywall plane formed by new 2x12 rafters.

After we demolished a few old plaster-and-lath partitions, we reinforced the roof framing from the inside. Our strategy was to hang a new 2x6 rafter off of each existing rafter and then add new 2x12 rafters between the existing rafters. We attached new 2x6 rafters to the old rafters using 11<sup>1</sup>/<sub>4</sub>-inch-long 2x4 blocks as hangers (see Figure 1). By bumping these blocks to the underside of the roof sheathing, the new 2x6s matched the plane of the new 2x12 rafters.

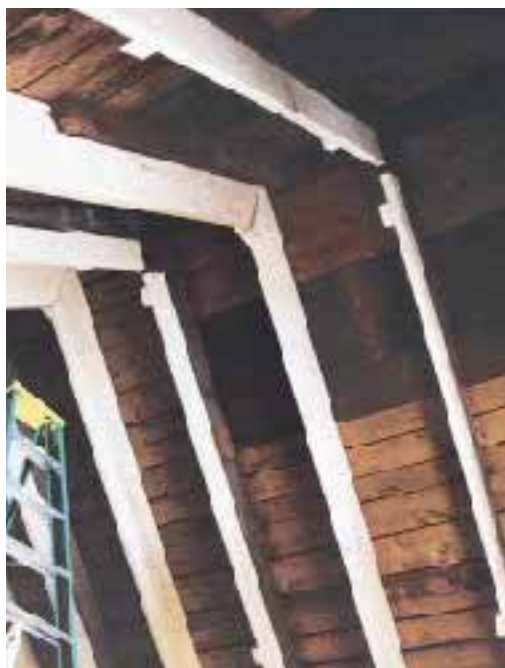
**Figure 2.** New 2x12 rafters were installed between existing rafters to strengthen the roof framing. There was enough give to the old roof sheathing so that the new rafters could be installed without having to fiddle with jacks — a sledgehammer did the job.

Early on, we thought we'd have to jack the roof, section by section, to install the new 2x12 rafters. We were surprised to find, however, that the roof was light enough to lean into and lift by hand. We flattened all the old nails that were protruding through the sheathing, then wedged the rafters into place using a block, sledgehammer, and a healthy dose of Mr. Armstrong (Figure 2). Next, we installed Prop-R-Vent foam roof-venting channels, followed by 9 inches of R-30 fiberglass (Figure 3). Although it would have been nice to add a layer of rigid foam insulation, tight door clearances, coupled with budget considerations, dictated that we settle for just rafters, batt insulation, and strapping. For strapping, we installed furring strips on top of the vapor barrier. We adjusted areas that were still slightly out of plane using a straightedge and shims.

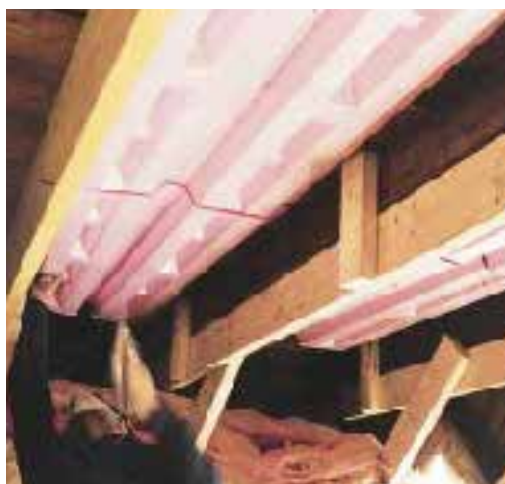
**Figure 3.** Roof vents keep the roof sheathing cold during snow season to prevent ice dams.

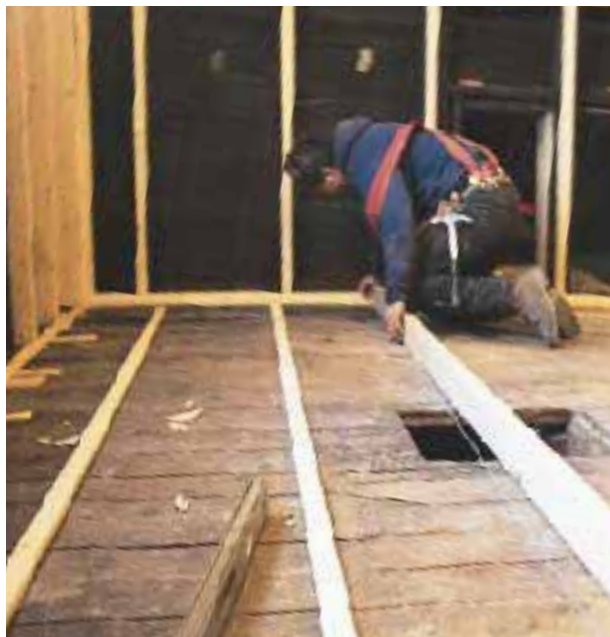
**Figure 4.** After installing a level nailing strip around the perimeter of the room, the author snapped cut lines on each sleeper. This scribed sleeper system leveled and took the sags out of the floor.

With the roof and walls taken care of, we turned our attention to the settled and sagging floor. Since the kitchen and den were located directly beneath the attic space, jacking was out of the question because it would have damaged the finishes in these rooms. Instead, we opted for a custom sleeper system over the existing floor. We began by using a water level to put a benchmark in every corner of the room, then we ran a nailing strip around the entire perimeter of the room using a string to stay straight and level. This established a level floor plane. Next, we temporarily fastened 2x4s on edge directly above each existing floor joist. By snapping a line flush to the tops of the nailing strips on each side of the room, we were able to cut scribed sleepers (Figure 4). After the sleepers went down using construction adhesive and coarse-threaded decking screws, we installed  $\frac{3}{4}$ -inch tongue-and-groove plywood (Figure 5). In the end, we had a nice level surface that served well later on when carpet and built-ins were installed.

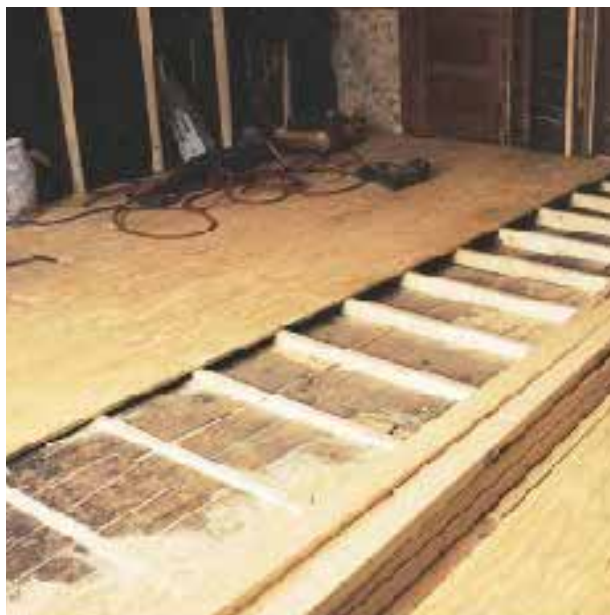
**Figure 5.** A new  $\frac{3}{4}$ -inch tongue-and-groove plywood subfloor provided a sound base for carpet and built-ins.

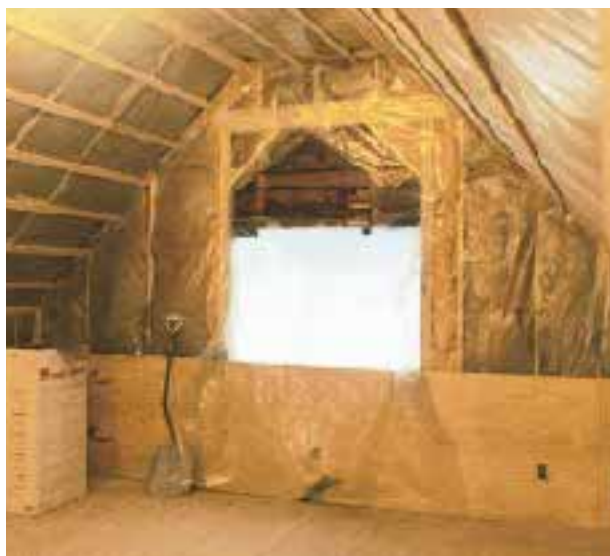
**Figure 6.** Prepped for finishes, the new attic room has straight ceiling lines, a level floor, and a much stronger roof. Along the bottom of the walls, plywood provides solid nailing for paneled wainscoting.
