RADON VENT RETROFIT

For a reasonable cost, an in-line fan removes radon gas from beneath the slab and vents it to the outside

by Peter Beaupre

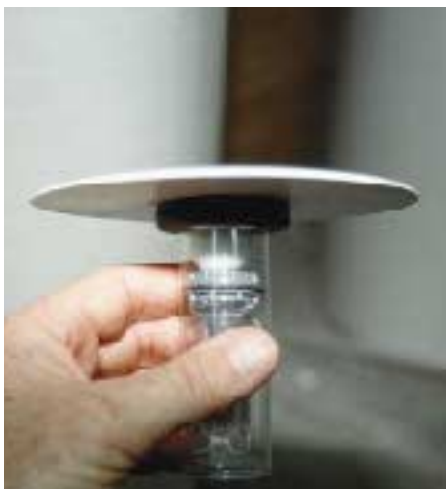
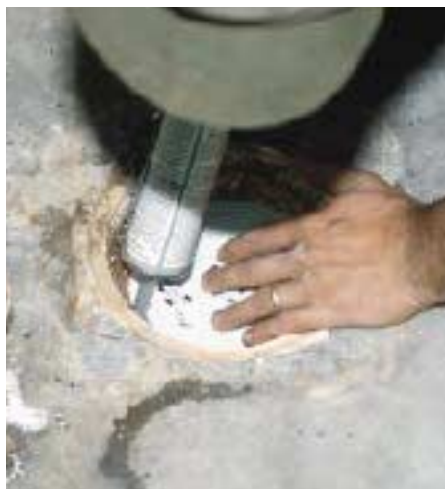
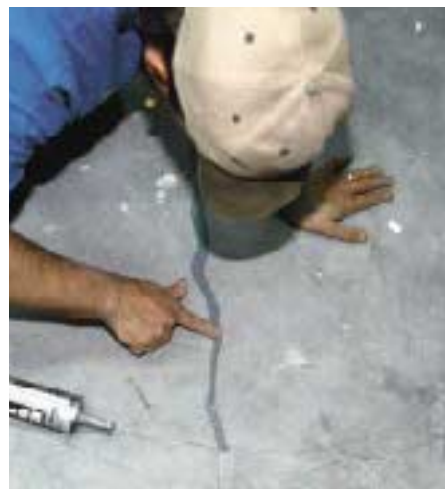
Figure 1. A special check valve is used to prevent the sub-slab ventilation system from sucking indoor air through the floor drain. It opens for drainage when weighted down by accumulated water, but when the drain is dry, a spring-loaded ball provides a seal that maintains negative pressure beneath the slab (left). Once the valve has been cemented in place (center), any visible cracks in the slab or foundation walls are repaired with a durable sealant (right).

Our first step was to cement a special check valve into the floor drain and seal visible cracks in the floor slab (see Figure 1). Although that won't solve the radon problem in itself, it's necessary to prevent the vent pipe embedded in the slab from sucking air through such openings, effectively short-circuiting the whole system.

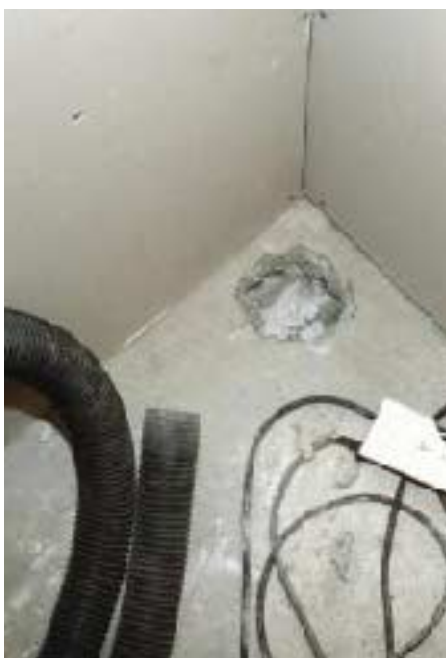
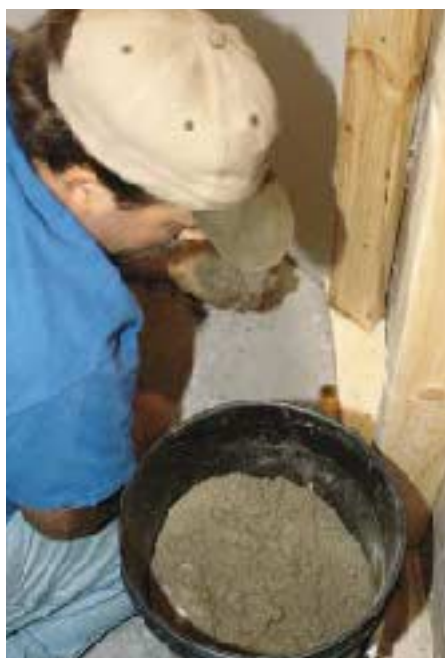
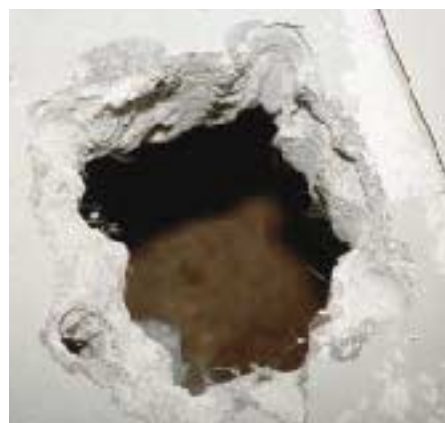
Figure 2. Once a vent opening through the slab has been made with a rotary hammer (left), the fill beneath is dug out to create a sump (center). The finished sump is about a foot deep and as wide as a worker can reach by hand (right).

the builder had provided us with photos of the sub-slab taken just before the pour. The photographic coverage wasn't complete, but we could see that one out-of-the-way corner of the utility room was free of rebar, radiant pipe, and other obstructions. Using a rotary hammer, we punched a 6-inch opening in the slab before cutting through the extruded polystyrene insulation beneath (Figure 2, page 2). That made it possible to dig a cavity in the sand beneath — partly by hand and partly with the aid of a shop vac — to provide a sump for the bottom of the vent pipe. After cementing the 3-inch PVC vent pipe in place with hydraulic cement, we were ready to cut a hole through the adjoining partition wall and extend the vent horizontally along the corner of the ceiling and out through the exterior band joist (Figure 3, previous page).

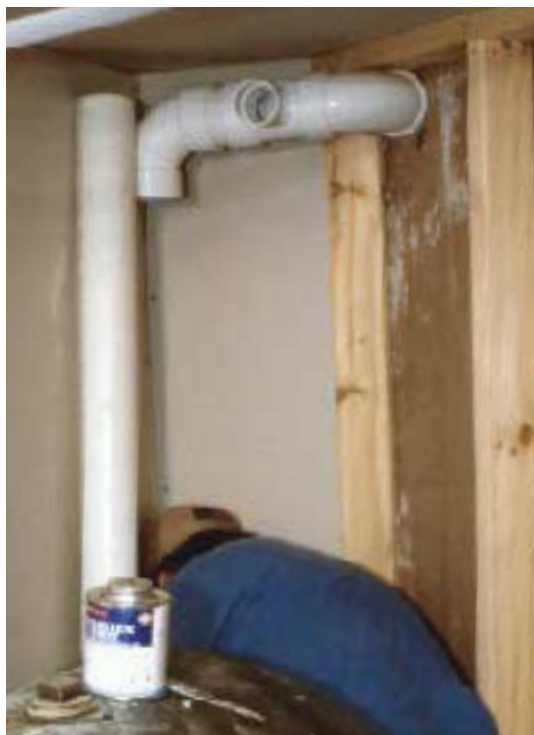
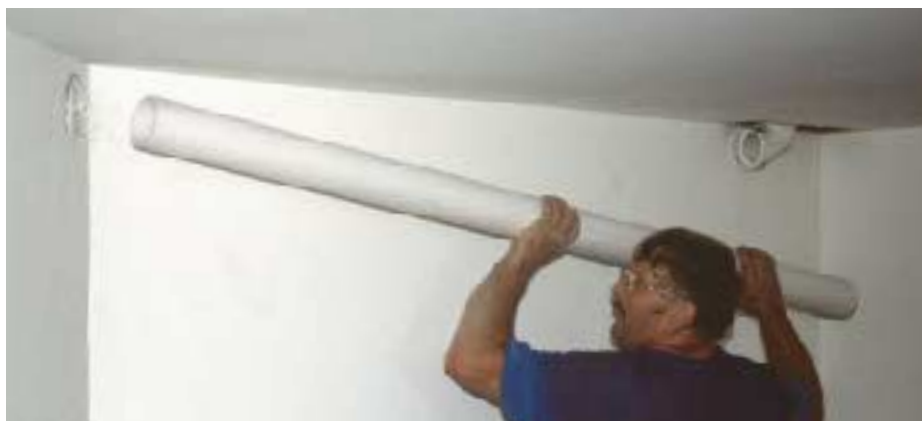
Figure 3. A length of 3-inch PVC — the lower end of which will be cemented into the slab — turns to pass through a partition wall (left). The sanitary tee will accept a second vent pipe leading to the garage. Below, the main vent line continues through a finished portion of the basement (later enclosed in a pipe chase) before exiting through an opening in the band joist. Like plumbing vent pipe, radon venting must be pitched enough to allow condensate and rainwater to drain.

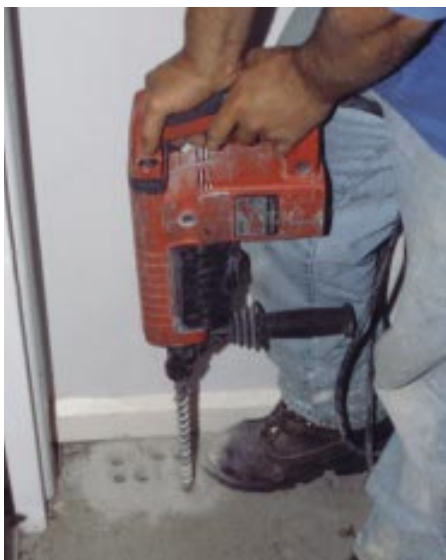
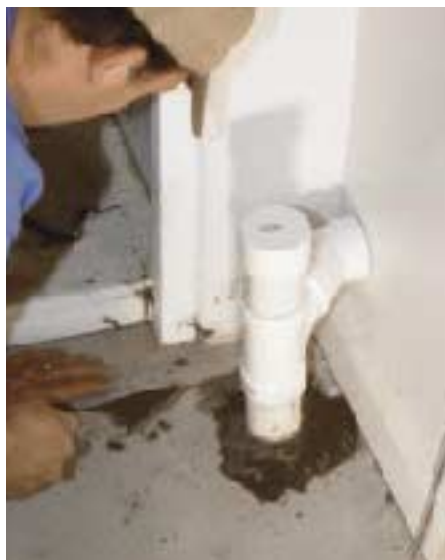
Figure 4. A second hole was hammered into the garage slab to create an additional vent sump (left). The vertical pipe was cemented in place with its open end extending just beneath the underside of the slab, minimizing the risk of blockage by an unexpectedly high water table (right). The uncemented cap on the vent line allows for later expansion, if needed.

Adding a secondary vent. With a straightforward floor plan, a single slab vent is usually enough to do the job. In this case, though, the built-in garage was supported by its own continuous strip footing, effectively isolating that section of the sub-slab from the finished area served by the initial sump. (Radon isn't ordinarily a concern in a single-story garage, but if there's living space above — as there was here — the area must be treated.) To deal with that, we created an additional sump in the garage floor and connected it back to the main vent stack with a long run of 2-inch PVC (Figure 4). Fortunately, we managed to route the pipe through a closet, under a flight of stairs, behind a bathtub in the downstairs bathroom, and back into the utility room, keeping it out of view and making life easier for the finish carpenter. To make sure that some future plumber doesn't connect a sink drain to the radon-reduction system, the piping is identified with stickers (Figure 5).

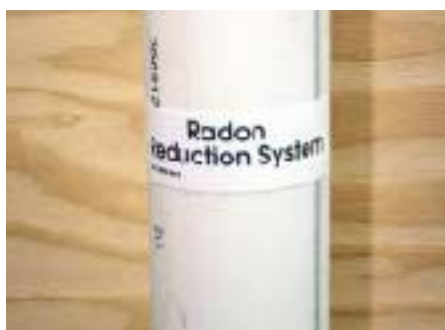
Figure 5. The radon-reduction piping is clearly marked at regular intervals to ensure that it won't be confused with plumbing drains.

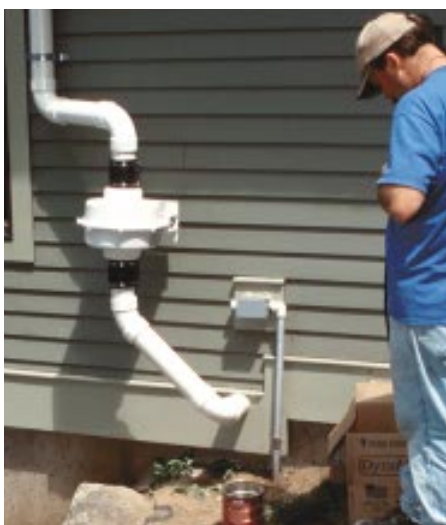
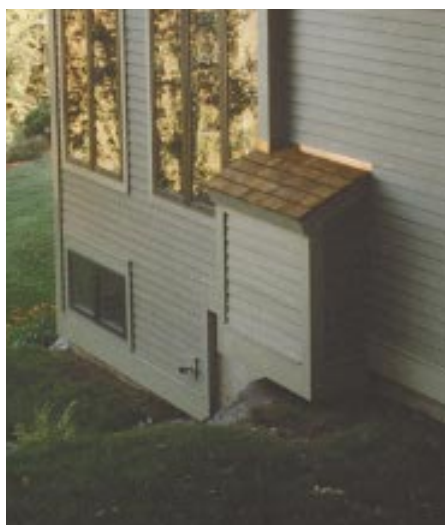
Figure 6. External vents always require a fan to provide a reliable draft. The vent pipe was secured to the fan housing with standard neoprene plumbing connectors before continuing up the wall of the house (left). The finished assembly — located on an inconspicuous outside elevation — was later boxed in for a more finished appearance (right).

With the inside piping done, we connected the vent pipe to the fan and ran it up the exterior wall and through the gable-end overhang (Figure 6). Purely by chance, an existing weatherproof

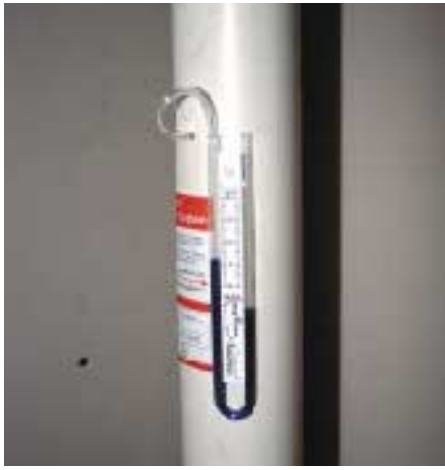
Figure 7. A vacuum monitor installed in the vent pipe confirms that the fan is providing the required negative pressure, although further testing is needed to determine whether indoor radon levels have actually declined.

Before switching on the fan for the first time, we attach a U-tube manometer to an easily visible location on the vent pipe so we can confirm that we're getting the required vacuum. In this case, we found that the system was pulling $1\frac{1}{8}$ inches of water, which translates to about 80 cfm (Figure 7).

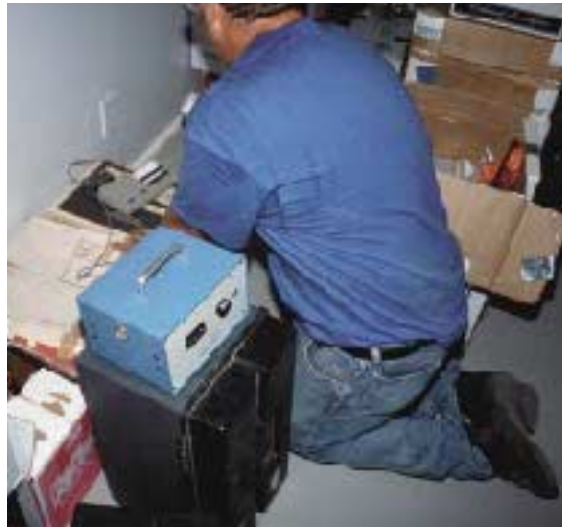
Figure 8. An electronic radon-monitoring device continually tests the amount of gas present. Once each hour, it prints out the current radon level as well as an average that factors in all previous readings.

Final test. In this case, though, the radiant heat coils in the slab prompted us to skip that step, because we didn't want to risk puncturing the tubing. Instead, we went directly to the final test, which involves setting up a pair of electronic monitoring devices, each of which prints out a record of the current radon level once every hour (Figure 8). If the numbers we came up with were still too high, we'd have to bore additional holes in the slab and add additional vent pipes to bring them down.

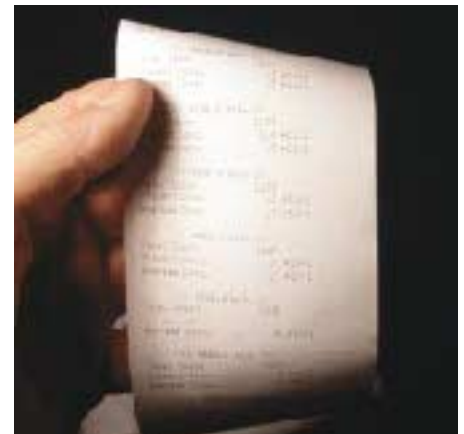
Figure 9. After four days of continuous testing with two separate monitors, the highest average recorded came out at .5 pCi/L — comfortably below the 4 pCi/L action level.

But four days later, when we evaluated the printouts (Figure 9), we found that both machines had recorded levels far below the 4 pCi/L action level. (One recorded a four-day average of .2 pCi/L, while the other, some distance away, showed .5 pCi/L.) While those figures may fluctuate slightly over time — they may rise slightly when the house is closed up tight during the winter months, for example — they'd never approach the action level, let alone the much higher levels seen originally.
