# A Close Look at Stucco

Problems with stucco persist, yet properly installed standard details are still the cure

by Dennis McCoy

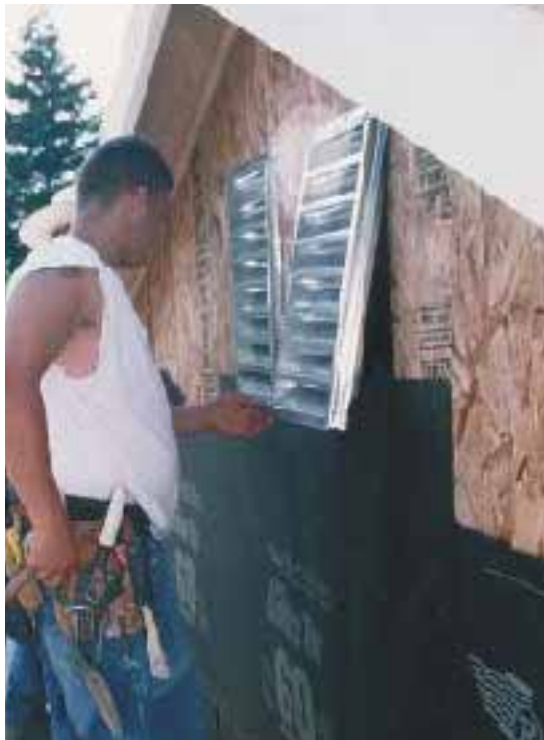
Flashing details frequently involve the interaction of two trades. Here, for example, the stucco crew members responsible for installing the building paper had to remove and reinsert a gable vent installed by the framers so that they could run building paper under the vent flange.

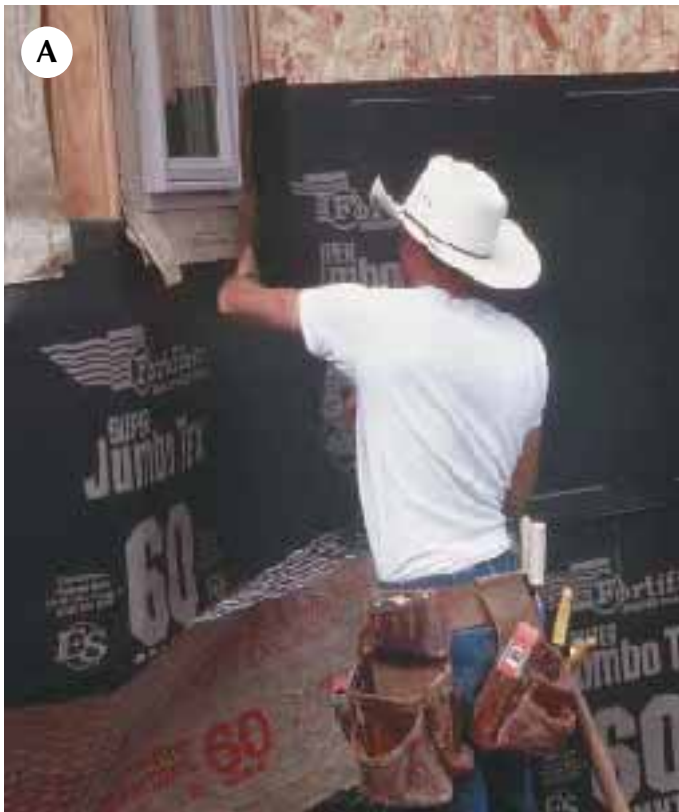
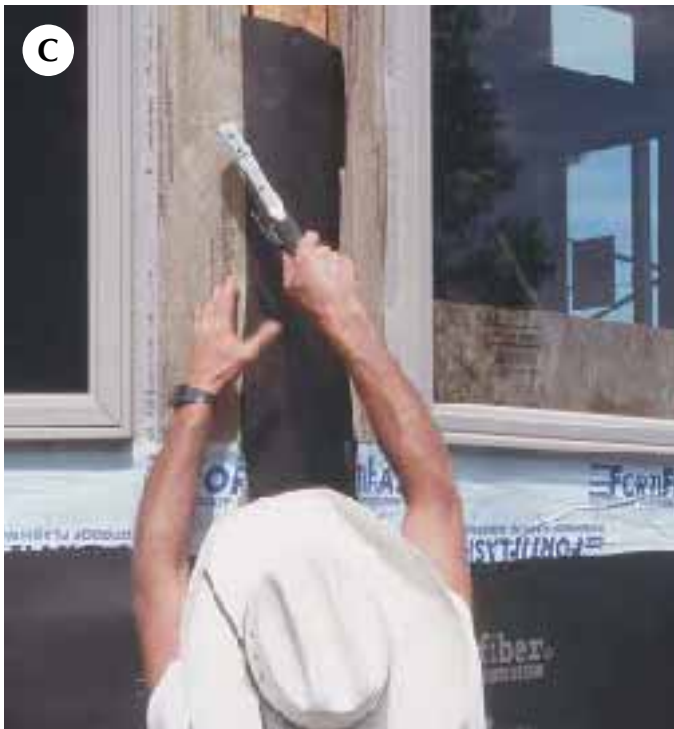
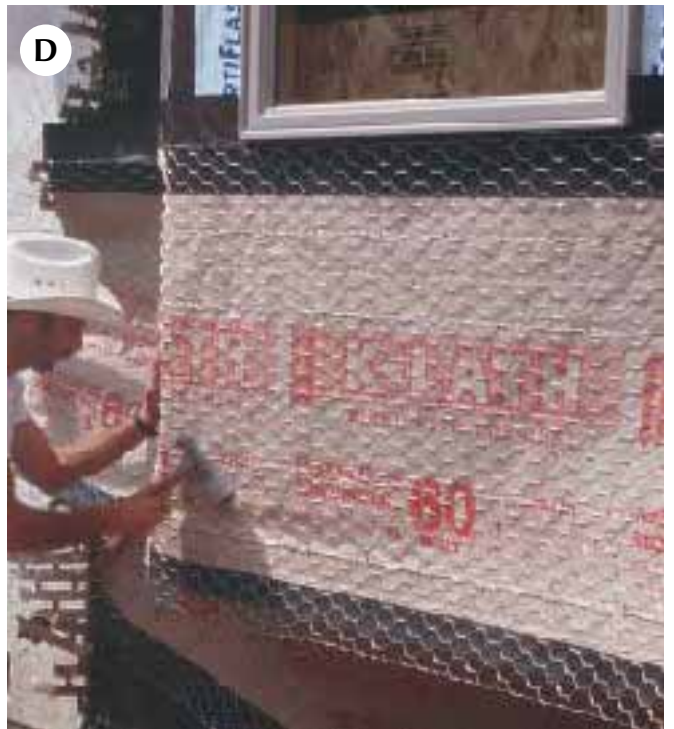
Integrating building papers with window flashings can be a challenge on site. In California, where this crew works, stucco contractors aren't typically licensed to install windows, so the paper crew must work with the existing flashing. Here, the window crew left the window perimeter protected by strips of flashing, with side strips lapped over the bottom strip and the head strip lapped over the side strips and the window flange. The paper installer lifts the bottom flap and runs paper under it (A), then seals the flashing to the paper with adhesive membrane (B). Next, he lays paper under the side window flashings and staples the flashing down before applying membrane to this joint as well (C). Paper-backed lath then butts directly to the window flange (D), but water that gets behind the stucco at the window sill and jamb will be handled by the membrane, the flashing, and the first layer of paper.

Coordination on site can make or break this installation. Where window flashings dump under the paper, it's probably because the window installers put the flashings in before the stucco installers came to paper the

building. The paper has to go on first, then the flashings, then the window, and finally the lath. Each trade has to wait for the one before, or you have to figure out a way to leave the flashings hanging so they can be integrated into the building paper later.

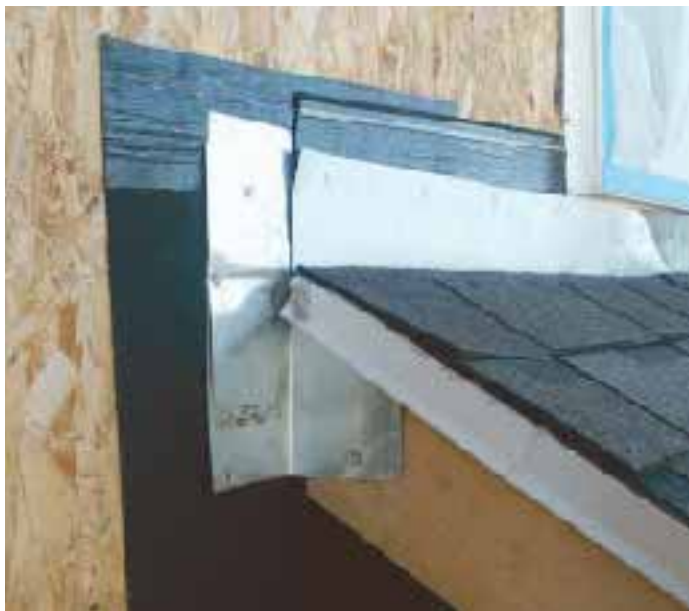
Here, the window installers and the roofers have not coordinated their work. Roof flashing will effectively catch water coming off the main wall if stucco papers are applied to lap over it. However, the window flange dumps behind the roof flashing instead of onto it. The author's crew removed this window and reflashied the opening before reinstalling the window.

Another typical case is shown in the photo on page 7. Here, the window flange is likely to dump behind the roof flashings if someone is not careful. This situation was found on one of my company's retrofit jobs. My crew removed the window, papered the wall with papers lapping on top of the roof flashing, flashed the window opening so the flashing dumps on top

of the paper, then reinstalled the window with flanges outboard of the papers and flashings so that water always moves away from the building as it heads downhill.

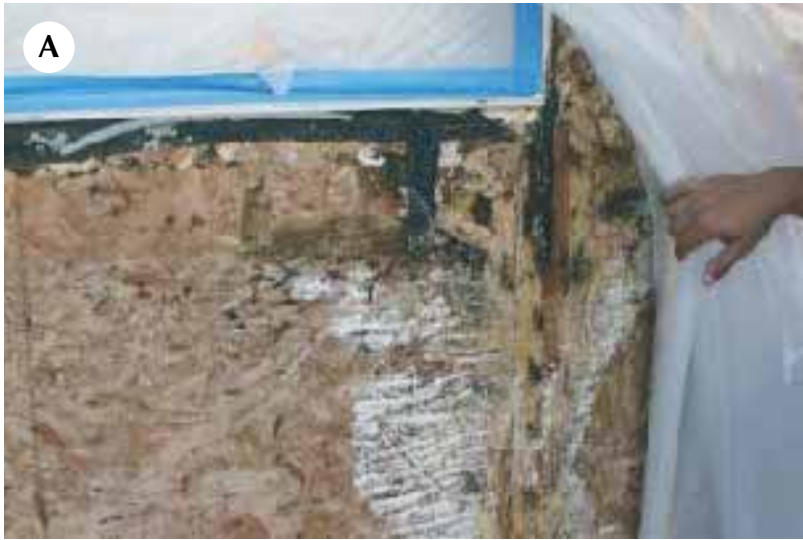
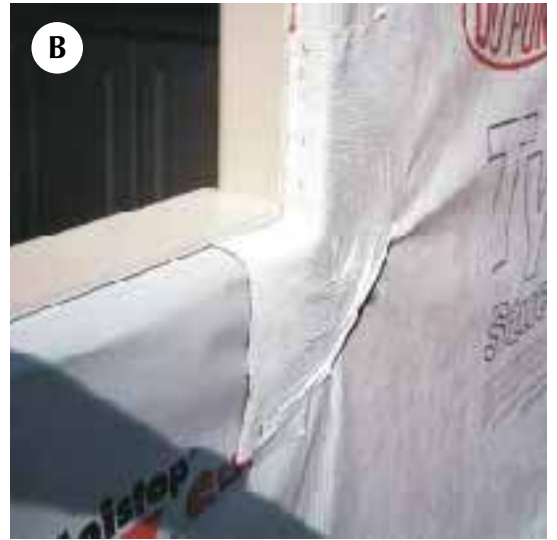
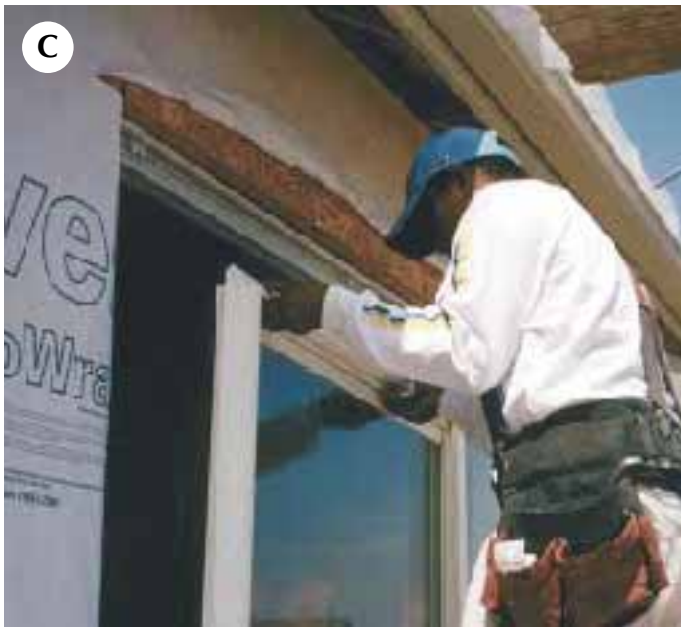
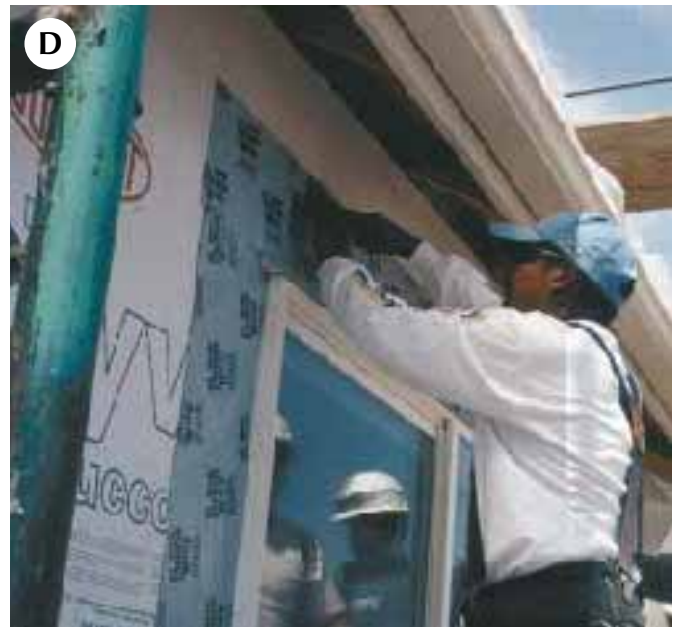
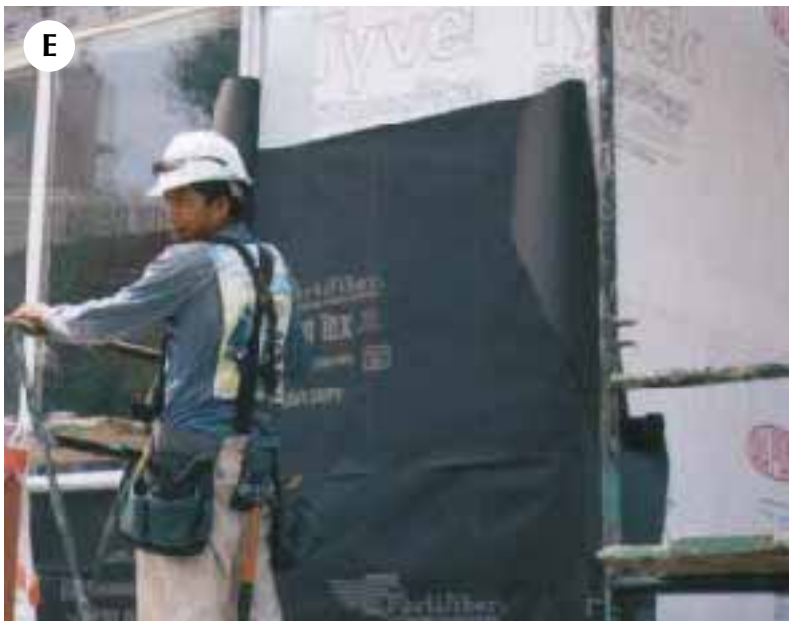
Less than ten years old, this building had been repaired twice previously with surface-sealing methods that did not work. The author's crew first stripped the stucco. At this window corner (A), badly detailed flashing and paper let water soak the sheathing and framing, leading to rot. After pulling out the window, the author's crew repapered the wall with Tyvek StuccoWrap, then applied membrane and Tyvek FlexWrap to the rough sill to protect the wood structure even if the window leaks (B). The crew then replaced the window (C), sliding the top flange under the Tyvek and sealing the flange to the Tyvek all around the window (D) before applying a second protective layer of Grade D building paper (E).

Bad window details damaged several spots on the building in the photos on page 8. Though it was less than ten years old, this building had been repaired twice previously with surface-sealing methods that did not work. After pulling out the window, we repaired the wall with Tyvek StuccoWrap, then applied membrane and Tyvek FlexWrap to the opening to protect the wood structure if the window should ever leak (as many on this building

have). We then replaced the window, sliding the top flange under the Tyvek and sealing the flange to the Tyvek on all four sides. Finally, we applied a second protective layer of Grade D building paper. More than a hundred houses in this one neighborhood, built by different builders both large and small, need this treatment.

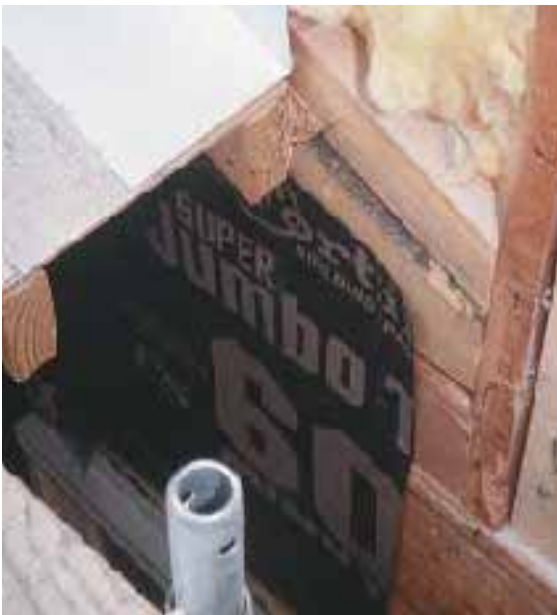
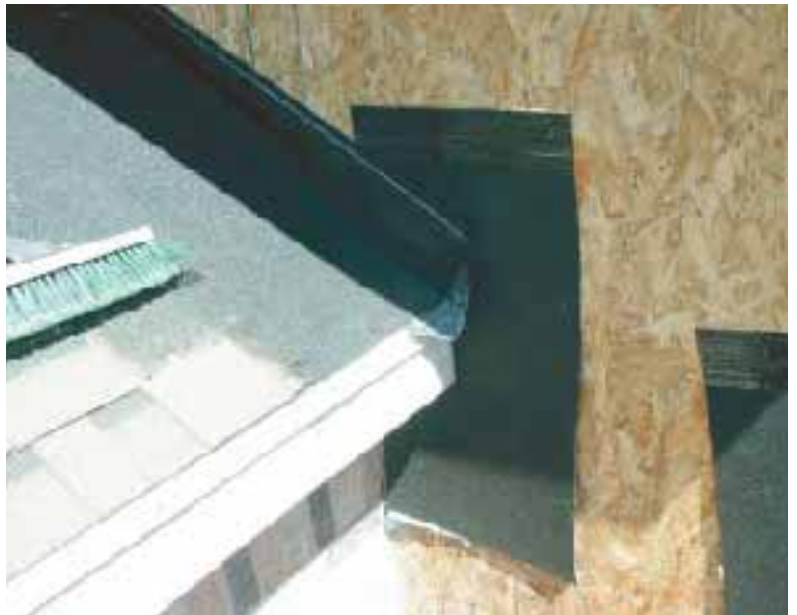
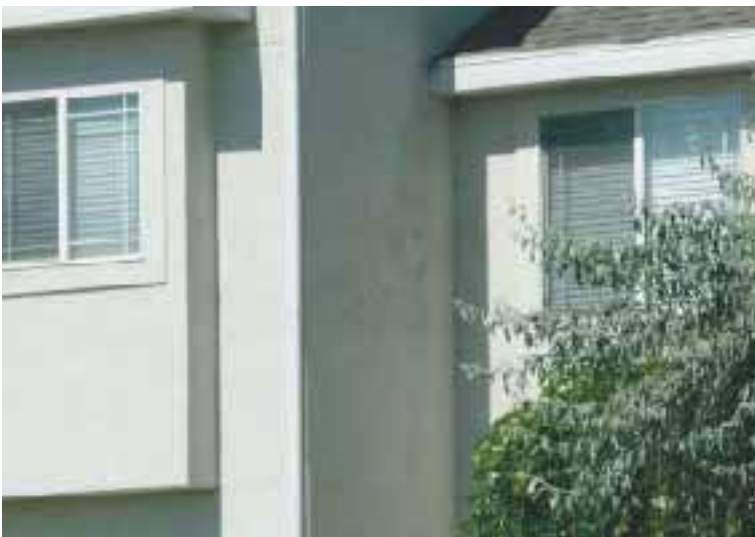
Roof-to-wall intersections create particular problems. At top left, this bad detail held up the work: The rafter placed tight to the building wall does not allow paper to slip behind it, and the flashing left by the roofers will direct water behind the stucco and into the wall if used as configured. The photo above shows a water diverter (kick flashing) installed by the author's crew in a retrofit job: This design will lead water out away from the wall and dump it off the roof's drip-edge rather than into the wall. Papers installed on the main wall can readily integrate with the membrane and flashing between roof and wall at the rafter tail. At left, a wall-and-roof intersection built without the correct flashing detail shows discoloration and staining after a few years in service; the author typically finds significant rot in buildings with this detail, even though the wall surfaces may show only minor traces of trouble.

Every roof needs some kind of L-shaped flashing where the roof abuts the wall. Metal step flashing, or as we call it, “step shingles,” is typical for asphalt or shake roofs; tile roofs usually get a continuous piece of metal J flashing.

Where stucco is new in the market, the appropriate metal step shingles for stucco application can be hard to find. Folded flashings intended for use with asphalt shingles and vinyl siding are too small for stucco. In Salt Lake City, the typical step shingles on the shelf are 8 inches long, with a 2-inch leg for the wall and a 4-inch leg for the roof. Stucco requires a 2-inch reveal between the bottom termination of the stucco and the roof surface (many EIF systems need a 3-inch reveal), and a 2-inch lap of the building paper over the metal, so step flashings must have at least a 4-inch vertical leg.

Since you can't be sure of finding the right size metal flashings in all markets, I always use rubberized asphalt sheet material like Ice and Water Shield as a backup.

However, the flashings are still important, particularly the water diverter or “kickout flashing” at the bottom of the roof, which kicks roof runoff away from the wall system. Where this is not installed, water from the roof will overwhelm the stucco system and cause at least a visual problem, and commonly a major structural problem.
