# IN THE NEWS

## Deck Researchers Scrutinize Railing Attachment

## Flexible Gas Piping Involved in Fires Caused by Lightning

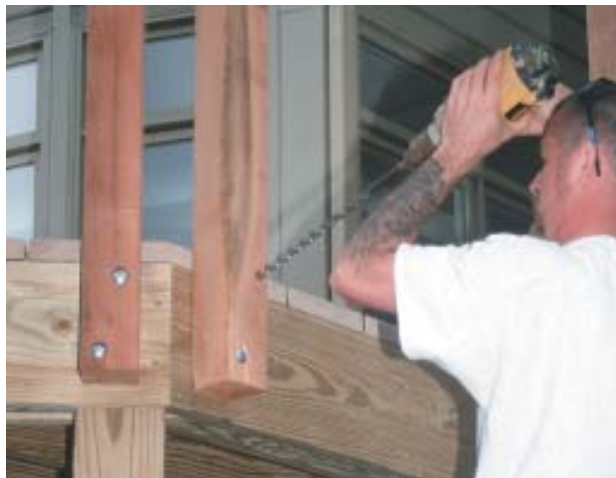
A Virginia Tech task force examining the critical structural details for residential decks and balconies released detailed data and conclusions about deck-to-house attachments this spring (see “Load-Tested Deck Ledger Connections,” 3/04). Now the team is shifting its focus to the other end of the deck. In a process that Virginia Tech professor emeritus Frank Woeste expects to take at least a year, the group will apply its mix of field investigation, engineering analysis, and laboratory

testing to railing and rail post connections in hopes of identifying which details will prevent death and injury and which won't.

In contrast to total collapses caused by a failure of the ledger connections, says Loferski, railing failures usually involve only one or two people. “When ledgers fail, it’s because a lot of fasteners let go at once. With railings

and rail posts, a catastrophic failure can occur when only one or two fasteners fail. A couple of people lean over, and they fall.”

But in the real world, says Loferski, the railing failures he knows about had nothing to do with overloading: The structures were clearly inadequate. “One or two of them might have worked when they were new, but even those were underbuilt. Typically, the railings that failed were less than ten years old, and they tend to be built with untreated wood that has deteriorated in service, and with ungalvanized nails that have rusted. Often people used finish nails or screws that were never adequate for the design loads even before they started to rust.”

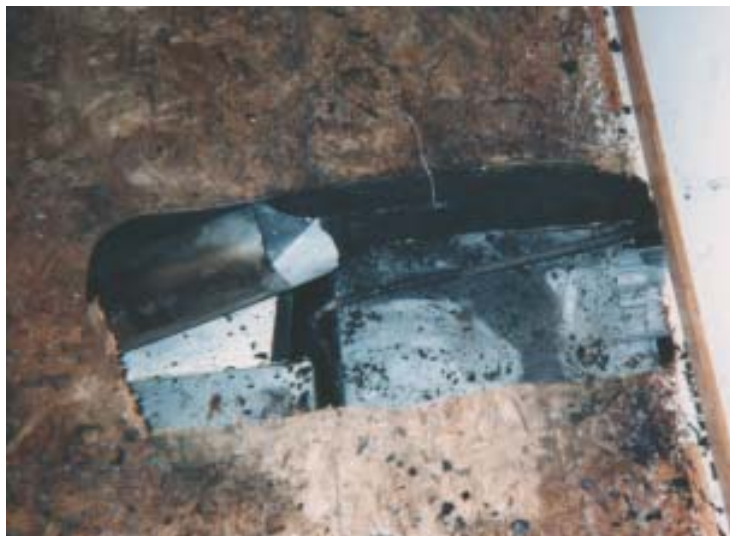
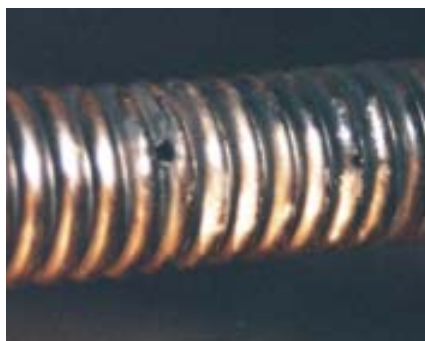
A fire was ignited in this crawlspace by a lightning strike that arced from the flexible gas tubing to a metal heating duct. The local fire department arrived in time to save the structure.

The holes in the tubing wall are visible in the photo at right. The plastic insulation that originally covered the tubing was burned away in the fire.

In all cases, the surge then passed along the CSST before arcing to ground where the tubing passed close to another metal object, such as a furnace duct. In at least four of the seven events, the arc was powerful enough to burn one or more holes in the stainless-steel tubing and ignite the escaping gas.

Woodall’s article states that UL-certified materials had been used in all the cases described and that no building code violations were noted. It proposes several possible countermeasures, including grounding of metal fireplace boxes and placing sleeves of PVC pipe over the flexible gas line where it passes over water pipes or metal furnace ducts.

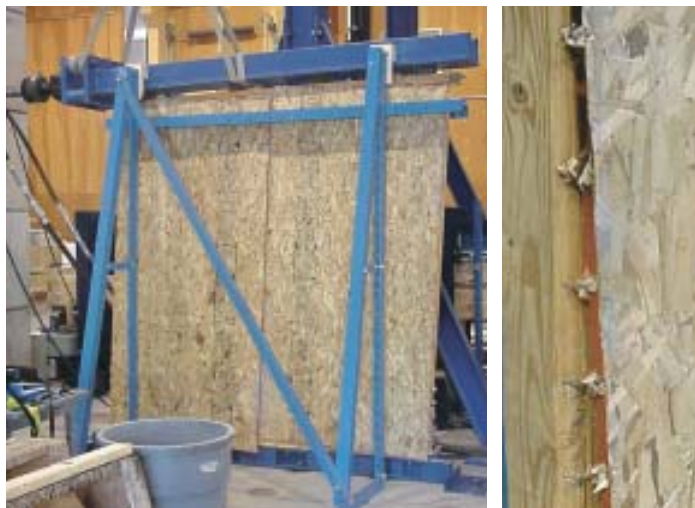
**R**esearchers at the University of Maine have developed a fiber reinforcement system for structural wood panels that can boost the racking strength of a typical house wall by 20% and double the shear values for an engineered stud-and-plywood or stud-and-OSB shearwall. Professors Habib Dagher and William Davids share a patent for the new technology, which centers on reinforcing edge nailing areas with a tough fiber-reinforced polymer, to enhance the holding power of nails. Besides strengthening conventional wood shearwalls, the pair expect the method to be useful with panelized systems and narrow shearwall sections. For more information, see the University of Maine's Advanced Engineered Wood Composites (AEWC) website at [www.aewc.umaine.edu](http://www.aewc.umaine.edu).
