# RAISING THE CEILINGS IN A Whole-House Remodel

Thanks to a good plan,  
a sizable crew, and a  
bunch of 20-ton screw  
jacks, the walls of this  
house grew taller

by David Morgan

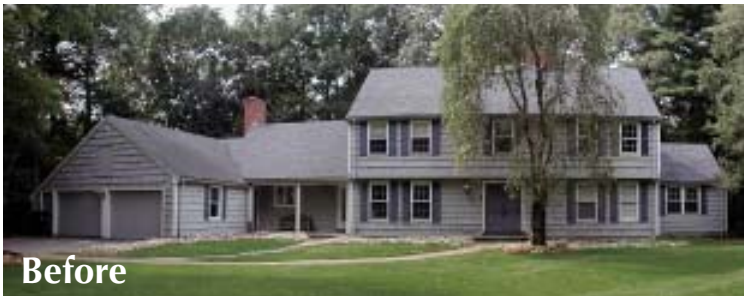
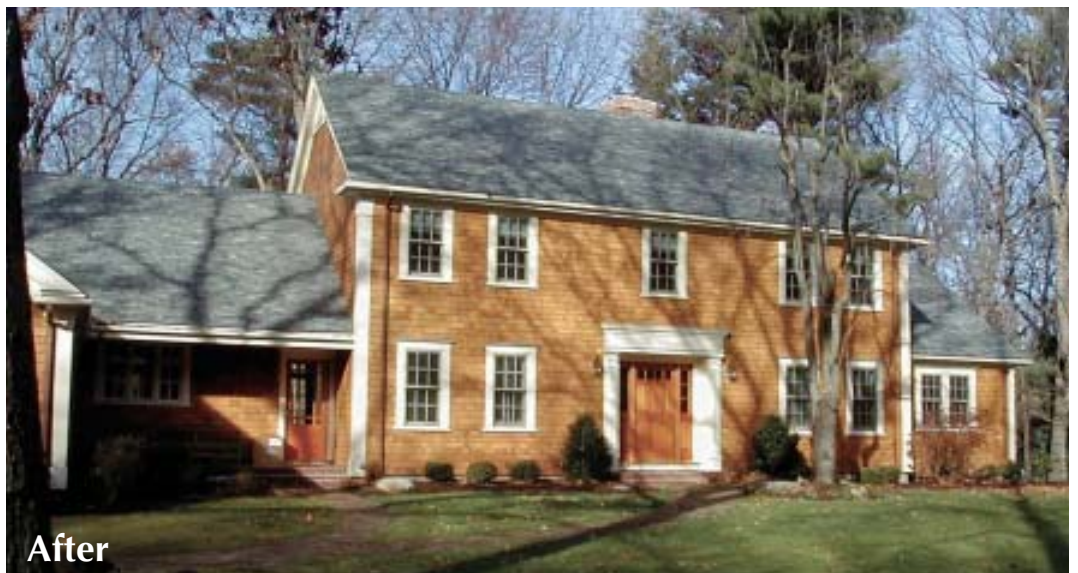
Before

**W**e were three months into a whole-house makeover, installing new windows, doors, exterior trim, roofing, and siding, when the homeowner, a tall man, asked if there was any way we could improve on the low, 7-foot-6-inch ceiling height throughout the house. My first reaction: No way. But the more I thought about it, the more feasible it seemed. We were already installing all-new interior window and exterior door trim, which meant that all the rooms required header adjustments, plaster patching and painting, and so on. The kitchen and baths also were being updated, with new cabinets, fixtures, and finishes. All the carpeting was going to be replaced and the wood floors sanded and refinished. Most of the work involved was already factored into the budget.

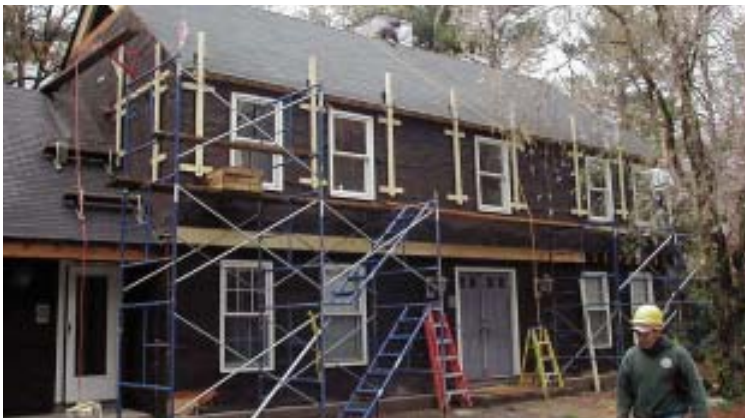
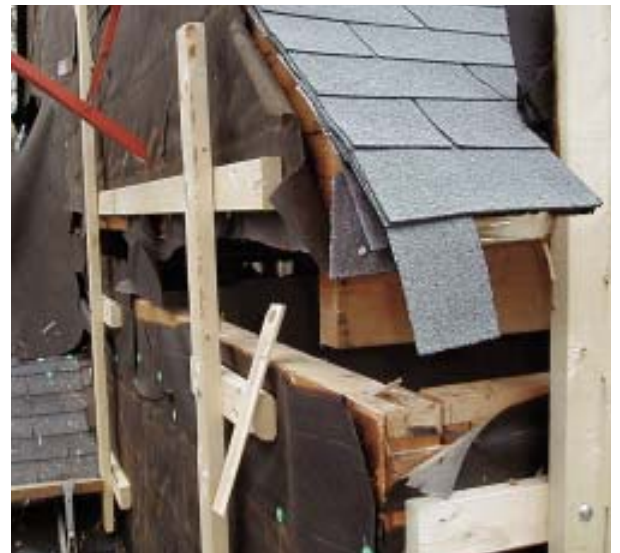
**Figure 2.** To maintain the original alignment and prevent the roof structure from shifting during lifting, the author's crew bolted 2x4 vertical struts to the tops of the walls around the house's perimeter.

A major concern was making sure that the roof would stay square, plumb, and aligned over the top plates during lifting. If it was not carefully restrained, we could have trouble placing the raised section back where it belonged. We solved the problem by through-bolting 2x4s vertically to the tops of the exterior walls around the entire perimeter of the house (Figure 2, next page). We notched the overhanging

roof sheathing directly above to provide slots for the 2x4s, so that they'd trap the roof above the walls and keep it from twisting in the wind or wracking out of alignment during the jacking.

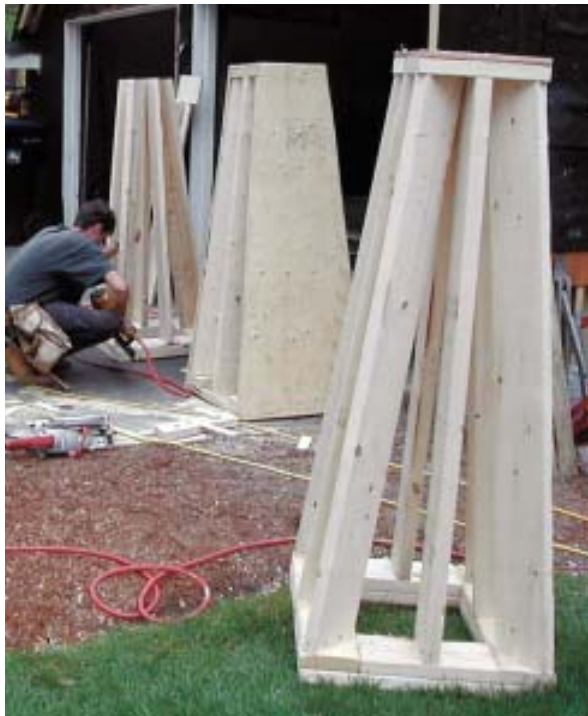
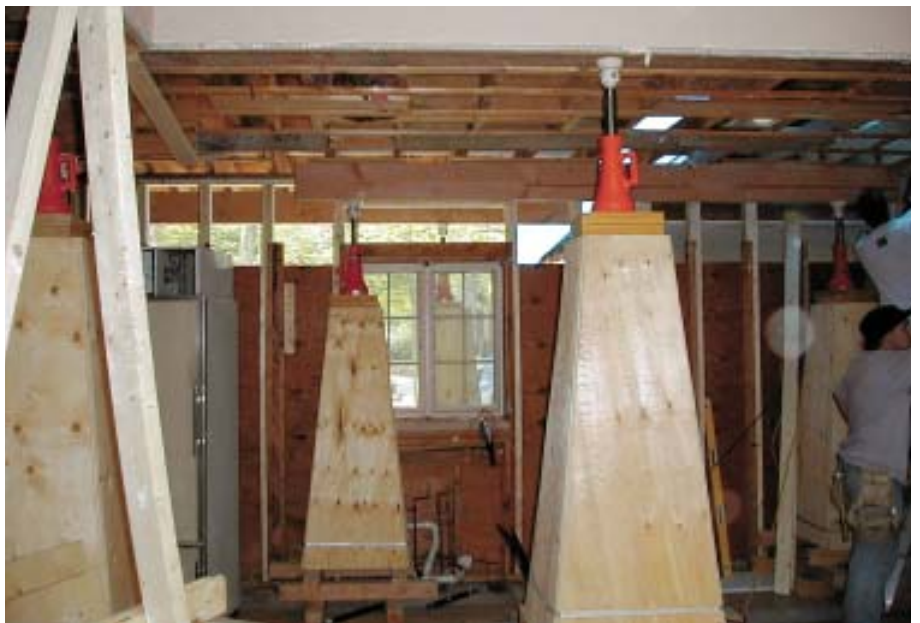
**Figure 3.** Site-built pyramidal jacking stands safely extended the screw jacks' reach to just below the lifting beams.

One of the early issues we had to decide was how to safely extend the reach of the screw jacks to the ceiling joists. My first thought was to place the jacks on the floor and use fir 4x4s or two 2x4s nailed together to prop under the 4x10 lift beams. But that presented a serious problem of stability — it would be easy for a post to kick out suddenly under a load, posing an unacceptable risk. We decided instead to build a quantity of structural pyramidal jack stands whose height could be supplemented as needed by stacking 4x4 cribbing under them. Some stands could serve as dead men, while others served as jack stations (Figure 3).

**Pyramid stands.** We made the stands by cutting 5-foot-long 2x8s at the requisite angle to taper from a 2-foot-square base at the bottom to a 1-foot-square top platform. We wrapped the sides, top, and bottom with  $\frac{5}{8}$ -inch

plywood and screwed it with  $1\frac{5}{8}$ -inch galvanized deck screws. As a final precaution, we wrapped a band of perforated, galvanized-steel strapping around the base about 8 inches up from the bottom and screwed through it into the studs with  $2\frac{1}{2}$ -inch galvanized deck screws. In the unlikely event one or more studs failed under load, we figured the band would help keep the base from spreading.

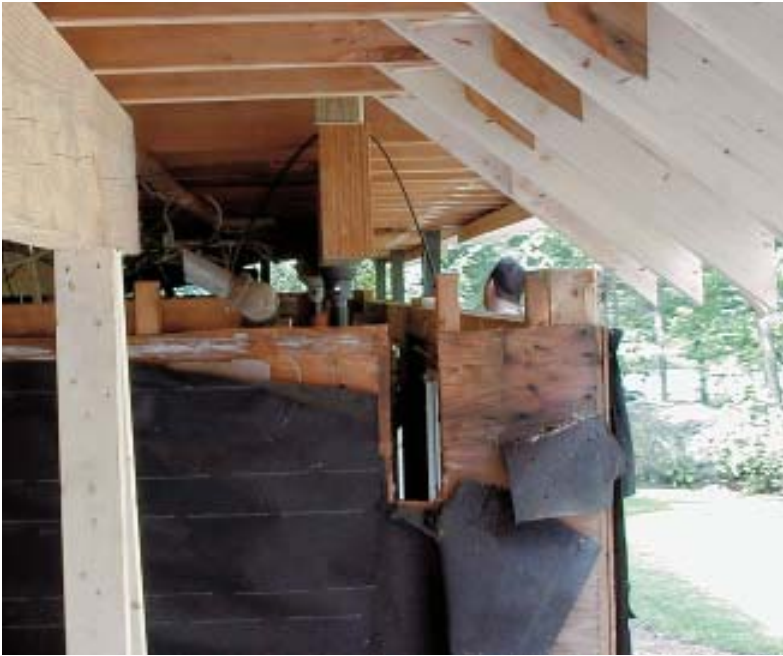
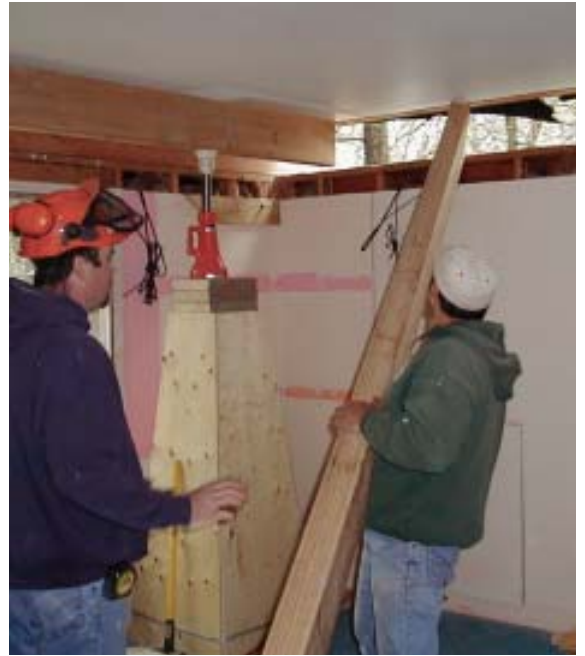
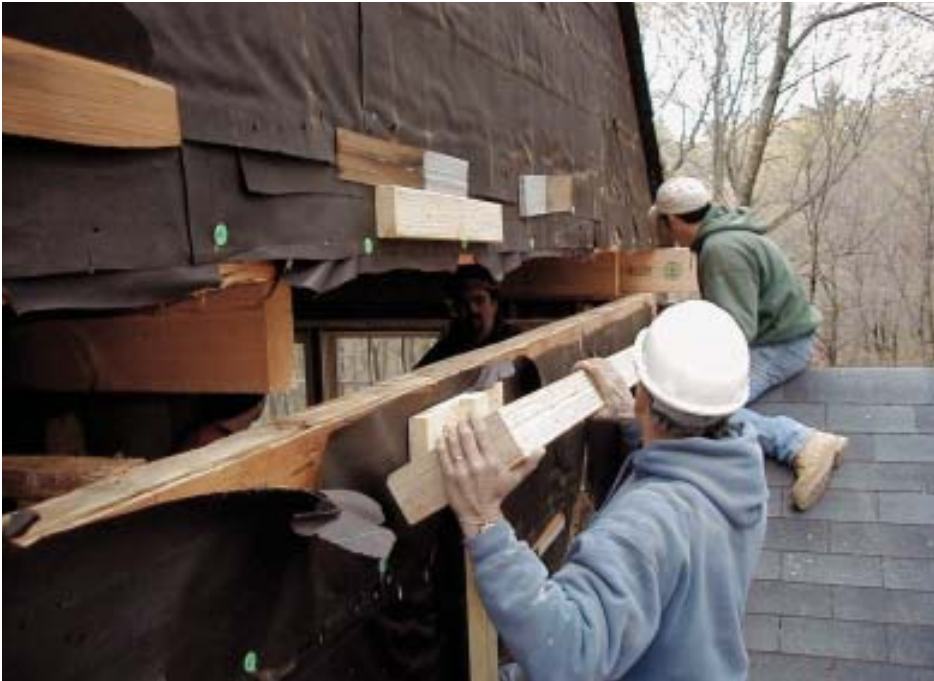
**Figure 4.** Working in small increments, the seven-man crew slowly raised the roof structure by 9 $\frac{1}{2}$  inches, allowing the nominal 4x10 engineered LVL plates to be inserted into position on top of the wall.

With the LVL beams cut and ready for placement, we proceeded with the lift. The screw jacks allowed us to raise the roof in small, controlled incre-

ments. We started with three rotations of each screw — about  $\frac{5}{16}$  inch — across the front, then performed the same step at the middle and at the back. We repeated this sequence until we were able to set the beams on the lower top plate (Figure 4).

Toenailing to the top and bottom of the beam provided a quick and accurate means of aligning the plates, leaving them straighter than they had been originally.

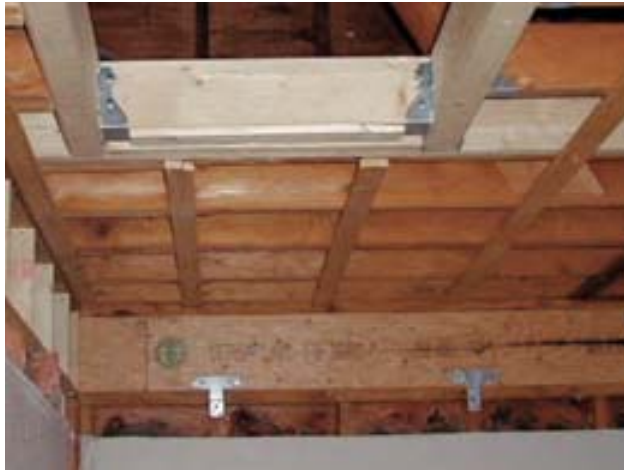
**Figure 5.** T-straps tie the LVL beam to the original plate at 16-inch intervals, helping to prevent the beam from rolling outward under lateral loads.

To consolidate the new and the existing framing, we cut back the plywood exterior sheathing about 15 inches down from its top edge and in-laid new, 2-foot-wide sheathing with glue and nails, tying together the existing studs, lower top plate, and LVLs. On the inside, we used 66T T-strap galvanized connecting plates (Simpson Strong-Tie, 800/999-5099, [www.strongtie.com](http://www.strongtie.com)) to tie the bottom of the beams to the tops of the walls,

which would help prevent the beam from rolling under lateral wind loading or during a seismic event (Figure 5). The connecting plates caught the LVL beam along its bottom edge on 16-inch centers and were nailed into both the wall plate and the studs.

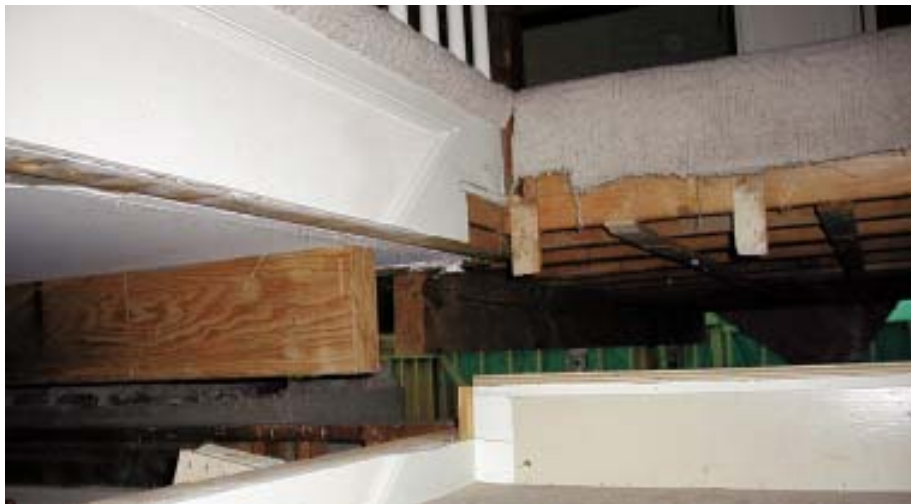
**Figure 6.** Though the staircase would be rebuilt, the original stair helped determine the distance that the first-floor ceilings were raised: two riser heights, or 15 inches.

We would be lifting the entire second floor — walls, roof, and all — a total of 15 inches. We settled on this height because the existing stair risers were a comfortable 7½ inches each. We decided that one riser wasn't enough and three would be disproportionate to the house. With a 15-inch rise, the new first-floor ceiling height would become about 8 feet 9 inches. Because the stair was more or less centrally located in the house, we had room on the first-floor level to elongate the flight by two treads. The stairwell remained unaltered, but we determined that it was best to build an entirely new staircase rather than supplement the existing one (Figure 6).

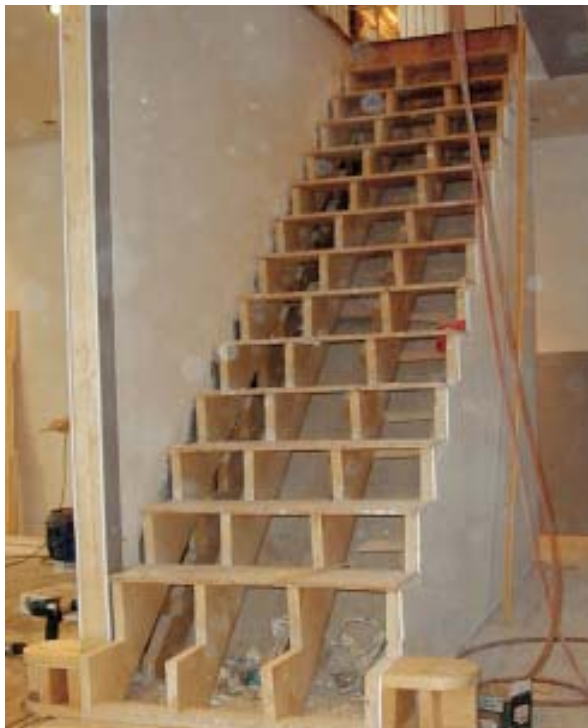
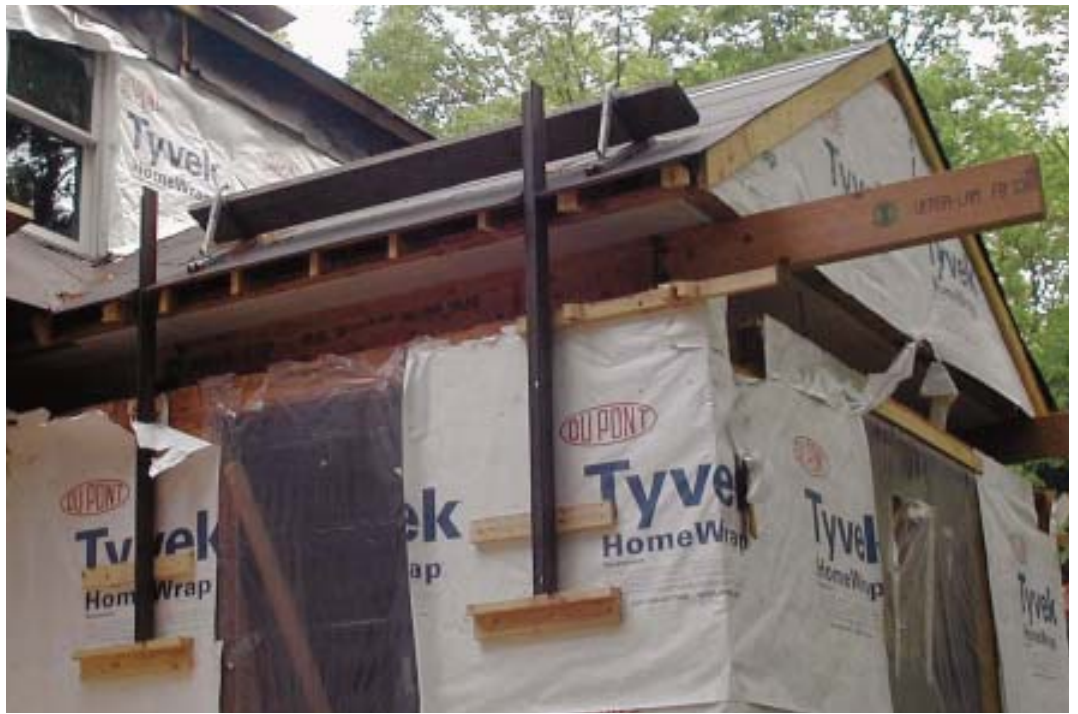
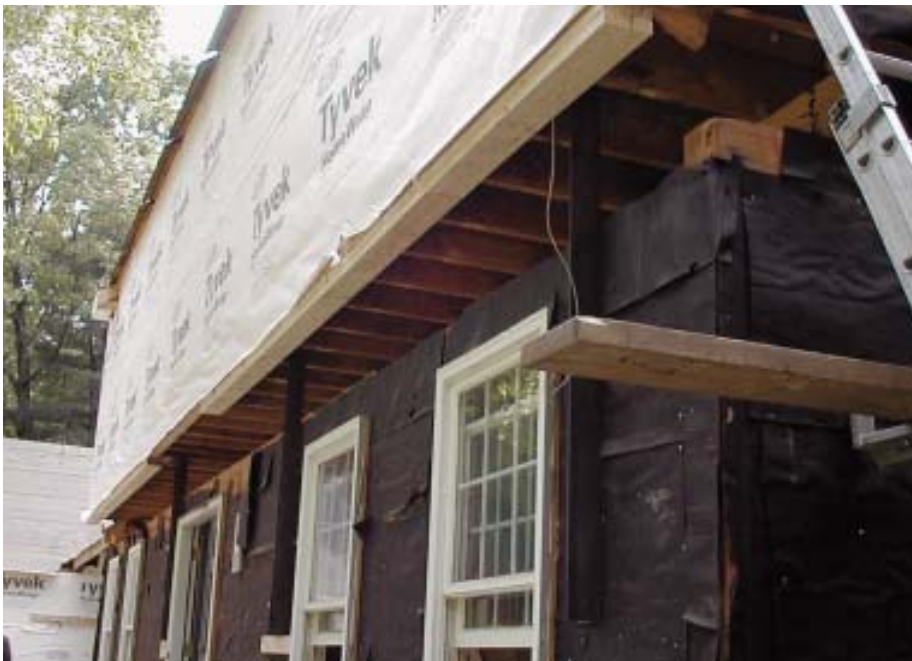
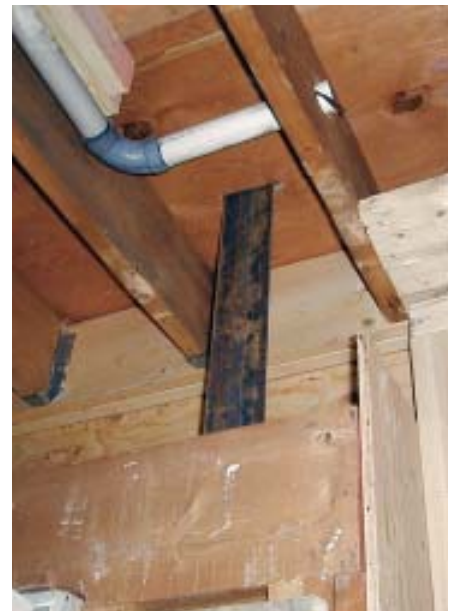
**Figure 7.** To prevent the upper story from being displaced when it was lifted, the author installed 4-inch steel angles to restrain it (above). At the overhanging front elevation (left), the crew cut L-shaped slots for the angles to pass through the second-story floor (below).

First, instead of using 2x4 retainers to prevent the building from moving out of alignment as it rose, we fabricated 7-foot lengths of 4-inch steel angle for that purpose (Figure 7, next page). We drilled holes for ½-inch through-bolts to pass through the wall, where they would be captured in the same way that sidewall staging brackets are mounted, with the capture

blocks spanning pairs of wall studs on the interior side. Instead of costly 10-inch or 12-inch carriage bolts, we bought much more economical 1/2-inch threaded rod and cut it to the lengths we needed.

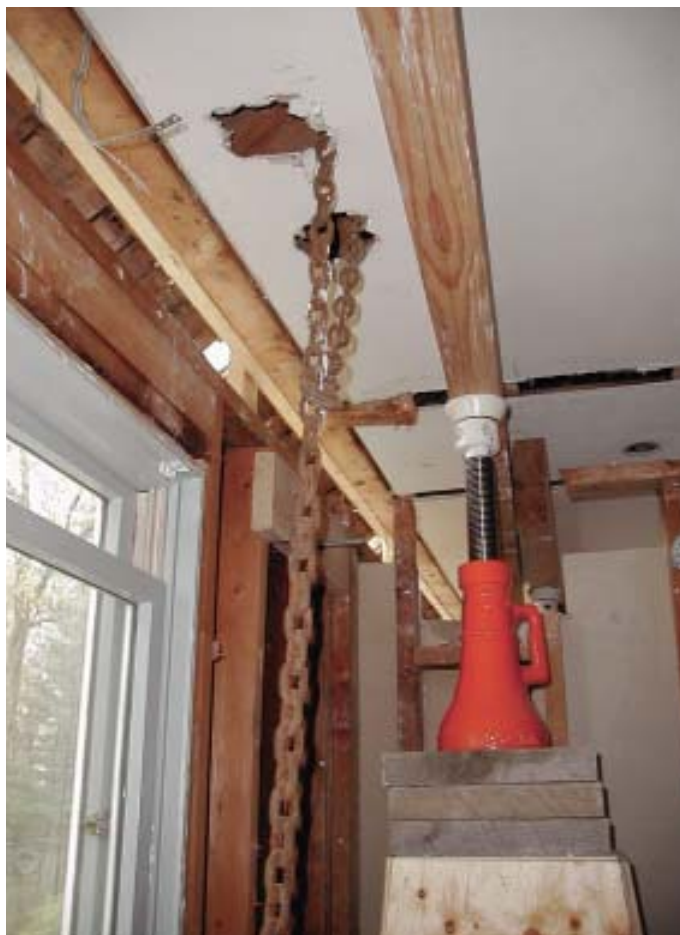
**Figure 8.** As a precaution against sudden strong gusts of wind, the crew tied the front and back of the house to the first story with a pair of heavy chains.

As yet another precaution, we tied the middle front and middle rear of the building's second-floor joists to the first-floor joists with heavy chains in two places. This backup system would help hold the top and

bottom portions of the house together if a sudden wind came up (Figure 8, next page).

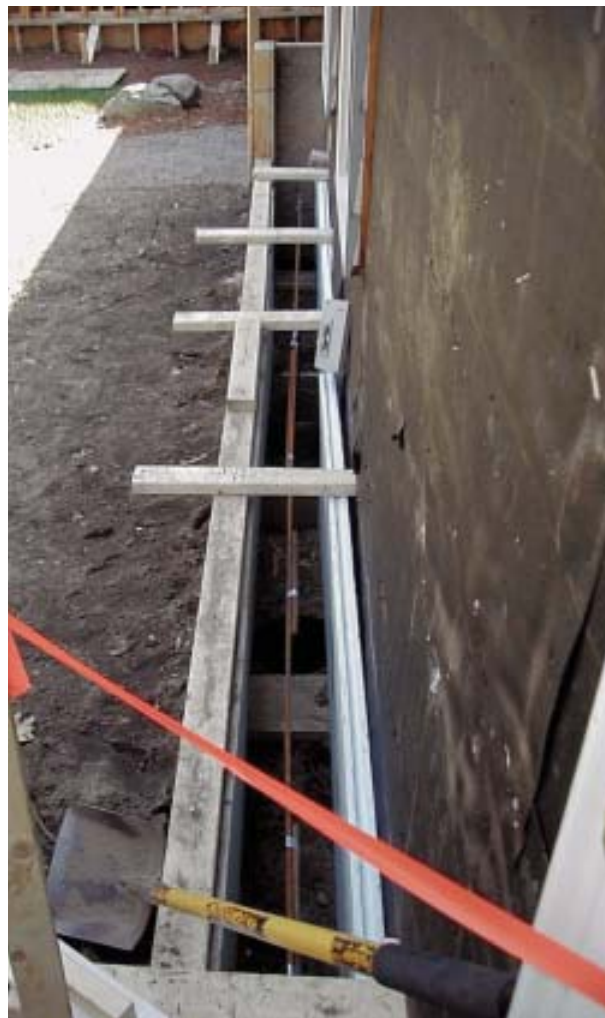
**Figure 9.** A new grade-beam concrete foundation, poured directly along the existing basement wall, and new wall framing provided direct support to eliminate the overhang of the second-story eaves wall.

At the front of the house, we poured a new foundation alongside the old one, filling the gap between the old and new walls with 2-inch rigid foam insulation to save on concrete, which we had to place by hand in wheelbarrows in order to protect the existing landscaping (Figure 9).

To further cut down on concrete, we formed the foundation as an 18-inch-high grade beam on top of concrete

piers placed every 4 to 5 feet. We reinforced the piers vertically with rerod bent at right angles to join the horizontal rerod we placed in the grade beam.

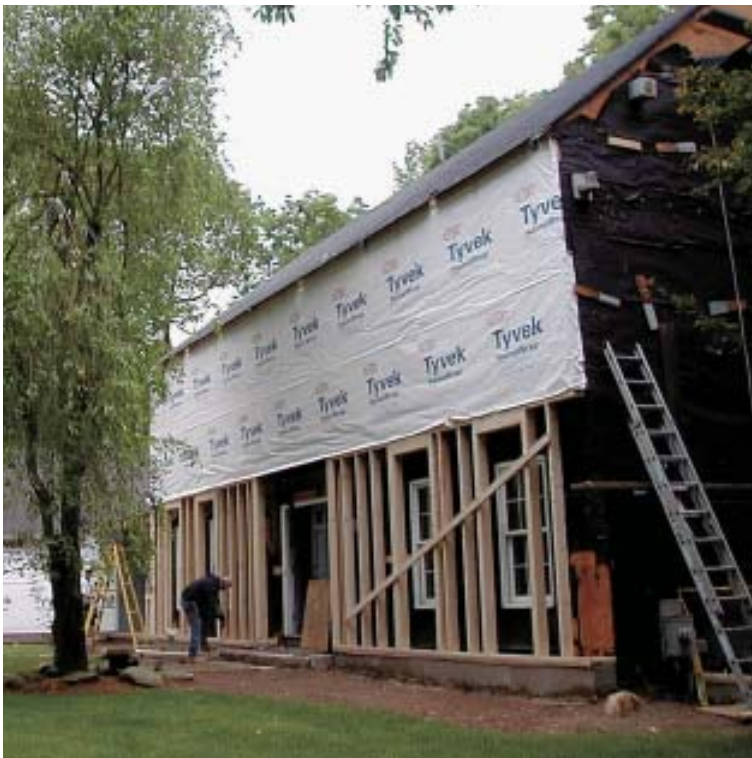
**Figure 10.** While the front wall went up quickly to support the building at its new height (left), the center and rear partitions had to be revised one stud at a time, by cutting and sistering in full-length studs under a new top plate. Nonbearing interior partitions were elevated with short cripple-wall sections (below).

With the second floor raised, we were able to put the new front wall in place quickly and focus on the rest of the house (Figure 10, next page).

bearing partition, we worked piecemeal. We sistered the existing studs with longer ones cut to the new height and toenailed them to a new, double top plate. Above the interior, nonbearing partitions, we simply added small knee walls to extend the tops.

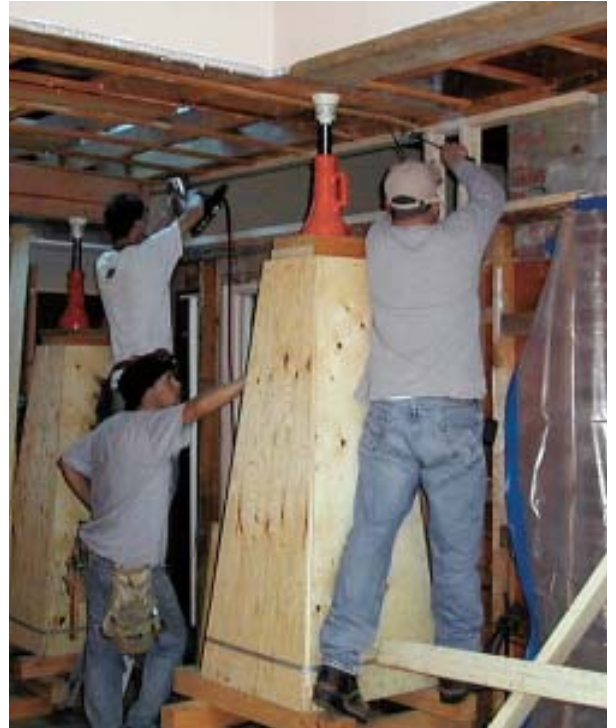
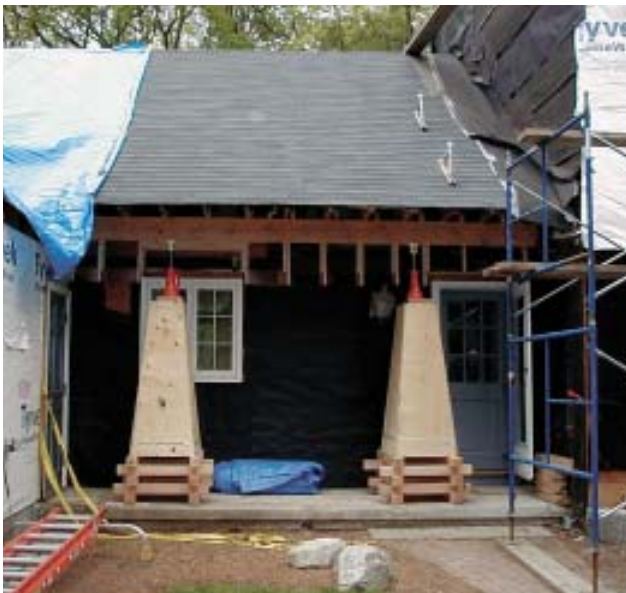
**Figure 11.** The screw jacks were limited to a 10-inch lifting range, so the jacking stands had to be supplemented with 4x4 cribbing placed in crosswise layers under the base.

a quantity of 16-foot 4x4s and cut them into 4-foot lengths. We used these as cribbing underneath the pyramid jacking stands. This provided a stable, strong method that could be quickly placed as needed (Figure 11).

To set the cribbing, we used a screw jack on a nearby pyramid to temporarily transfer the load. A pair of crossed 4x4s added 7 inches to the

jack-stand height, slightly more than needed to finish the job.
