## Ledger-Attachment Code Proposal Survives Committee Review

Final 2009 IRC hearings to be held in May

## Recycling Treated Wood, Nails and All

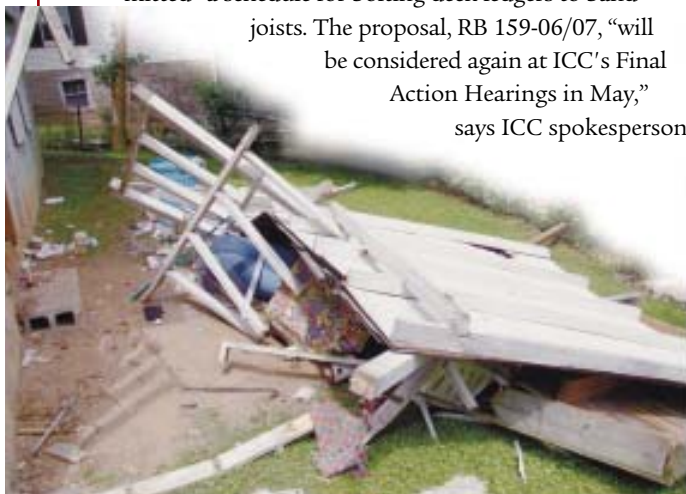
The proposed fastener spacing (table R502.2.2.1, below) is based on research done at Virginia Tech and Washington State University. Under controlled conditions, researchers attached pressure-treated southern pine and hem-fir ledgers to a spruce-pine-fir band joist and subjected the connections to successively larger loads until they failed.

Provision R502.2.2.1.1 in the same proposal requires the bolts to be staggered and to be placed 2 inches in from the bottom, top, and ends of the ledger. See the full text at [www.iccsafe.org/cs/codes/2006-07cycle/ProposedChanges/volume\\_2/11-RB139-RB162.pdf](http://www.iccsafe.org/cs/codes/2006-07cycle/ProposedChanges/volume_2/11-RB139-RB162.pdf). — *Laurie Elden*

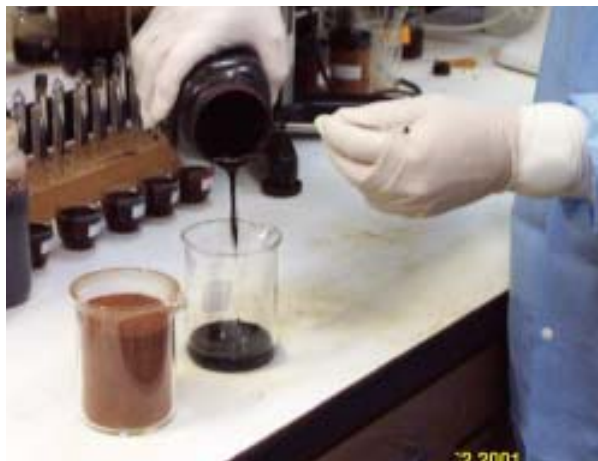
Researchers at the LSU AgCenter grind CCA-treated wood — including nails or screws — into small particles, which are then liquefied in an organic solvent. The result is the separation of 99.8 percent of the preservative chemicals from a nontoxic, liquefied wood that can be used for resins, molded wood products, foams, and plastics.

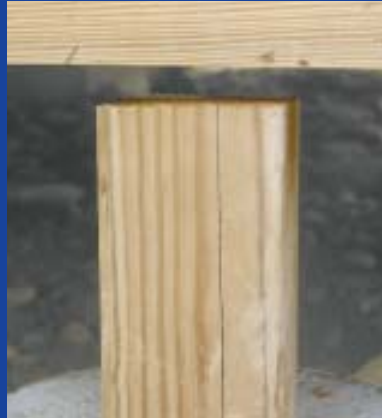
This deck "connection" was on a new house with a township-issued CO. What could this carpenter have been thinking?

Maybe something like, "I'll stick another post down here just in case the deck gets overloaded," or "Hah — won't have to worry about ACQ corroding the framing connectors." See photos of other notable construction defects at [www.remasinspections.com](http://www.remasinspections.com), the Web site of Jeff Remas, owner of Remas Inspections in Clark Summit, Pa.
