Letters

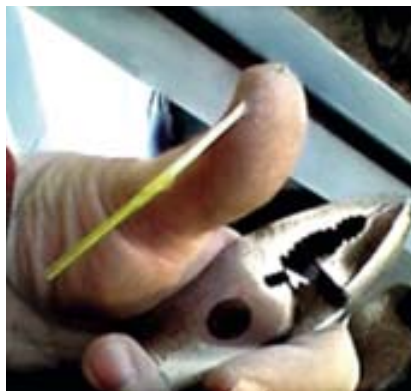
It was as if someone were trying to remind me of my foolish behavior from only a day earlier, when, unlike the carpenter in the picture — who uses a block of wood to align the material being nailed — I had ignored my better judgment and instead chose to align a corner using my thumb while nailing. The photo shows the result. Kudos for showing the right way to do it.
