## **DAY'S END**

Floating a Pergola
In Place

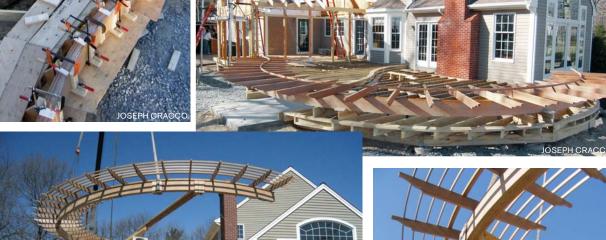
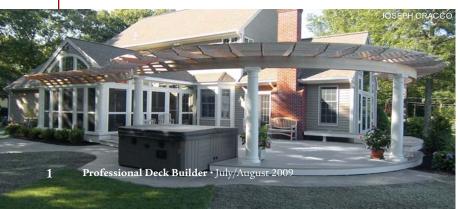
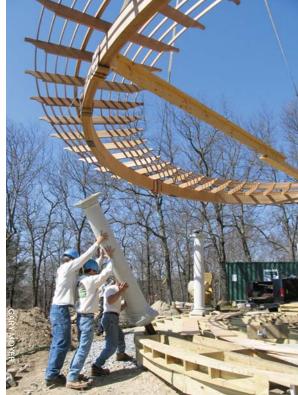
Built by Joseph Cracco and his company, Modern Yankee Builders of Cumberland, R.I., this pergola is 78 feet long: 60 feet is curved and supported by steel columns, and 18 feet (the construction of which is another story) runs along the screened porch. Cracco did exhaus-

tive research into epoxies and made trial runs to determine how best to lay out, glue, and clamp clear cedar to laminate the 60-foot curved beam on site, no small feat in cool April weather. Choosing lap joints for gluing together the lengths of 1x2s (atop the purlins) cost an extra 40 man hours, as the wood split at the joints when the pieces were bent, and the crew had to reglue using scarf joints. Even so, the assembly was ready right on schedule for the crane, which lifted the structure while the crew placed the columns underneath. To see more photos of this project, go to "Complex Pergola Details," a PDBWebExclusive at deckmagazine.com. -Laurie Elden
