## Trouble With Dryer Vents

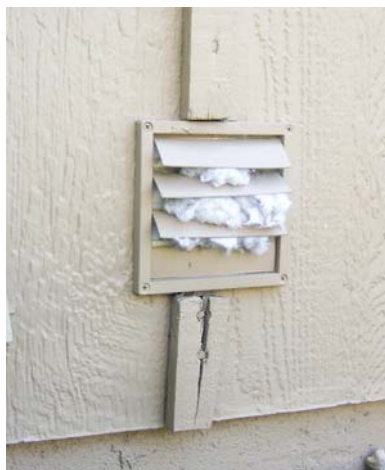
**Figure 1.** Unbelievable as it may be, this photo wasn't staged. The lint caught in this dryer exhaust termination came through the duct and constitutes a serious fire hazard.

Dryer fires generally occur when lint builds up in the vent (**Figure 1**). This obstruction not only provides fuel but also increases the internal

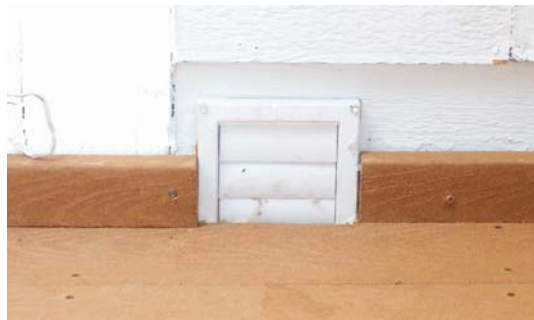
**Figure 2.** Even a small accumulation of snow would block this termination, preventing the discharge of heat from the dryer and trapping lint.

You could consider locating a low deck below the dryer vent, if structural considerations such as ledger attachment could be accommodated. Keep in mind that a 12-inch vertical clearance is typically required beneath the lowest portion of the vent's hood and the grade or floor below (**Figure 2**). This is intended to prevent snow, leaves, or other external debris from blocking the exhaust. It also gives the occupant of the home plenty of room to inspect the backdraft damper and clean out any collected lint. It doesn't, however, leave a lot of room for the deck.
