Can Mold Give You Headaches?

You bet it can: When it comes to this pervasive fungus, a little can go a long way toward wrecking a job

by Mac Pearce

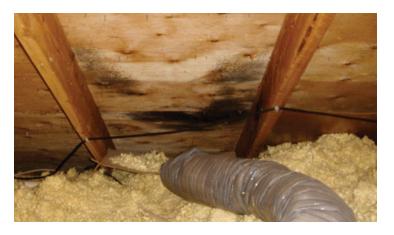
plumber stuck his head up through an attic hatch and saw a disconnected flex duct — a bath exhaust pipe — lying in a bed of fiberglass insulation. Immediately downstream from the duct was a small patch of blackened roof sheathing. So he closed the hatch, climbed down the stepladder, and announced that there was a mold problem in the attic and that he wouldn't do any work until the problem had been resolved.

I arrived early in the morning, before the day got too hot (attic work in the summer can be unbearable). As the owner had said, there was only one visibly moldy spot in the attic, where the bath vent had been pointing. I collected tape lifts and contact plate samples from the suspicious black spot, and from unstained wood framing and sheathing a few feet away from the problem area and at several other locations around the attic. I also collected samples of insulation from directly under the mold spot and other areas.

I examined the samples in my lab and discovered that the only measurably moldy area in that attic was the one little black patch; the rest of the samples were clean. I happened to be acquainted with the CEO of the involved environmental firm, so I called him to discuss my findings and suggested that he ask his guy

In the end, the homeowner decided to follow my recommendation: He scrubbed off the moldy patch with a sponge full of bleach and that was the end of the matter. He spent 50 cents instead of 20,000 dollars.

As a final thought, always make it a point on your jobs to get up into the attic and confirm that all the exhaust ducts are properly connected.

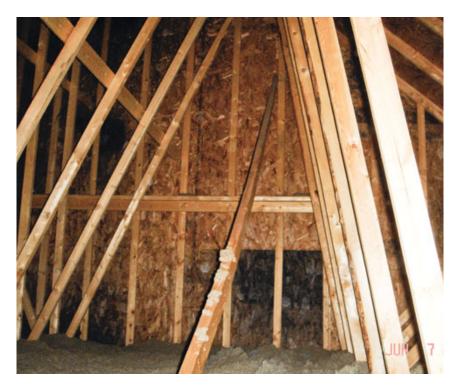
This time there was no avoiding an August afternoon visit. I climbed up into the attic, which I measured at 140°F. I teetered across the trusses, pouring sweat and getting groggy. When I reached the stained gable end, I observed a couple of neat, 2-by-4-foot rectangular patches of discolored OSB sheathing. Again I collected tape lifts and contact plates from the stains and from adjoining sheathing and framing, and took lots of digital photos.

It is said that nature abhors a straight line, and in this case the shape of the dark patch was an important clue. What would make fungus grow in such a neat shape?

The explanation was simple: It wasn't mold at all. My friends at the wood products lab at the University of Minnesota readily identified the growth as sap-stain

could have grown in this area of a blazing hot attic. The neat straight borders told the tale: The panel had gotten wet while sitting outdoors in the lumber pile, partially covered by other pieces of wood. It was installed with the stain already on it — evidence of a careless carpenter, not a moisture or mold problem in the home.

My culture showed the fungus to be dead, no doubt cooked long ago by the searing attic heat. There certainly was no indoor air quality problem related to this stuff. There was no blanket of spores waiting to be released, just a small patch of slightly flaky OSB that still maintained its structural strength. The needed repair

was to apply a quart of antimicrobial white paint — not to "cure" the problem, but to avoid panicking the next inspector.

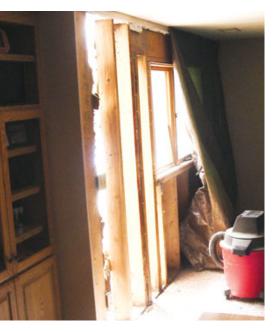
t was a 12-year-old home in a suburban development. The kids were shooting pool in the family room in the walkout basement when one of the boys noticed a mushroom growing from under the carpet against the wall. So Dad tore

out the paneling and drywall and found that floor-to-ceiling rot had destroyed the framing and sheathing. His first fear was that he had caused the problem himself; he suspected that he had improperly flashed the ledger board when installing a new deck off the kitchen directly above the rotten wall. But when he pulled off the siding, he found that the framing and sheathing were rotten above the deck as well. The trail led upward, directly to the sill of the kitchen casement window.

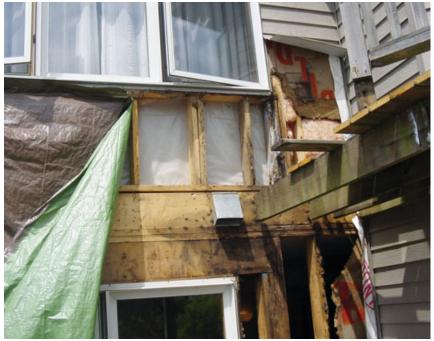
His wife was concerned that tearing out all the moldy, rotten wall material had contaminated the house, so I was asked to come out and test the home. She also was curious why the window was leaking, so I asked a builder friend, who told me that the weatherstripping on that brand of window tended to break down with UV exposure.

I invited him out to the home and, sure enough, we found a gap in the seal that ran around the inside of the window frame. The window was on the south elevation, where it got lots of direct sunlight, and the weatherstripping had simply disintegrated, leaving a 1/2-inch by 1/2-inch hole in the bottom corner of the frame. Because of the way the window frame was assembled, this hole allowed water to run directly into the wall cavity whenever it rained. Studies have shown that such a seemingly small hole can leak gallons of water during a driving storm. Trapped between the sheathing on the outside and the vapor barrier on the inside, the water had nowhere to go. The framing and sheathing stayed soaked, rotted, and eventually produced the fruiting bodies that the kids discovered.

The home was out of warranty, so the builder had no legal obligation to fix the problem. When contacted by the homeowner, the window manufacturer suggested that the homeowner pursue the manufacturer of the weatherstripping. Needless to say, the owner's blood began to boil. Before things got ugly, however, everyone saw the light of reason - with the help of a persuasive attorney. The homeowner repaired the water damage, the window maker replaced the south and west windows, and the builder stepped up and replaced the metal siding that had been torn off. In the end, the home was repaired and its value restored.

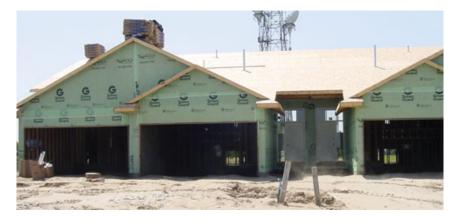
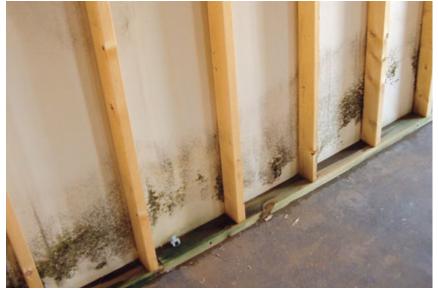
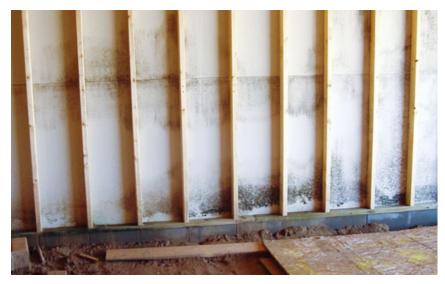
code official to inspect a mold problem on a townhome development under construction. The scenario was the same one I had seen on other projects: The gypsumboard party walls of several of the units had a luxuriant growth of black mold.

The source of the problem was obvious. During construction, the gypsumboard party walls were built on footings surrounded by bare dirt. When hot, rainy weather turned the ground to mud, a fungal garden grew, with visible mold extending in a horizontal band from the mudsill up as high as 4 feet. I cut a 6-by-6-inch-square piece out of the moldy drywall on one wall and found that it had mold on both sides. I could also plainly see mold on the back of the adjacent wall's gypsum board.

In the end, the builder took the bull by the horns: He supported the upper stories with temporary bracing, tore out the offending paper-covered party wall, and replaced it with concrete block. It was a costly repair, but it worked, and he was left with a property he could sell with pride instead of excuses. He also learned a lesson that will prevent such a problem on future projects.
