# Letters

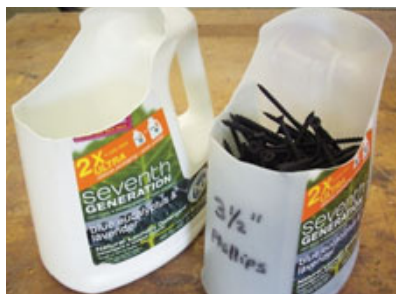
Like many contractors, we use job-site trailers with shelves, but no one likes to paw through bags looking for the nail or screw they want. So our staff has started saving their laundry detergent containers. We cut the jug so as

to leave the handle in place while providing easy access to the contents.
