Backfill

High, Dry, and Tight

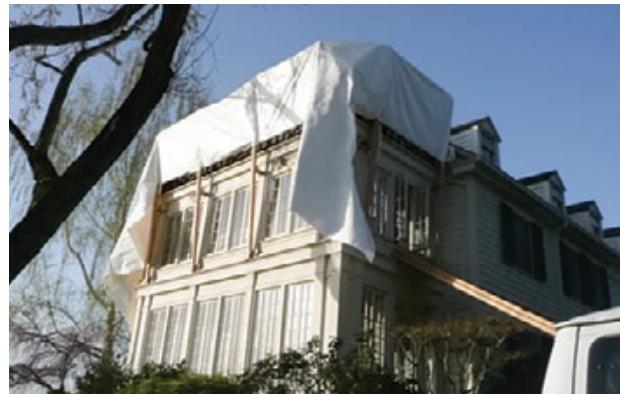
The builder’s crew spent about a day assembling a frame to support the shrink-wrap film, which here has been draped over the work area but not yet stretched tight.

To reduce the risk of flooding, Kasten arranged to have a local abatement contractor enclose the space above the deck with heavy shrink-wrap film, a material typically used to weatherproof large objects like boats, RVs, and modular home components. This, he hoped, would protect both his work area and the rooms below, where other contractors were hard at work on projects of their own. “It took us a day to set up the support structure and temporary railings,” he says. “The wrapping crew came in, spread the film, and shrank it tight with propane torches the next day, and we were ready to go.”

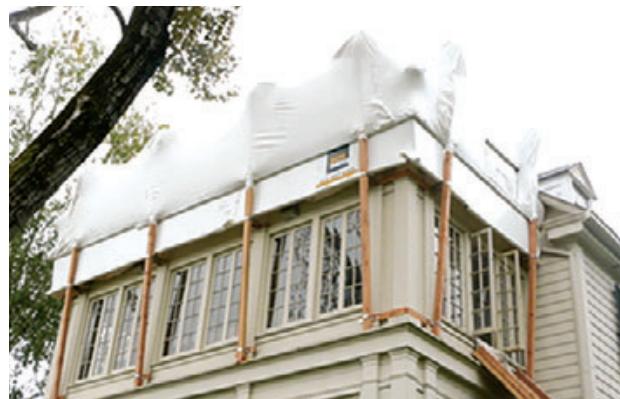
After being shrunk to its final size with high-output propane torches — a ticklish task carried out by an experienced abatement crew — the weatherproof and windproof cover remained in place for the duration of the six-week project. The debris chute visible at right was used by another contractor working in living space below.

As luck would have it, the installation marked the beginning of a week-long dry spell. But when the rains did come, they came long and hard. “I’d been worried about it for days,” Kasten says, “so when it started pouring, I raced over there to look, but it hadn’t leaked a drop.”

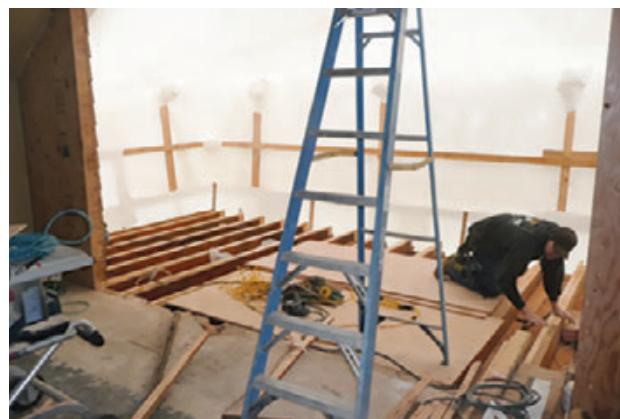
The job involved removing the existing roof, cutting down and sistering existing rafters, putting down a new roof, and then constructing a floating deck structure that was finished flush with the original bedroom floor. Much of the work was accompanied by the sound of heavy rain drumming on the plastic cover.
