# Restoring a Round Porch

Rot-resistant materials and better details extend the life of this unique coastal porch

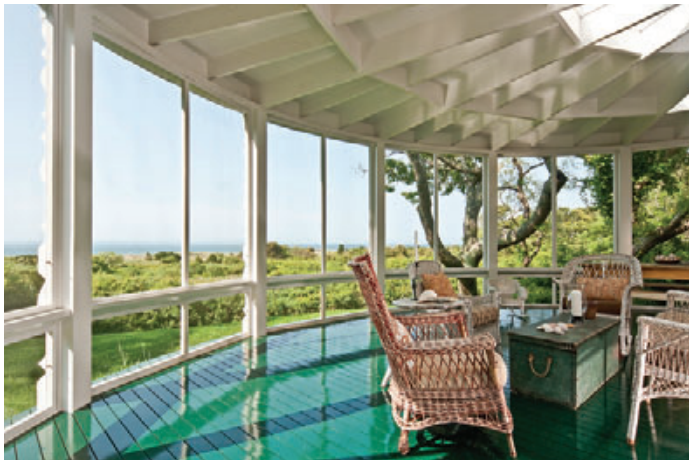
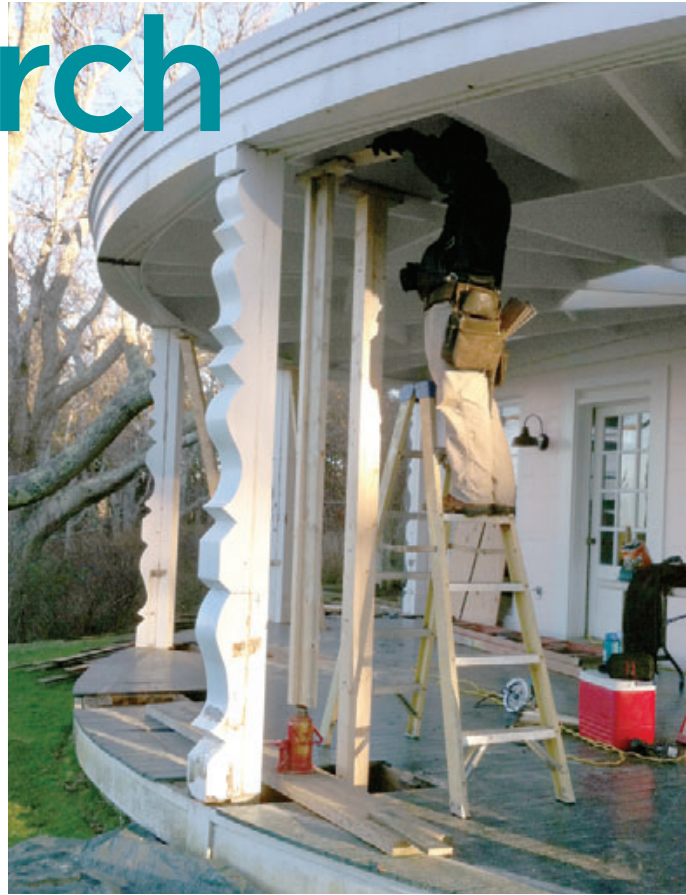
Recently we renovated a semicircular screened porch, one of the key features on a classic 1930s Martha's Vineyard home. Like a lot of coastal porches, this one had rot issues, particularly at the base of the sculpted fir posts. The posts had been repaired more than once, but the underlying problem had never been corrected. Our plan was to retain as much of the original woodwork as possible, replace what we had to, and incorporate details that would prevent future rot.

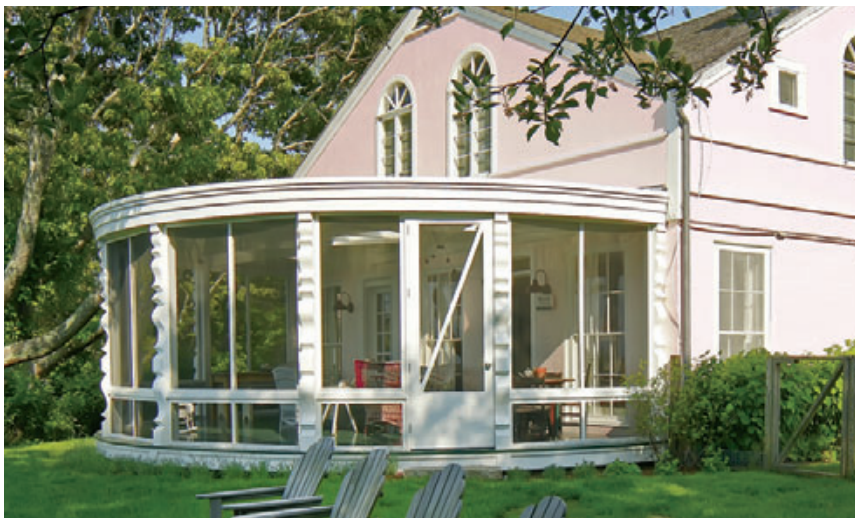
Before pulling the supports, we documented the existing ceiling height, the distances between the posts, and the size of the openings for the screen panels. This would make it easier to replace everything in its original location and

replicate the appearance of the original porch. The posts were held in place with 20d nails driven down through the top plate, a surprisingly strong connection that was difficult to disassemble. (After seeing how durable this connection proved to be, we used a similar detail when we re-installed the posts, replacing the 20d nails with 6-inch TimberLok structural screws, four per post.)

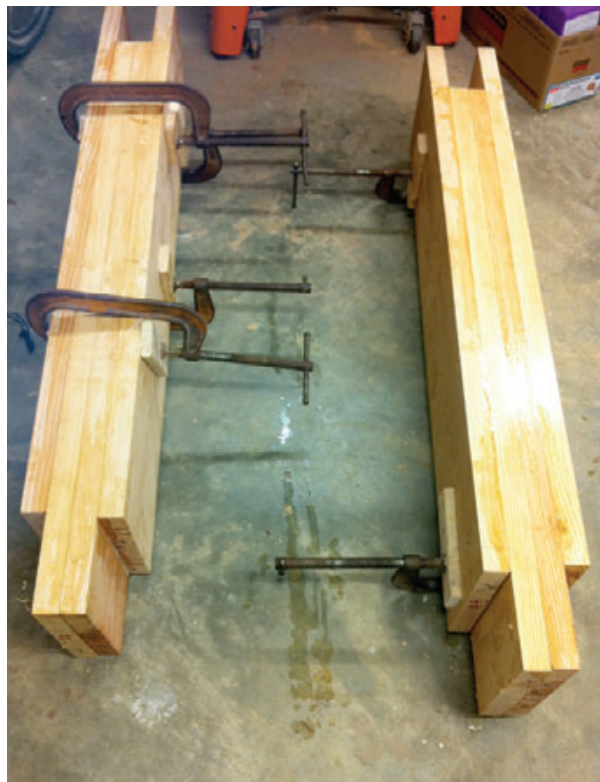
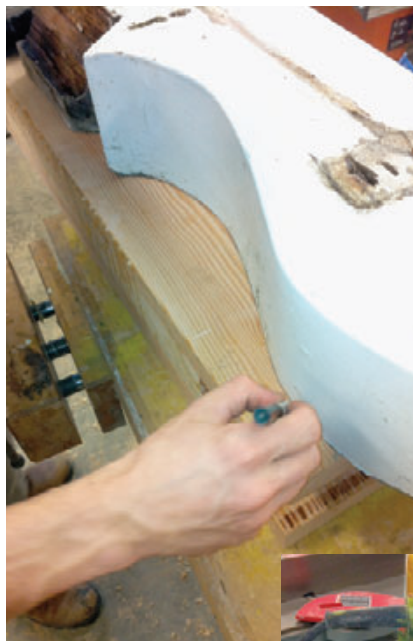
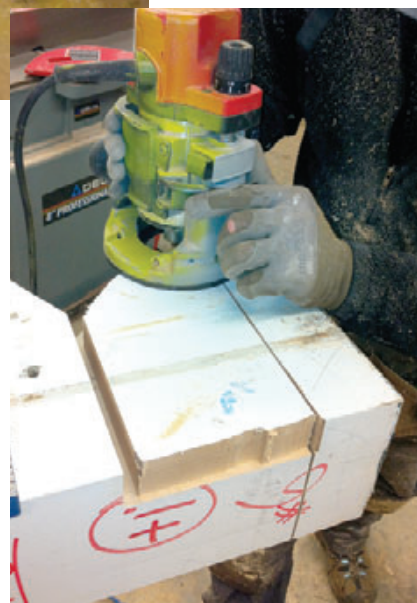
**Figure 1.** The 2x10 fir laminations of the partial replacement posts are offset to create a slot for joining to the original post sections (far left). After scribing the original column patterns (left) and cutting them out on a band saw, the author created a matching tongue profile with a router (below).

We assembled the replacement sections from four layers of 2x10 vertical-grain fir

laminated together with West System two-part epoxy (see Figure 1). We clamped the laminations together as the epoxy set, and also reinforced the assembly with torque screws and 1/2-inch-diameter through-bolts, countersinking the bolt holes and later filling them with fir plugs. To create a T&G profile that we could use to join the new and old column sections together, we offset the two outer laminations by 6 inches.

Using the removed column sections as templates, we scribed the appropriate profile onto each of the new blanks, then cut the profiles out on our band saw. We used a router with a 2-inch straight bit to give us a clean joint for the tongues on the old columns, then finished and fine-tuned the tenons with a chisel and belt-sanded the cuts smooth.

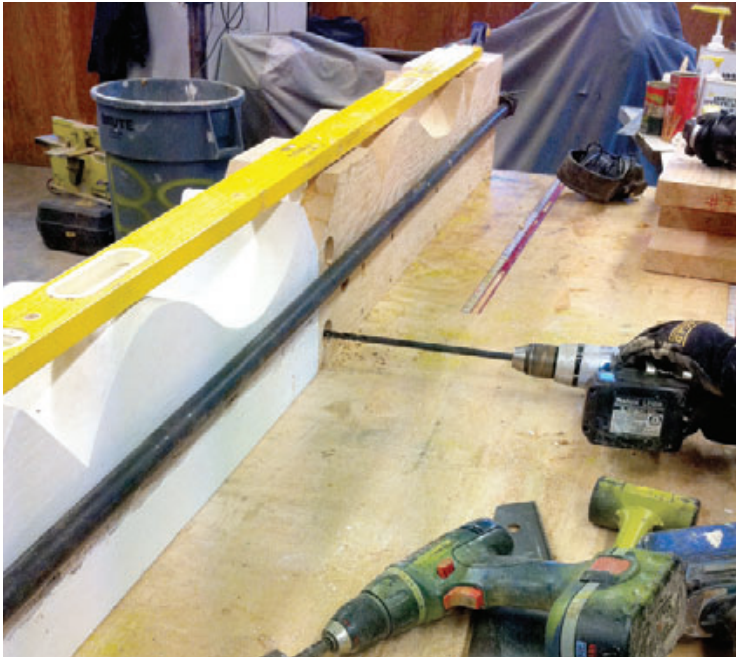
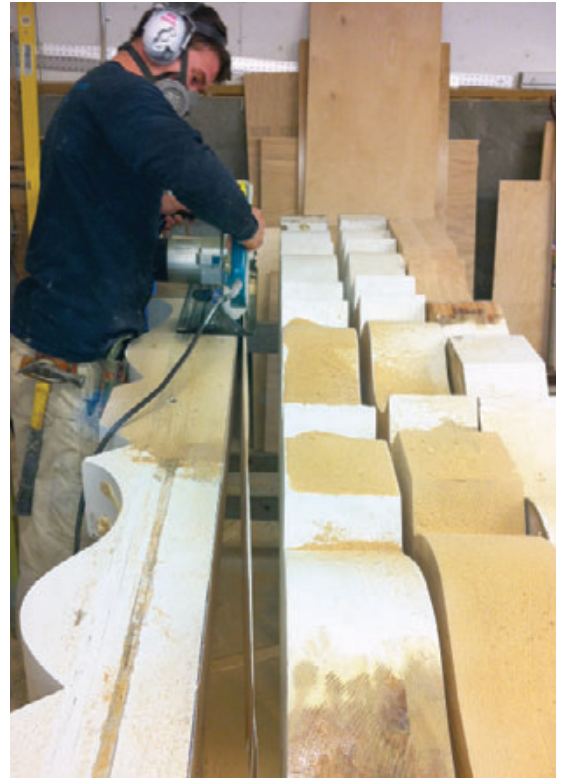
**Figure 2.** The new and old column sections were joined together with galvanized through-bolts and epoxy (above). Once the columns were reassembled, a worker straightened them with a large-capacity beam saw (right).

We joined the old and new column sections together with more epoxy, reinforcing the joints with 1/2-inch-diameter galvanized carriage bolts, which we drove through predrilled holes (Figure 2).

We also countersunk these holes, and later filled them with wood plugs. Some of the old 6-inch-by-9 1/2-inch columns were warped, so we trued and cleaned them up with our 16-inch beam saw. We patched blemishes and minor areas of rot with epoxy thickened with epoxy filler, then smoothed the cut edges with a belt sander. To clean up the scroll work, we used a drill-mounted paddle-style sanding wheel and a Fein detail sander. Then we primed the columns and brought them back to the site.

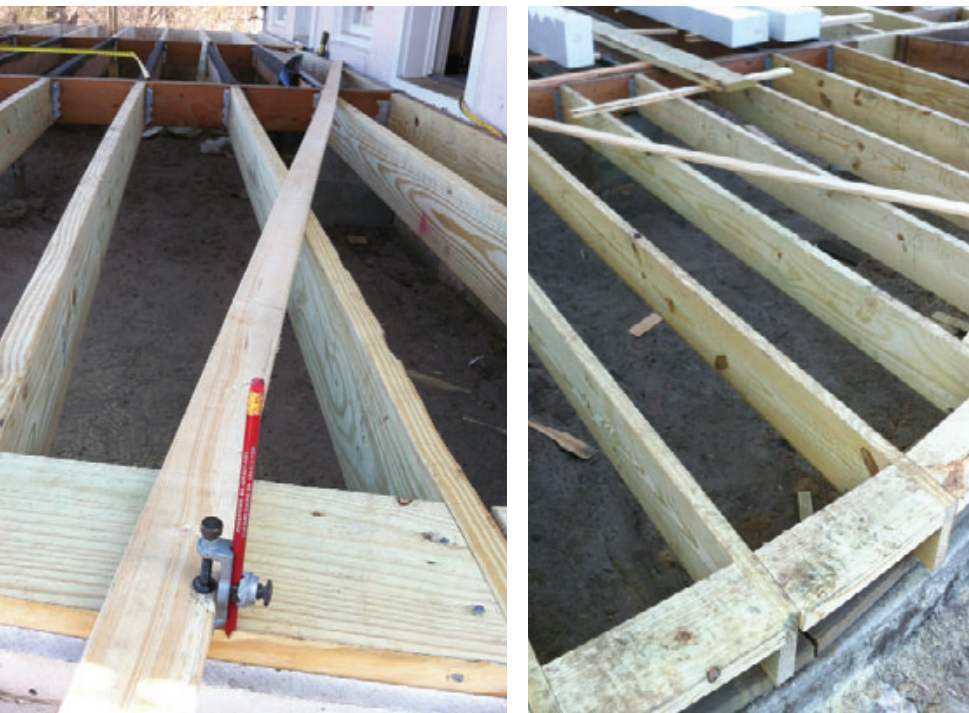
**Figure 3.** The author replaced the rotted joists with treated framing, then used a trammel arm (left) to scribe the deck's radius onto blocking installed on the flat around the perimeter of the deck (right).

Finally, to make sure the radiused sill and rim joist would provide fair and smooth backing for new fascia trim, we set up a large trammel at the centerpoint of the deck (**Figure 3, next page**). Then we installed PT blocking on the flat around the perimeter of the deck, and used the trammel to scribe the radius on the blocking. After cutting the curved profile with a circular saw, we padded the framing below this cut to our new radius line.

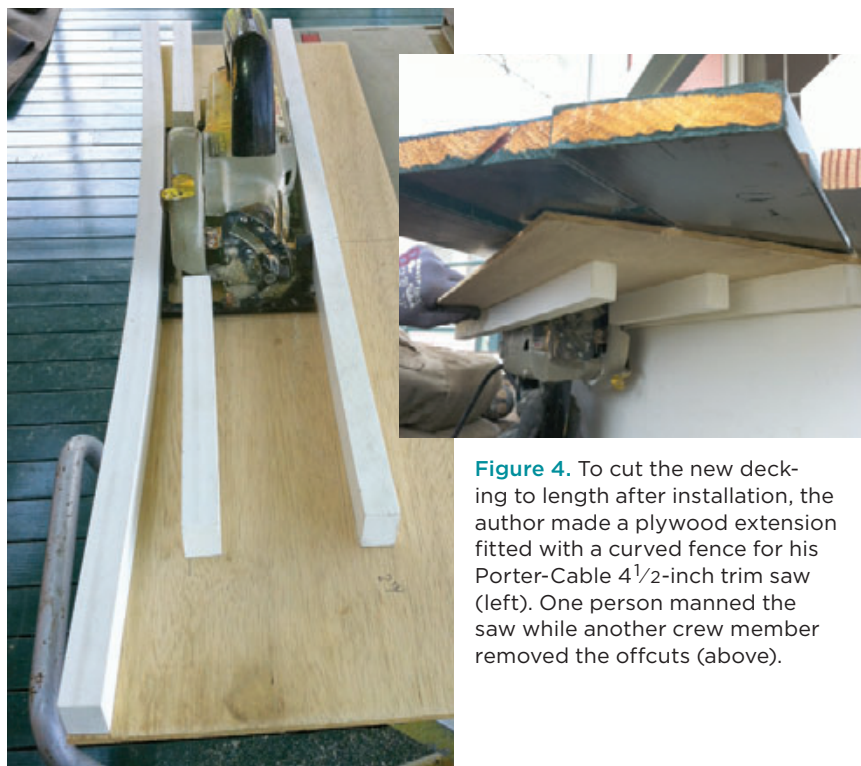
**Figure 4.** To cut the new decking to length after installation, the author made a plywood extension fitted with a curved fence for his Porter-Cable 4½-inch trim saw (left). One person manned the saw while another crew member removed the offcuts (above).

To cleanly cut the decking around the perimeter of the porch, we fashioned a simple jig for our circular saw consisting of a plywood table and a curved fence that matched the radius of the porch (**Figure 4**). With the saw clamped to the table, the jig was a little heavy but made it easy to safely and smoothly cut the radiused profile in the decking.
