Front Porch Revival

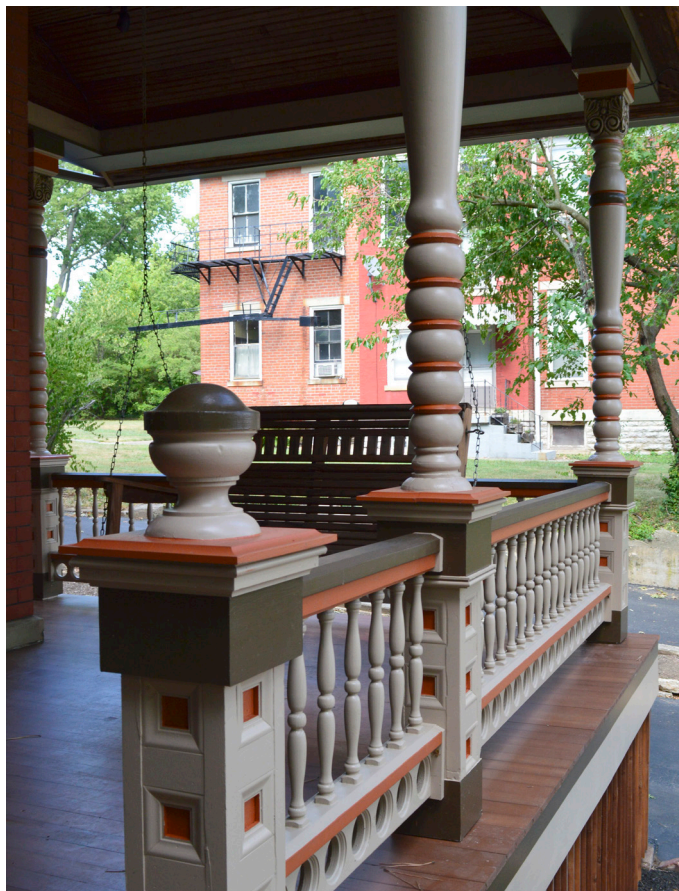
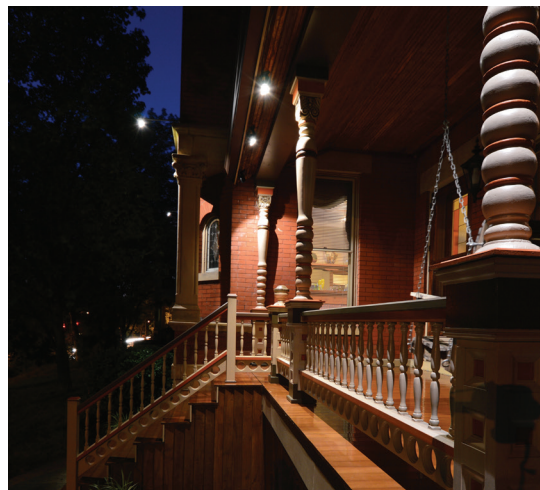
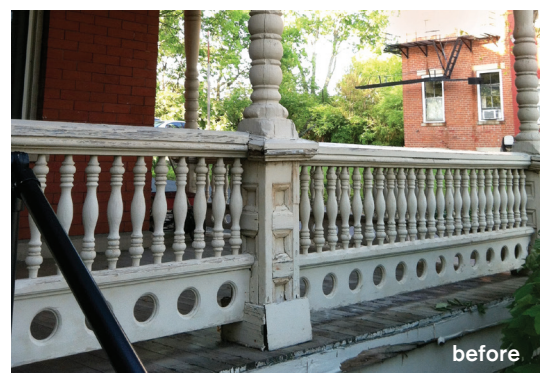
Each of the unique columns had originally been turned and hand-carved from a single poplar log, and most of the rot was concentrated down low where they were more exposed to weather. After cutting out the damage and patching as needed with PT lumber and two-part epoxy, Matulionis rebuilt them—though each column required 65 pieces of new trim to match the original look. The railings were too far gone to save, but proved to be useful as templates as he re-created the balustrade using redwood for the rails and well-dried PT for the balusters, which he turned in his shop.

To make painting the intricate color scheme easier, Matulionis pre-finished most of the components prior to re-

installation. While he used a spray gun to paint the rails, he painted the balusters by hand, mounting them on his “baluster turner,” a motor-driven unit of his own design that allowed him to rotate them while quickly brushing on even coats of paint. He supersized the unit for the columns but replaced the motor with a crank, so that it operated like a hand-driven rotisserie. A helper slowly turned each column while Matulionis applied the multiple painted rings needed to create the design, no taping required. It wasn't quite so easy at the tops of the columns, where a two-color floral pattern required more tedious handwork.

Before installing new T&G fir flooring and reinstalling the columns and balustrade, Matulionis sealed each board on all six sides with Sherwin-Williams Deckscapes stain. Later, he finished the flooring with three coats of spar urethane. A series of eight low-voltage LED lights illuminates the porch when it's time to step out at night. —*Andrew Wormer* ♦
