# Repairing Ornamental Plaster

BY RON AND WILLIAM BISSON

Last spring, we began plaster restoration work at the Fairbanks Mansion in St. Johnsbury, Vt. The mansion is part of the St. Johnsbury Academy (a private high school) and it serves as function space on the main floor and student housing on the upper floors. Built in 1884, the structure—the crown jewel of the academy's campus—has been under extensive renovations for the last couple of years. Most of the plaster cracking throughout the building was a result of normal wear and tear, but extensive foundation and structural repairs contributed to more-pronounced plaster damage localized to the first-floor rooms.

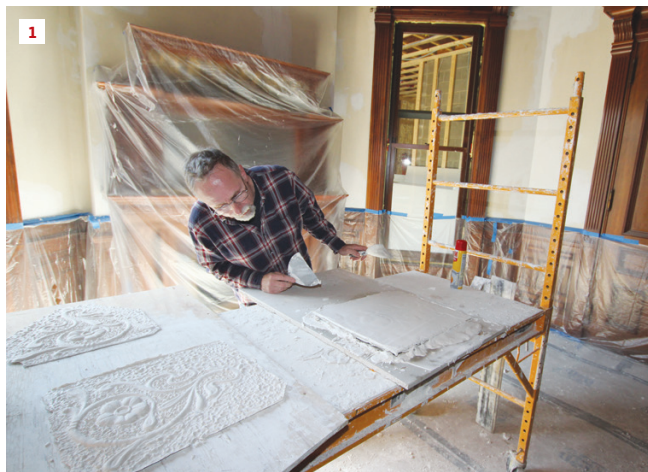
Master plasterer Ron Bisson inspects his replacement plaster flatwork (1), which will be used to repair the main entry hall ceiling of the Fairbanks Mansion in Vermont (2). Prior to making a mold, his son, William, brushes on one of seven coats of flex wax over an intact motif (3). Then the wax impression is removed from the ceiling and prepped for mold making (4).

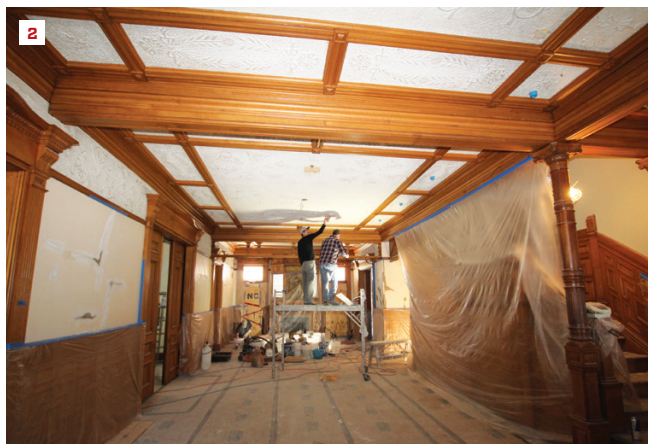
In terms of complexity, the ornamental plaster ceiling in the building's main entry hall (1, 2) was the project's most challenging restoration work for us. The ceiling's thin decorative patterns were done in what we refer to as flat reliefs. It had suffered from water damage and extensive cracking. Complicating matters, it had a rustic sponge finish. Though this rough, stippled finish looked like it had been added in intervening years, it was original and added a degree of difficulty to our work.

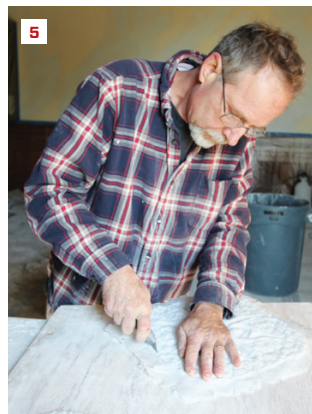
Ron trims the wax negative (5), while William and apprentice Derek Dawson mix fast-drying gauging (gypsum) to make the bottom, or saddle, of the mold (6). After the wax has been sprayed with oil, the gauging plaster is poured over the wax (7), flattened (8), then later flipped over (Hydrocal is used to make the new pieces). First, the mold's saddle is removed (9), then the paper-thin, Hydrocal replacement piece (10).

Starting out, we needed to make replacement pieces for some of the damaged decorative motifs. We chose intact candidates on the ceiling, masked them off with painter's tape, and applied petroleum jelly to the existing painted plaster surface to help release our impression molds. Then we applied flex wax in seven coats to a minimum thickness of 3/32 inch (3) to the shapes we needed. Once hardened, we removed them from the ceiling and prepped them for making molds (4)—we removed the painter's tape and trimmed the wax "negative" mold (5).

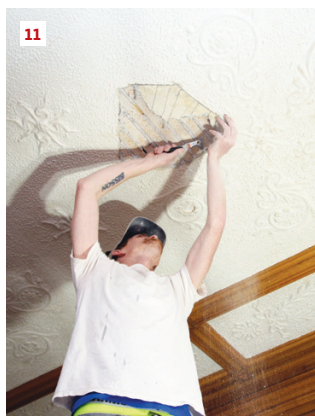
After the damaged piece has been removed (11), Ron applies a bonding agent over the old, dusty lath (12), then spreads a thin coat of plaster (heavy on the gauging, light on the lime) to the repair area (13). Squeeze-out from the replacement piece is tooled around the edge (14). Finally, touch-up lime putty is feathered to the existing painted surface, with the excess wiped (15) and tooled (16) off the existing paint.

First, we carefully removed the damaged decorative molding and some of the adjacent plaster down to wooden lath. We scored the existing plaster with a putty knife, cutting slowly through the finish and base coats. While removing the plaster, we pressed on the edge of the remaining plaster at the same time, so we didn't hurt the ceiling (11). We cleaned out all the gaps in the lath, allowing us to key our new plaster into the lath. We precisely lined up the replacement pattern
