## Grain Silo Pergola

by Dave Settlemyer

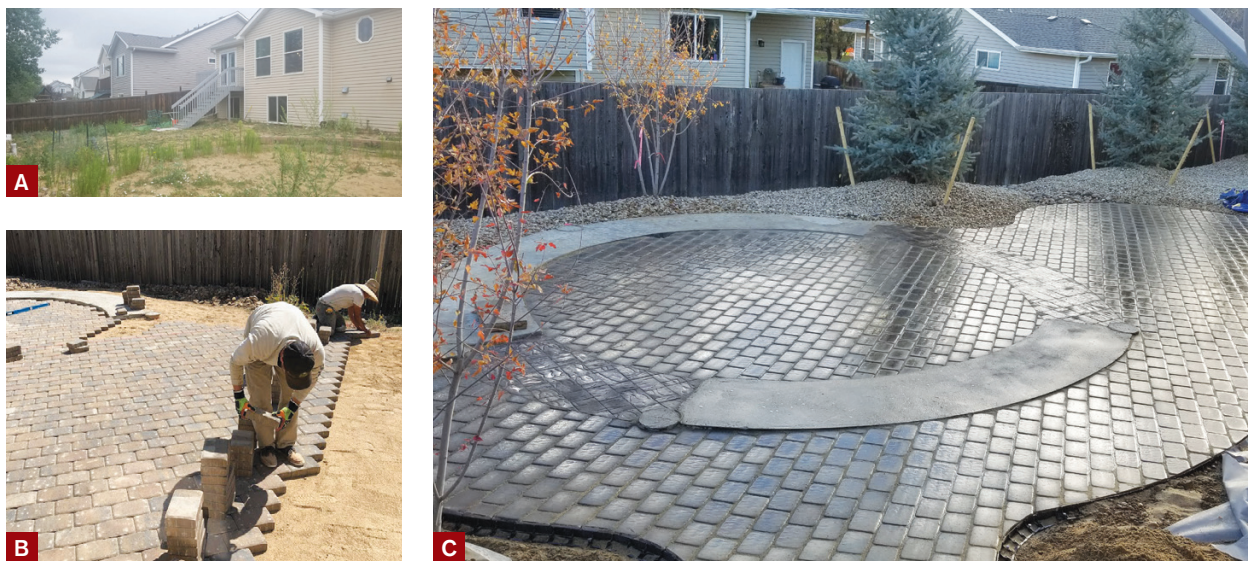
**Figure 1.** The barren backyard once had a small deck and an above-ground pool, which had long since been retired (A). The outdoor environment that the author designed featured a paver patio (B) and a new, larger deck. A pair of semi-circular concrete pads (C) mark the location of the grain silo pergola, the centerpiece of the project.

To prep the site, we graded and shaped the yard to accommodate additional xeriscape landscaping (**Figure 1**). Next, we cleared the patio base and drilled the support caissons for the silo post anchors. Because I planned to build the silo's kitchen cabinetry on site using steel framing supported by a concrete base, we poured a pair of semi-circular slabs prior to installing the paver patio. The slabs also outlined the silo's location and

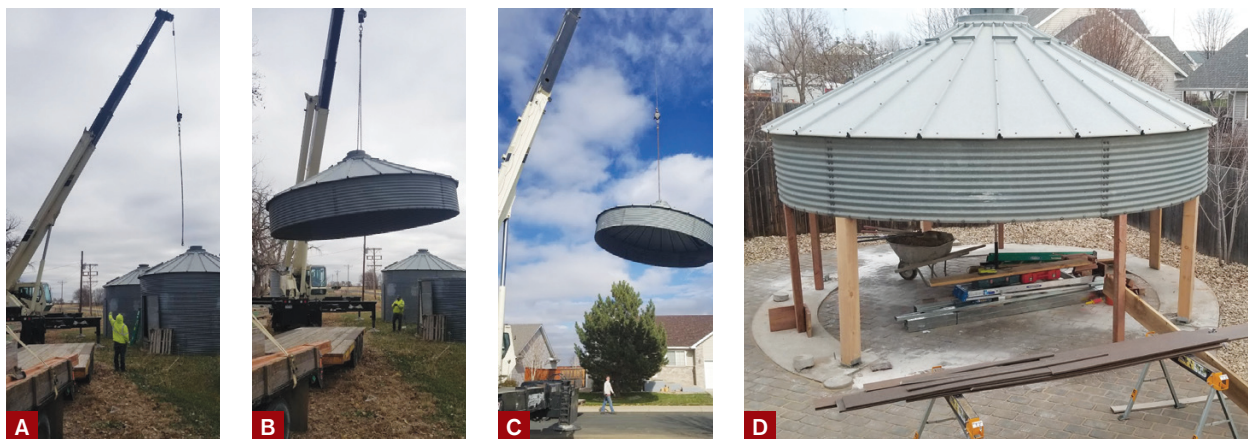
**Figure 2.** After most of the bolts holding the grain silo sections together were removed, a crane lifted the roof and upper section from the rest of the structure (A) and set it onto a flatbed trailer (B). At the client's home, the silo roof was hoisted over the house (C) and set gently onto temporary 4x4 posts. Later, permanent 6x6 posts were installed (D).

We hired a local crane company to help us move the silo, so it didn't have to be completely disassembled into individual panels (**Figure 2**). To prep for the move, we removed almost all the screws holding it

together at the top band of corrugated steel, leaving four screws to hold it up until the crane was ready to lift it off the base.

After removing the cap on top of the silo, we lowered the crane rigging down into the center and strapped an old tractor tire to the rigging. The crane operator lifted the rigging enough to take the weight off the structure so that we could remove the last four screws, then lifted the top section away from the base and placed it on a flatbed trailer.

We strapped the silo to the trailer and moved it two miles down the middle of a gravel road, through the back entrance to the owner's housing development, and up to the curb in front of the owner's house. There, the crane set up a second rigging and lifted the silo off the trailer, over the house, and into the backyard.

To finish up the crane work more efficiently, we lowered the silo onto temporary 4x4 support posts, positioning the silo high so that we could then lower it onto its permanent 6x6 posts later, without the crane. There the silo sat for about a week while we made adjustments to our caisson layout (it turned out the silo wasn't a perfect circle, thanks to the car accident that had damaged it, and so we had to move a couple of piers) and installed the permanent posts. While the silo was perched up high, we prayed for calm weather and no wind every day.

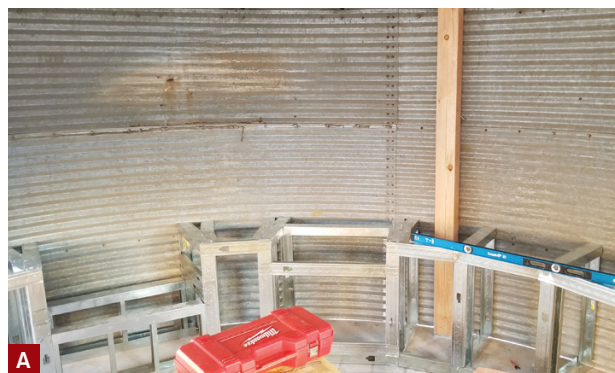
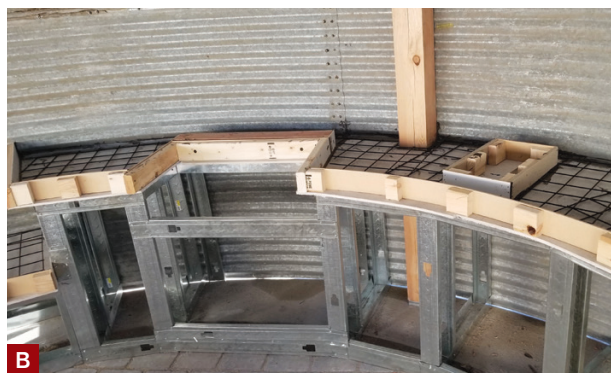
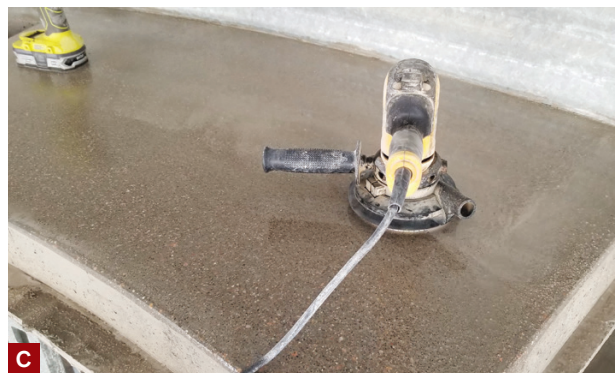
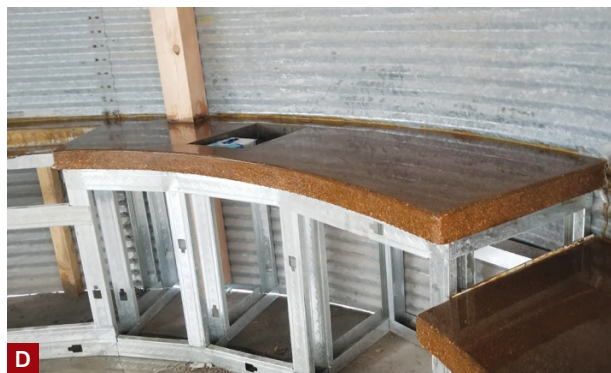
**Figure 3.** The author framed the kitchen cabinetry with light-gauge steel (A), then used cement board to form the base of the countertops, and smooth MDO plywood screwed to blocking to form the sides (B). Once the concrete cured and the forms were removed, the tops were polished smooth (C), then acid-stained and sealed with epoxy (D).

We used light-gauge galvanized steel studs to frame the kitchen cabinets (**Figure 3**). We chose steel framing because in addition to being perfectly straight and rot-resistant, it is non-combustible, an important consideration in an outdoor kitchen with an insert grille planned for installation in the countertop. Finally, we needed the steel framing to support the weight of all the concrete that we were planning to pour to form countertops.

We chose concrete as the medium for all the countertop work because it was the most adaptable material for the curvature of the pergola. We have a lot of experience with cast concrete and have developed a few techniques that we were able to incorporate into this project. For example, we used Hardibacker cement board as the base for our formwork, because it's strong and easy to secure to the framework with screws, and we don't have to worry about having to remove it after the concrete has been cast in place.

We polished the slabs to an 800-grit glass finish, stained them with a mix of amber and ebony acid stain, and sealed them with a two-part exterior-grade UV-resistant epoxy. All the elevations were cast in place, creating multiple levels of countertop. These allowed for flexibility with the placement of components such as a smoke box, grill, wash tub/ice bin, and refrigerator. We left several areas open under the counters in order to have versatility in placement of access doors and a balanced feel.

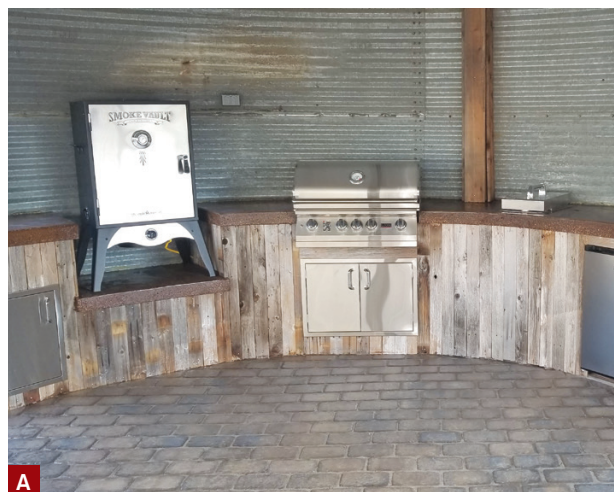
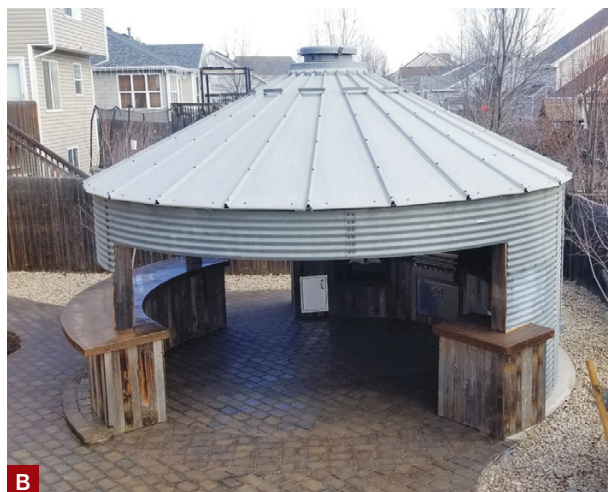
**Figure 4.** Reclaimed random-width fence pickets face the kitchen cabinetry (A), which wraps around the inside of the silo pergola. In the midst of a Colorado Front Range subdivision, the steel structure is a friendly reminder of the area's agricultural roots (B).

We faced the cabinets with multiple sizes of reclaimed 3-, 4-, and 6-inch-wide fence pickets, installing them vertically in order to match the pergola's circular shape more accurately (**Figure 4**). ♦
