## Backyard Pavilion

by Bayn Wood

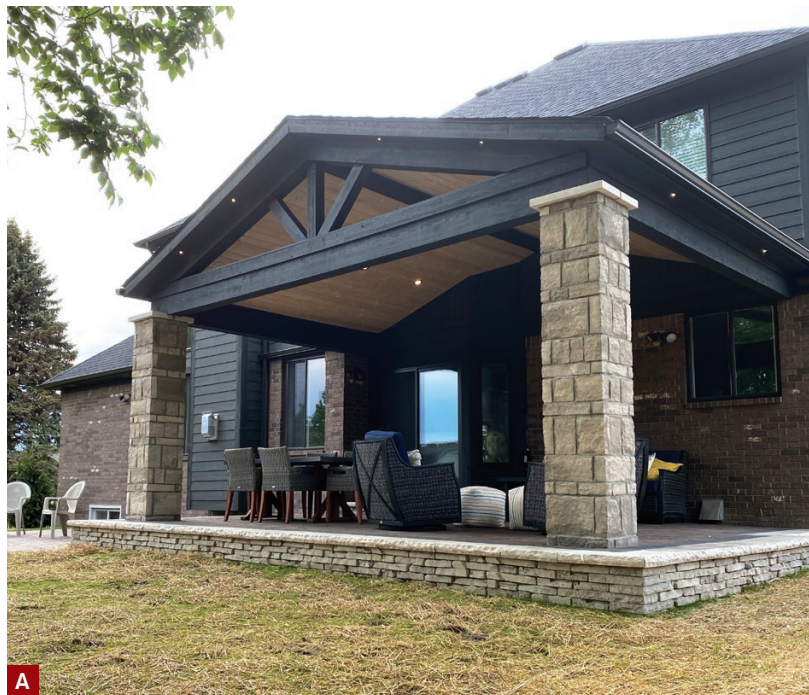
In our area, most newly built homes include some sort of covered deck, covered patio, or lanai. We get calls almost every day to add these types of projects, either to complete a new build or as a retrofit to an existing home. Prefabricated aluminum louvered pergolas are another option, but the cost of those is prohibitive for most of our clients; stick-built patio covers—we call them pavilions—like the one shown here are less expensive and, in my opinion, add better value to a home (A).

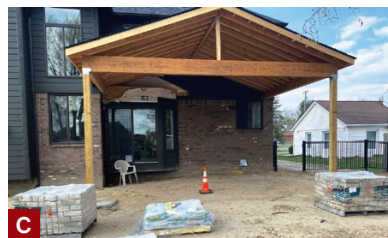
We framed the pavilion with triple 16-inch-wide LVL beams, which bear on 6x6 PT posts at the outside corners. The side beams carry into the house wall framing, which we beefed up to carry loads down to the foundation (C).

The ridge beam is a double 2x10 that fits into a ridge beam pocket that we framed in the second-floor house wall. The outside of the ridge load path is brought down to the LVL beam with a doubled 2x4 post. The only tricky part of the roof is the cricket layover roof that creates the valley to push the water away from the house wall.

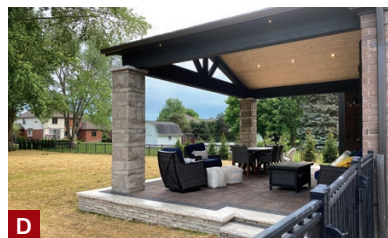
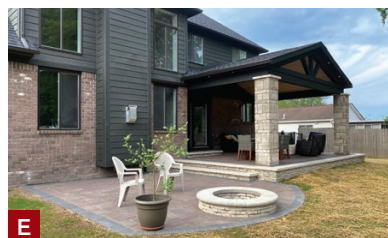
We clad the beams with 1-by rough sawn spruce painted to match the house. The two support posts, which bear on 28-inch-by-28-inch-by-42-inch-deep concrete piers, were clad with a stone veneer to match that used on

the home's front elevation (D, E). The ceiling is unfinished 1x6 tongue-and-groove pine with Trex low-voltage lights, which are used in the soffit, as well.
