BY CLAYTON DEKORNE

## 800 Years and Counting

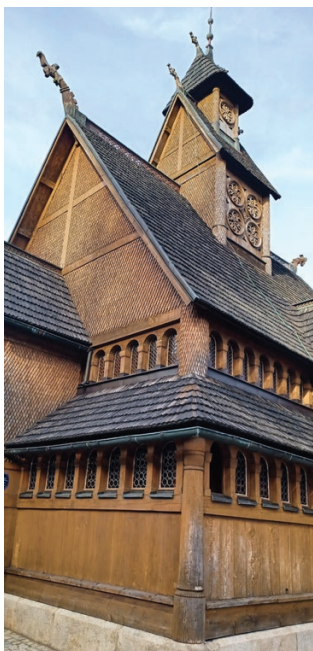
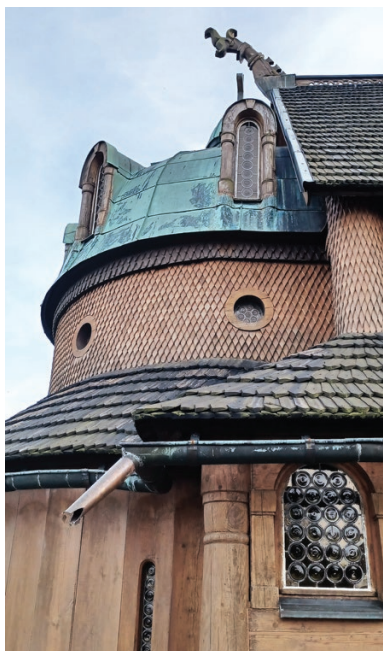
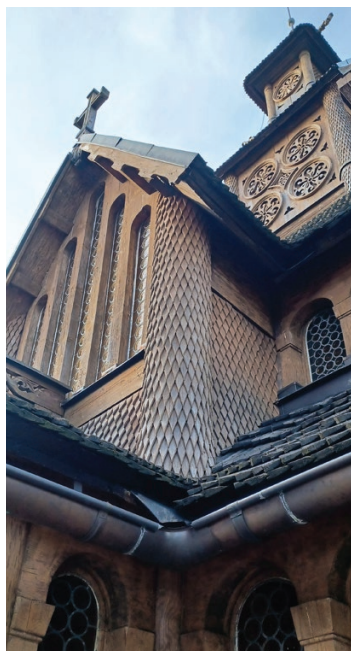
The Kościół Wang, as it is locally known today, is a Norwegian “stave” church dating from around 1200 that was moved in 1842 to Karpacz, Poland. There are no metal fasteners except in the domed copper roof, gutters, and some flashings. Even the wall and roof shingles are doveled in place.

Stave construction seems to be a uniquely Viking technology that evolved from methods the forest-and-fjord dwellers devised for building ships. Essentially, it’s a post-and-beam structure formed from all-heart Norway spruce and Scots pine that the builders prepared by lopping off the branches of living trees in early spring so the trees would bleed sap and concentrate resins in the heartwood. Once frost-hardened, the trees were felled in early winter, yielding a pitch-infused, extra-rot-resistant wood. Walls were formed from thick vertical boards that were “fish-joined” (an arrow-and-groove-type edge joint) to each other, and the ends dovetailed into horizontal sills that rested high and dry on gravel beds and granite footings.

Though they had never seen such a building, the local builders, also forest dwellers, were no strangers to building timber structures with the same four essential tools—ax, chisel, auger, and draw-knife—that the original builders had used. Using the weatherworn parts as templates, they fashioned most of the building from local woods and kept only the pitch-soaked posts, sills, and trussed rafters, which, to this day, remarkably still give off a scent of tree pitch.
